de Alcântara Rufino, Marina; Silva Foicinha, José Renato; de Alcântara, Enner Herenio ENVIRONMENTAL IMPACT OF URBANIZATION ON SANTA EULÁLIA SMALL FARM, SÃO LUÍS-MA, BRAZIL

Sociedade & Natureza, vol. 1, núm. 1, mayo, 2005, pp. 801-807 Universidade Federal de Uberlândia Uberlândia, Minas Gerais, Brasil

ENVIRONMENTAL IMPACT OF URBANIZATION ON SANTA EULÁLIA SMALL FARM, SÃO LUÍS-MA, BRAZIL

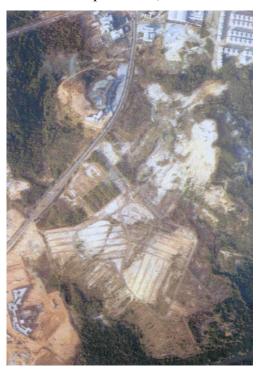
Picture 1: Aerial sight of Santa Eulália small farm, source: SOBRINHO, 2002.

Santa Eulália small farm meets totally in the urban center of São Luís, it takes place only 8 km of the center and it has an access by the Avenue Carlos Cunha / Ponte Bandeira Tribuzzi. Currently, it fits an area of permanent protection, inserted in the diverse category of use, whose type of established occupation is the exposed soil, together with the degraded mangrove area, as it can be visualized in picture 1, (MARANHÃO, 1988).
