Sociedade & Natureza, vol. 1, núm. 1, mayo, 2005, pp. 781-788

URBANIZATION AND ENVIRONMENTAL DISRUPTION OF CATCHMENT BASINS AS A RESULT OF HOUSING DEVELOPMENT AT CIDADE OPERARIA AND ADJACENCIES, MARANHÃO ISLAND

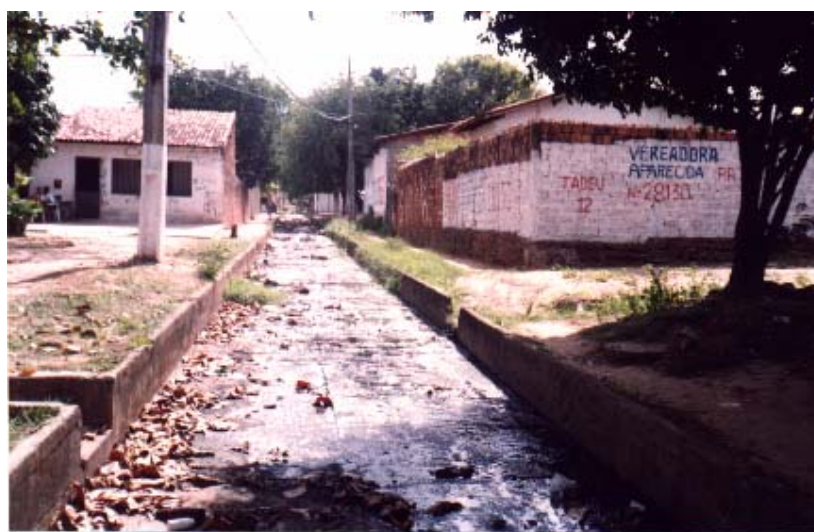
One of the tributaries of the Paciencia River, located between the units 203 and 201 ($02^{\circ}34'14''\text{S}$ e $44^{\circ}11'57''\text{W}$), has been channeled with concrete to receive and drain pluvial waters from the housing complex. It also receives considerable flux of solid waste, facilitating the proliferation of pathogens. Its spring can be identified by the arrangement of the houses in a concentric display that indicates the configuration of the original relief. This area also presents the highest elevation within the valley (Figure 2).

Figure 2: Tributary of the Paciencia River.

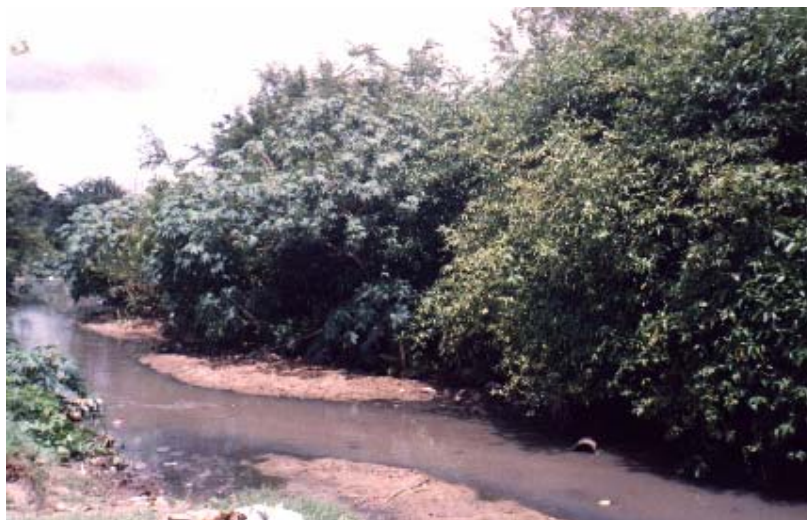
As we move towards the mouth of the stream, the medium course becomes visible ($02^{\circ}34'14''\text{S}$ e $44^{\circ}12'00''\text{W}$) due to a steep change in the declivity of the river bank. The housing development in this area is clearly disorganized, and has caused considerable vegetation clearing along the river lower course ($02^{\circ}34'14''\text{S}$ e $44^{\circ}12'23''\text{W}$), leading to erosion of the banks, and earthfilling, as well as acting as a repository for domestic effluents (Figure 3).

Figure 3: Confluence of the Paciencia River and the tributarie.

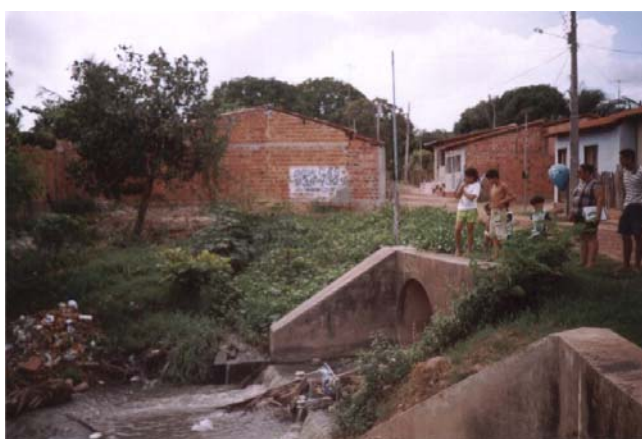
These settlements without minimal infra-structure have considerably increased the volume of untreated sewage being released in the streams and rives, adding to the sources already established at the localities of Jardim America, Vila Janaina, Units 103, 105, and 205 of the Cidade Operaria, Recanto dos Passaros and Geniparana. These effluents are released right in the Santo Antonio River, approximately 250m downstream from its spring (Figure 3).

Figura 4: Dejeção of sewers in the high course of the River Santo Antonio – Recanto dos Pássaros.
