Gawakiewicz, Rafał; Szafarczyk, Anna
SURVEYING IN THE STUDIES OF THE STABILITY OF EARTHY CONSTRUCTIONS,
FOCUS ON SELECTED HISTORICAL MOUNDS IN KRAKOW (POLAND)
Boletim de Ciências Geodésicas, vol. 22, núm. 2, abril-junio, 2016, pp. 325-341
Universidade Federal do Paraná
Curitiba, Brasil

**SURVEYING IN THE STUDIES OF THE STABILITY OF EARTHY
CONSTRUCTIONS, FOCUS ON SELECTED HISTORICAL MOUNDS IN KRAKOW
(POLAND)**

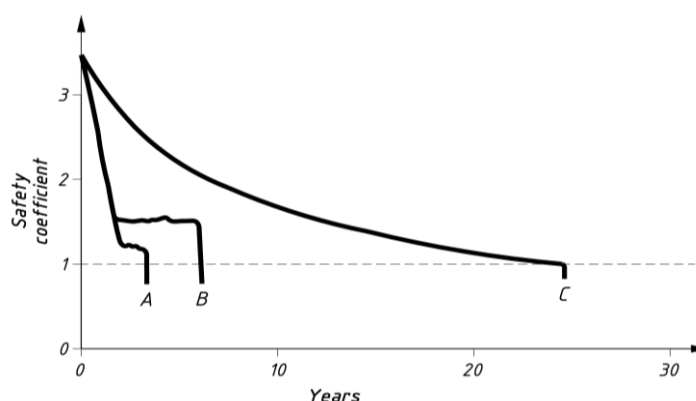
Figure 2: Graphs of the course of the development of selected (typical) land slide.

The characteristic of the strains of mound earthy masses in time, is also presented in the graph of land slide movements of Terzaghi's scarps (Figure 2), resulting from the influence of precipitation and the impact of surface waters on the cone of the mound, causing water saturation of these masses. Also Figure 3, illustrates the subsequent phases of relatively small changes as a result of the decrease in the safety coefficient (Reale et al., 2015) and changes in the ground conditions causing the acceleration of the landslide process and the appearance of landslides and subsequent stage of halting the process (Handwerger et al., 2013). The total result is usually repetitive in time. Figure 3 defines the characteristic of the strains of earthy masses in scarps as a three stage process, consisted of the following stages:

- **initial phase (movement A – B)** – the phenomenon of soil creep or slow slide, which occurs after transgressing the border of safety coefficient equalling one;
- **phase of quick displacements (movement B – C)** the movement of ground masses in a relatively short time;
- **phase of slow movements (movement C – D)**, similar to the observed in the initial phase.

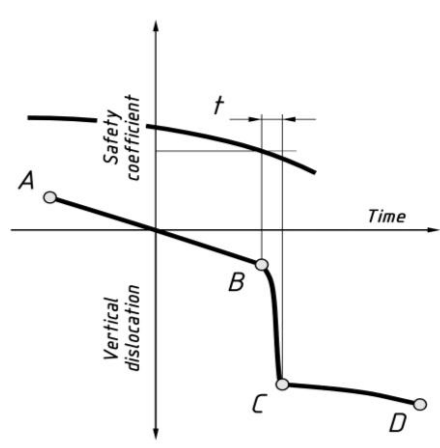
Figure 3: Stages of the land slide movements of scarps according to Terzaghi

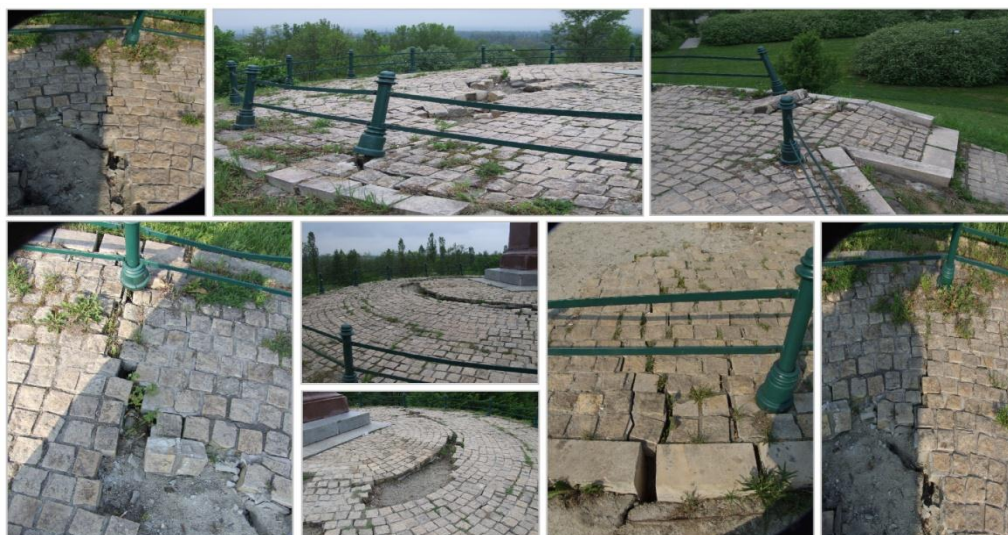
Figure 4: The view of destruction of the upper view balustrade of the Wanda Mound in 2010 and 2012, as a result of intensive and long term precipitation

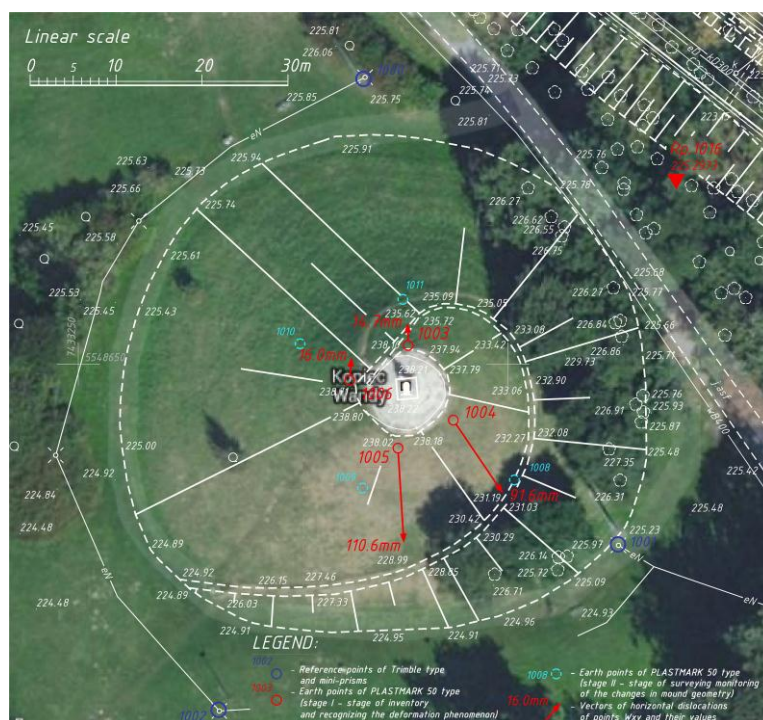
Figure 5: Vectors of horizontal 4 control points localized in the neighbourhood of the balustrade (the values cover the period 02.06.2012 ÷ 26.07.2013 - the Google Earth satellite image was applied)

In June 2012 in the framework of the implemented series of works connected with the inventory of Krakow's historical mounds, on the crown around the stone balustrade, 4 points of the control line making a quadrangle and 4 points of the resistance grid localized outside the outline of the construction (8 points altogether) were put – Figure 5. Using surveying technologies within the integrated measurements (GNSS, traverses and precise levelling), spatial coordinates of these points in state systems PL-2000 (horizontal coordinates) and Kronsztadt '60 (vertical coordinates) were determined with the highest possible precision and full inventory of the construction was made, including the 3D model. Occurring within the subsequent 14 months deformations of the mound, studied individually in the horizontal (Figure 5) and vertical (Figure 6) plane, made impulse to start activities aiming at the definition of the full characteristics of these changes in time (including the intensity and direction). The obtained results of the measurements documented a significant asymmetry in the values of horizontal displacements (an order of magnitude), where the southern slope was significantly dislocated in the southern

direction, and the northern slope was moved only slightly in the opposite direction. Also in a vertical plane, within 14 months, significant changes occurred in the heights of the points of the control grid and a significant dispersion of subsidence values occurred in the range of $-4.0 \div -88.2\text{mm}$. The highest changes in the space dislocation vector W_{XYH} were recorded in point 1005 of the value nearly 142mm in the southern direction. The analysed of time intervals confirmed the correctness of the description of landslide movements, where the values of horizontal displacements exceed the values of vertical dislocations.

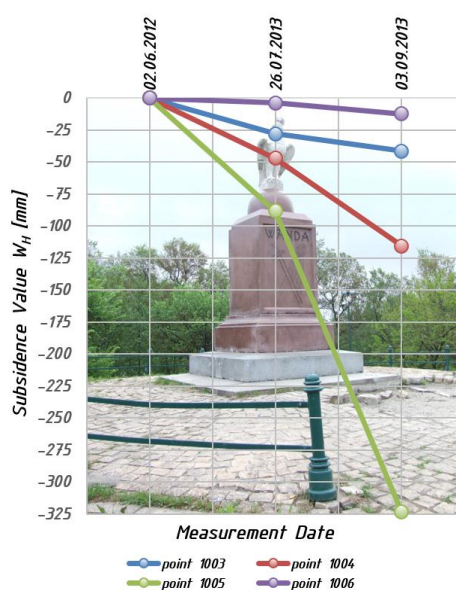
Figure 6: The graph of vertical dislocations of 4 control points located in the neighbourhood of the balustrade in 02.06.2012 ÷ 03.09.2013

Sudden clear movements of earthy masses in the upper part of the crown within less than 5 weeks (26/07/2013 ÷ 03/09/2013) and change of the characteristics of the slide resulting from the acceleration of the subsidence process, and slowing down horizontal movements made base for the development of the grid of control points. Thus to obtain larger image changes, in March 2013, further 4 points were stabilized at the height of 2/3 of the object – Figure 5. In the framework of recognizing the characteristic of these movements and the definition of the degree of unevenness of the deformation process in the earthy cone in: July 2012 – March 2015, altogether 11 measurement series, in the framework of point monitoring, a grid of control points was made (three times upgraded to more precisely define deformation phenomenon), with the application of integrated precise surveying technologies, i.e.: angular-linear measurements, levelling measurements and laser scanning. This work was carried out in different time intervals, often applying the principle of making measurement sessions, after intensive precipitation or visible effects of the deformation of the upper zone of construction; both in the part of stone balustrade, as well as the earthy part directly adjacent to it.

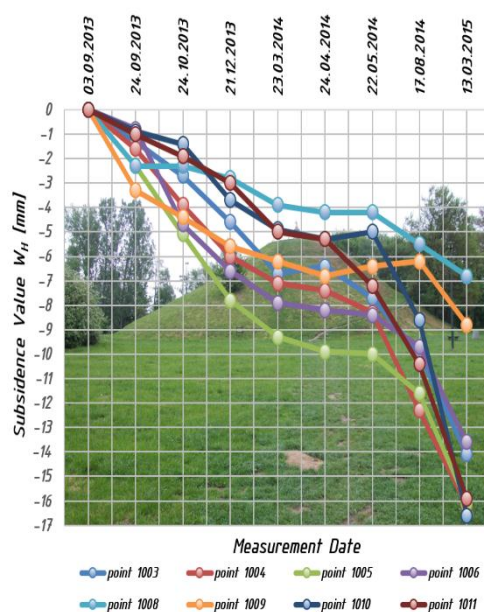
Figure 9: The graph of vertical dislocations of 8 control points located in the neighbourhood of the balustrade in 03.09.2013 ÷ 13.03.2015

On the other hand, from September 2013 after the time of significant subsidence resulting from a considerable slide of earthy masses clearly slowed down the process of the subsidence of points on the whole surface, even with short-time spring uplift of point 1009 and distinct acceleration of the subsidence values within the 10 latest months (Figure 8). This is confirmed by the intensity of subsidence of the points of maximal values -11.6mm (point 1010) and -8.7mm (point 1011) situated on the height of 2/3 mound on the north side. Again, one can observe asymmetry and distinct change in the preservation of the earthy masses on the whole height of the earthy cone. The southern slope in south-east profile (points: 1005-1009-1013), defines such asymmetry, where points situated on the height of 1/3 and the summit showed the vertical dislocation of values which is nearly 3 times larger than point 1009 situated on the 2/3 height of the mound. In table 3 the subsidence values of W_H control points in the discussed time interval: 02/06/2012 ÷ 03/09/2013 (STAGE I) located on the summit of the mound (graph Figure 6), while table 4 shows all the control grid points, stabilized on the surface of earthy barrow marked based on the remaining 9 measurement series, i.e.: in the time interval 03/09/2013 ÷ 13/03/2015 (graph – Figure 9).

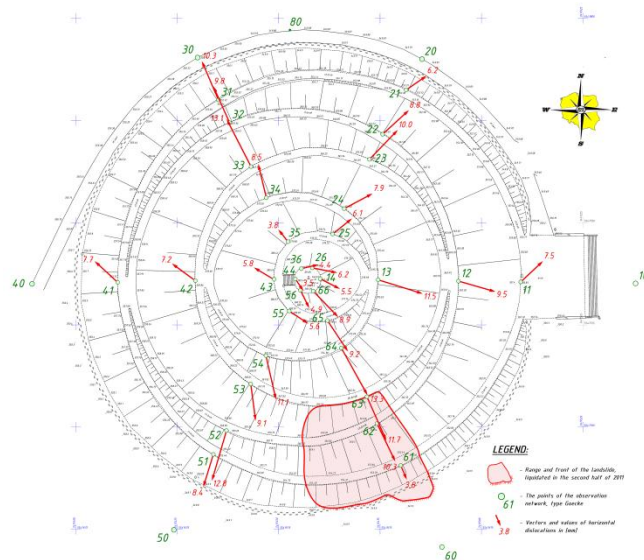
Figure 10: The output of vectors of displacements of horizontal points of the control grid localized on the surface of the Józef Piłsudski Mound in Krakow in 10.2012 ÷ 09.2014

Referring to the changes that occurred in a similar time interval of nearly 2 years on the largest of the Polish mounds - the Piłsudski Mound, there is a similarity in the characteristics of these change, and more precisely, the convergence of the directions of vectors of horizontal

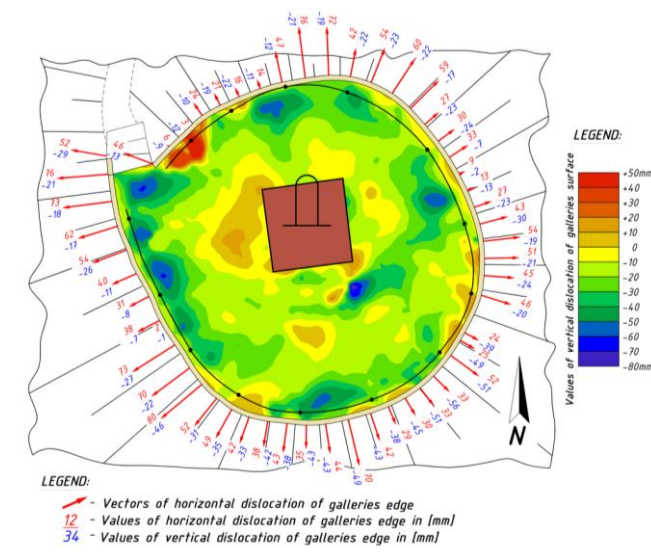
Figure 11: The image of height changes in the surface of the view balustrade at the Wanda Mound and horizontal and vertical displacements of the stone lining, recorded in 12.11.2013 ÷ 13.03.2015

Integrated measurements, i.e. angular – linear measurements, levelling measurements and laser scanning allowed the definition of the scale of horizontal and vertical displacements not only in control points located on scarps, but also stone edge of the balustrade. Thus the data analysis allowed defining the scale of the change and marking, also in this part of the mound, zones of significant deformation index of the ground building the substance of the mound (Figure 11).
