Experimental evaluation of colored HSC column in fire conditions.

Revista de la Asociación Latinoamericana de Control de Calidad, Patología y
Recuperación de la Construcción, vol. 3, núm. 1, septiembre-diciembre, 2013, pp. 39-54

C. Brites¹, P. Castro-Borges², A. Berto³, P. Helene¹

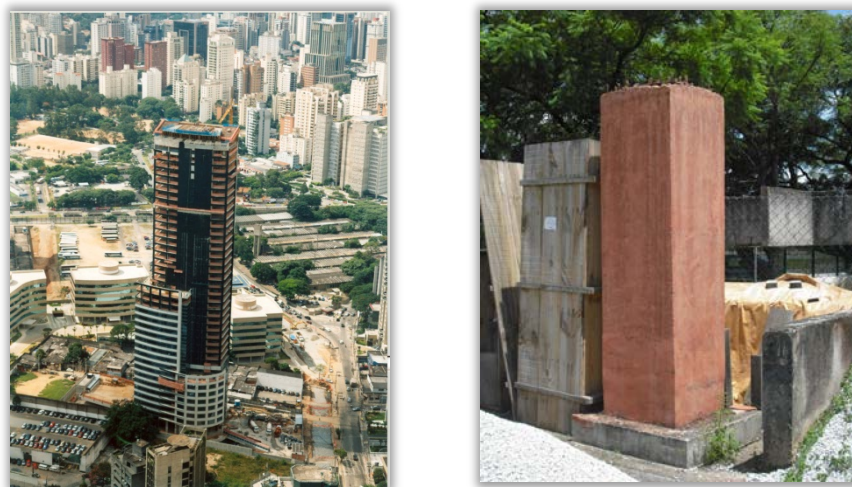
Figure 1. (a) *e-Tower* building, 162m high; (b) HSCC prototype replica, cast at the EPUSP laboratory yard, São Paulo, Brazil

Recently, Brazil was recognized internationally by breaking the record of cast-in-place high strength colored concrete, HSCC, which was employed in several columns of the *e-Tower* building in São Paulo City at the southwest region of the Country (Hartmann; Helene, 2003). When *e-Tower* was built in 2002, some replicas of these columns were cast-in-place at the yard of the Escola Politécnica of the University of São Paulo *EPUSP* (Figure 1) to serve as prototypes for future tests regarding mechanical behavior, durability and fire simulation.

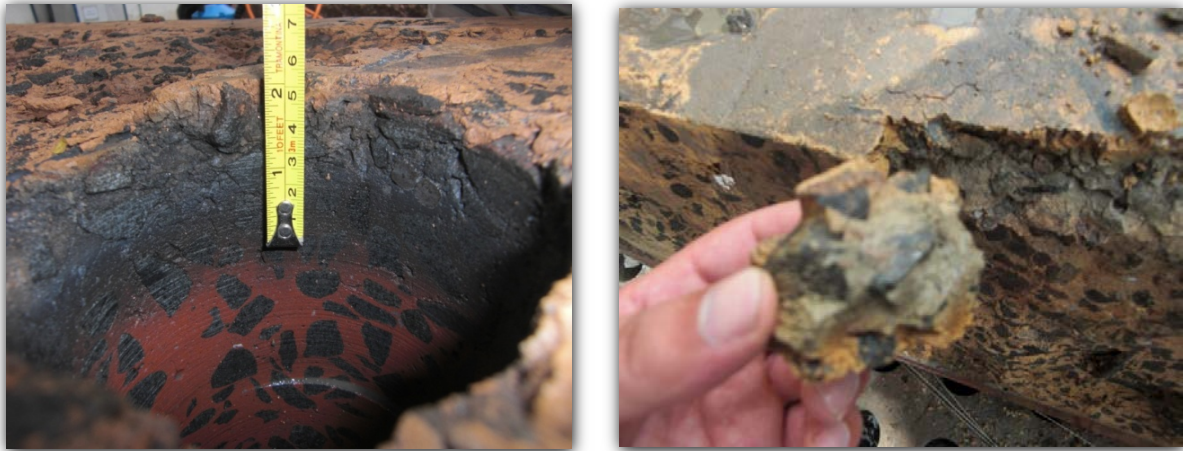
Figure 9. Colorimetric index prototype column.

In this case, principally due to the geometry and the size of the transversal size of the column, as well as the conditions of the experiment (slightly reducing atmosphere and a long exposure time to fire), it was verified that at least a depth of 55mm of the specimen showed a darker or black coloration at the central part of the sides and also that color alteration was not so evident at the

column surface and at some depth of the corners (Fig. 9), where color was less dark and a more faded (orange hue).

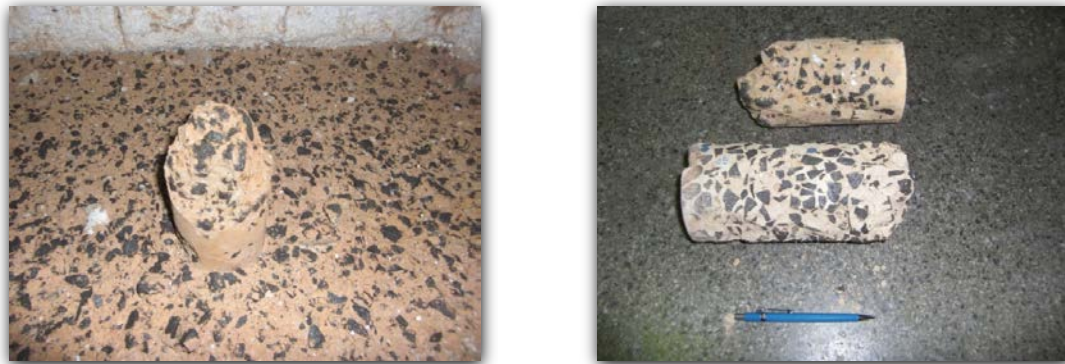
Figure 15. Small cylindrical unreinforced HSCC specimens partially disintegrated after fire testing; they had been placed together with the large prototype column.

2. It should be observed that in this experimental program, just as an example, three cylindrical (100mm x 200mm unreinforced concrete specimens and with the same age and mix concrete, were placed inside the furnace, which were in general disintegrated (see Figure 15) after 180min (3hr) of fire testing. Thus, it is recommended that small unreinforced concrete specimens not be utilized to evaluate spalling. Although they are useful for evaluating thermal concrete properties at different temperatures, they are not recommended to evaluate spalling of structural concrete members, as they may underestimate, in some cases, the high strength concrete performance in fire situations;
