Sargand, Shad M.; Vega-Posada, Carlos A.; Arboleda-Monsalve, Luis G.
Long term performance of existing asphalt concrete pavement sections
Revista Facultad de Ingeniería Universidad de Antioquia, núm. 66, marzo, 2013, pp. 45-56
Universidad de Antioquia
Medellín, Colombia

Long term performance of existing asphalt concrete pavement sections

Shad M. Sargand¹. Carlos A. Vega-Posada^{2*}. Luis G. Arboleda-Monsalve³

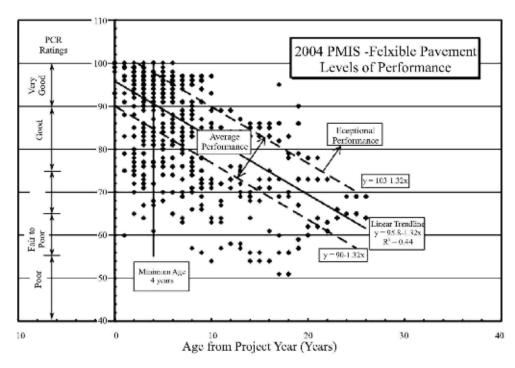
Figure 2 Pavement Condition Rating (PCR) for Flexible Pavements Taken From [13]

Figure 2 shows the Pavement Condition Rating (PCR) performance data for flexible pavements in the State of Ohio [13]. The selected sections and performance classification presented in the present study were a subset of data of those used to define the PCR chart in the State of Ohio. The PCR index describes the pavement distress mechanisms in terms of severity and frequency and is calculated as:

Where: n is the number of observable distresses and deduct is equal to the product of weight for distress, weight for severity and weight for extend. The pavement condition rating is measured on a scale from 0 to 100, zero being a pavement in poor condition and "100" indicating very good condition.

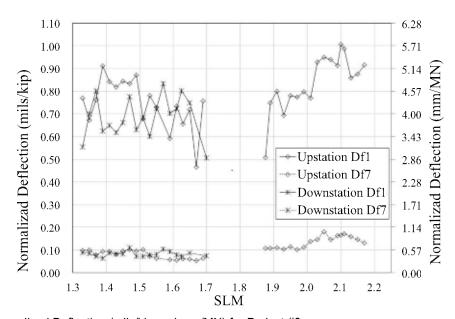
Figure 4 Normalized Deflection (mils/kip and mm/MN) for Project #3

The normalized deflections for sensors 1 and 7 (Df_1 and Df_7), spreadability, and the subgrade modulus of elasticity for the AC pavement sections were determined using FWD tests. For an easy reference, a typical set of plots for project # 3 are shown in Figures 4, 5 and 6 [20]. For this case in particular, the structural condition of the asphalt concrete layer can be classified as fair in the upstation direction and good in the

downstation direction whereas the subgrade structural condition can be classified as excellent in both directions. In general, the pavement ability to distribute the applied load can be classified as fair, indicating a deficiency in the stiffness of the base or subbase layers. The average modulus of elasticity of the subgrade was determined as 44.5 ksi (307 MPa). 52.8 ksi (364 MPa). and 47.1 ksi (325 MPa) for station limits (SLM) 1.27-1.74 (downstation). SLM 1.27-1.82 (upstation). and SLM 1.82-2.16 (upstation). respectively.
