Ferreira, Carlos A.; Coser, E.; Angelini, Joceli M. G.; Rossi, José A. D.; Martinez, Manuel L. B.
Effect of Artificial Aging on Polymeric Surge Arresters and Polymer Insulators for Electricity Distribution
Networks

Polímeros: Ciência e Tecnologia, vol. 21, núm. 5, 2011, pp. 436-442
Associação Brasileira de Polímeros
São Paulo, Brasil

Effect of Artificial Aging on Polymeric Surge Arresters and Polymer Insulators for Electricity Distribution Networks

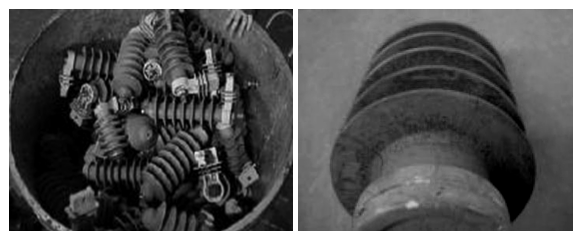
Figure 2. SR surge arresters and insulators with problems taken from the field.

The new samples and samples removed from the field are displayed in Figure 1 and Figure 2 respectively. Some studies have been carried out on silicone rubber used in the housing, obtained in the same way and subjected to the same aging conditions as the surge arresters. A, B, C, D and S denotes the different sample suppliers.

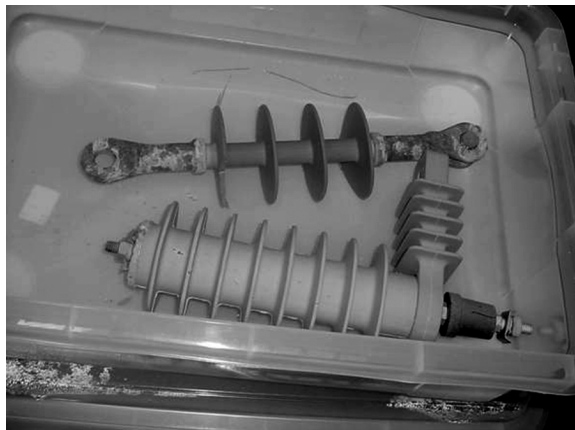
Figure 3. Samples immersed in water at room temperature.

Figure 3 shows the new samples during immersion into water at room temperature for 6 months.
