Maderas. Ciencia y Tecnología, vol. 16, núm. 2, 2014, pp. 149-158

OAK WOOD INHABITING FUNGI AND THEIR EFFECT ON LIGNIN STUDIED BY UV MICROSPPECTROPHOTOMETRY

Decayed-wood samples were collected from a naturally-infected bridge made of *Quercus robur*. Fruiting bodies of the white-rot basidiomycetes *Hymenochaete rubiginosa* and *Stereum hirsutum* were sampled. The white-rot fungus *Fuscoporia ferrea* and the secondary saprobiont *Mycena galericulata* were identified from the rotten wood by means of rDNA-ITS sequencing. The topochemistry of lignin degradation within individual cell-wall layers was determined by cellular UV-microspectrophotometry (UMSP) at 278 nm wavelength. Increased delignification occurred in compound middle lamella regions (CML), secondary wall layers of fibres (S₂), longitudinal and ray parenchyma cells as well in vessels. The highest lignin content at initial and medium decay was recorded in the CML, whereas in advanced decay secondary wall layers of the vessels exhibited the highest content of residual lignin. In all stages of degradation, the S₂ layers of fibres had the lowest lignin amount.

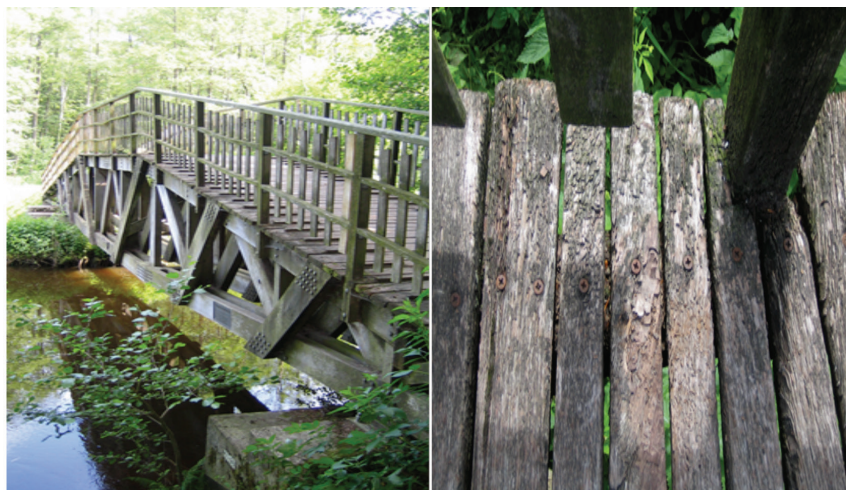
Figure 1 shows the investigated bridge (left) and a detail with fruiting bodies growing on the deck (right).

Figure 1. Investigated bridge and detail with fruiting bodies (Lerche 2010).

The bridge made of *Quercus robur* wood showed severe degradation after only 13 years in service, particularly in the deck and railings (Figure 1). Although laboratory resistance tests with basidiomycetous monocultures classify European oak as a durable timber species (Durability Class 2) according to EN 350-2 (CEN 1994), this was neither attested by laboratory soil box tests (DC 5) nor in field studies in ground (DC 5) and above ground (DC 4) (Brischke *et al.* 2009).
