# Some recommendations for the construction of walls using adobe bricks

This paper shows some results of the analysis of wall construction with adobe bricks, carried out in a pilot building in Villa Clara, Cuba. Our main objective was to obtain some construction recommendations to avoid the humidity due to capillarity. The recommendations deal with uprising speed of construction, adequate wall longitude, binding mortar between adobe bricks, adobe protection from weathering, etc.

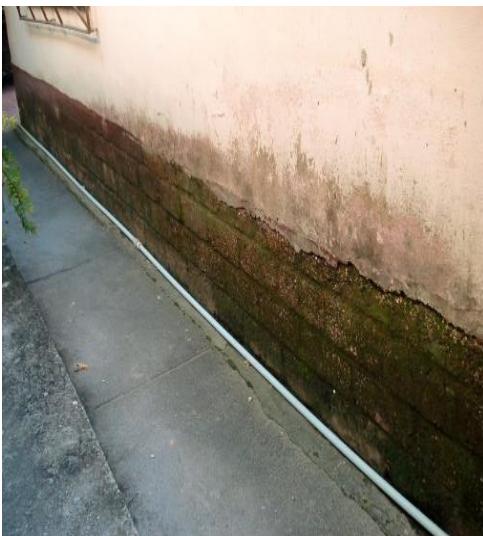
Figure 2: Fired bricks foot cord

The top-foundation, consist on a linear cord of fired brick, and it is concerned with the protection of the lower part of the wall against rain splash and environmental aggression but, as you can see in Fig. 2, it is not efficient enough to avoid the capillary humidity.

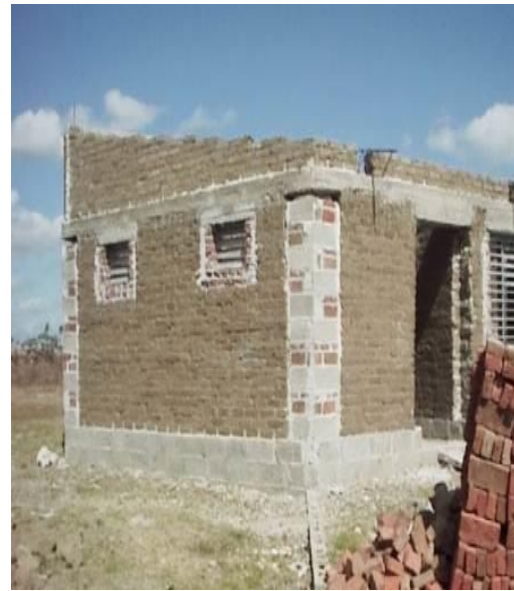
Foot beams made of hollow cement blocks is a more efficient protection against all kind of humidity, even against capillary effects as Fig. 3 shows.

Figure 3: Hollow blocks foot cords

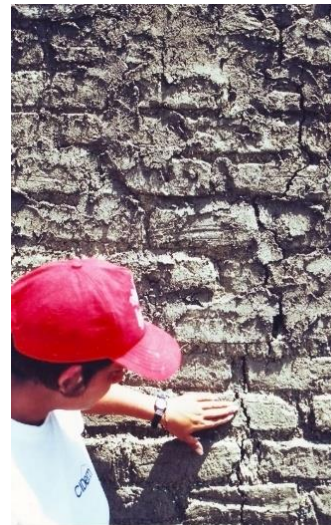
In walls longer than 5 m, with no intermediate pillars, a serious horizontal bending could happen and a vertical crack near the middle of the length may appear. It is caused by a drying stress higher than that allowable for this material (see Fig. 4).

Figure 4: Cracks into wall without pillar

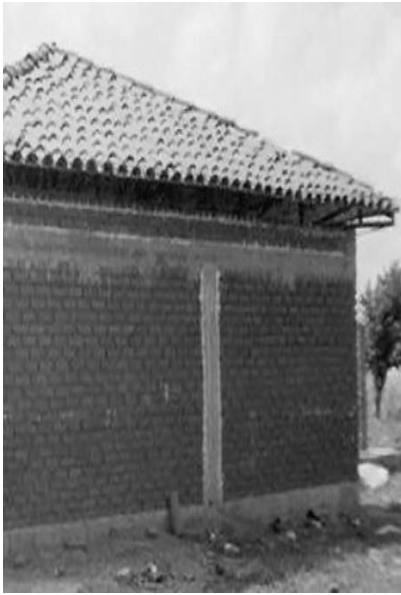
Figure 5: Wall with an intermediate pillar

To avoid this pathology, we could obey the recommendation of Habiterria Network [2], of keeping the length of the wall less than 2.5 times its total height, for walls without pillars. Our experience during this case study, following this recommendation, has provided the best results, as shown in Fig. 5.

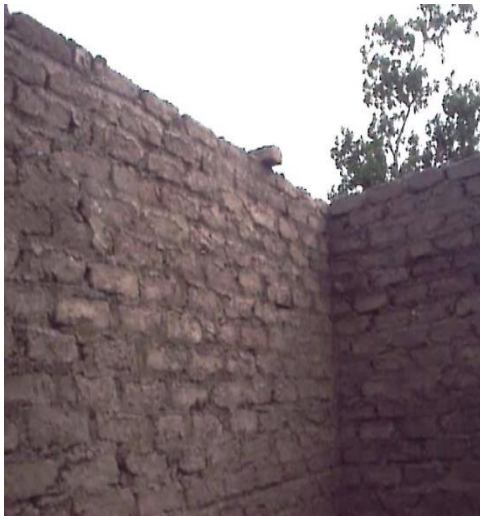
**Tested mortar for Walls built with adobe only.** From Table 2 we can say that sample number 3 has the higher compression strength. Then, sample number 3 is the most efficient. Fig. 6 shows a very good wall, built using mortar number 3 of Table 2.

Figure 6: Binding mortar for adobe walls plural o singular

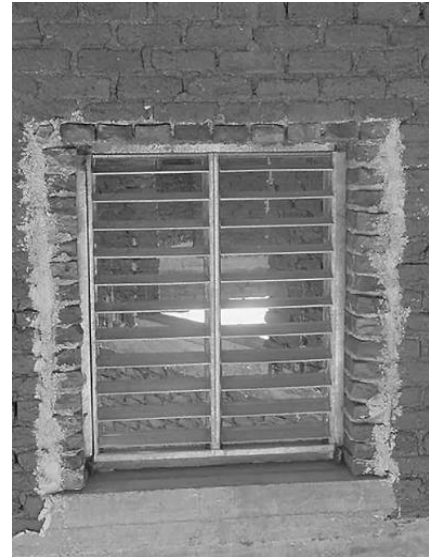
**Tested mortar for Walls built mixing adobe with other material.** We have also used combination number 3 of Table 2 for this purpose. Fig. 7 shows an adobe wall with some components of fired bricks, and mortar number 3.

Figure 7: Adobe wall, mortar number three and fired bricks

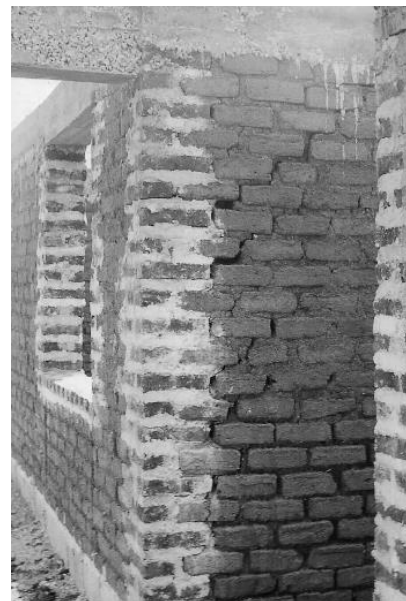
When the collar beam is supported by the adobe wall and brick (or cement block) pillars, 45 degrees cracks may appear at the point of contact between the pillar and the wall.

Fig. 8 shows a clear example of this pathology. The crushing of the soft material shortens the length of adobe parts and sliding between interface of adobe and bricks occurs.

Figure 8: Wall and pillar supporting together the collar beam

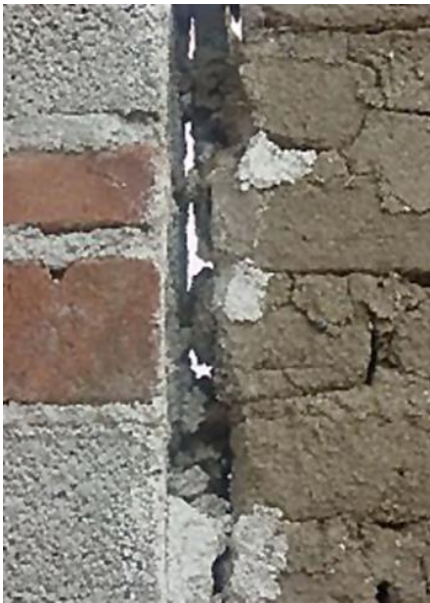
When the collar beam is supported only by pillars, the wall is free to small movements, because its behavior is near a cantilever wall. No vertical load is on the wall and it is very sensitive to any pulling or pushing action which could cause the collapse of the wall. Fig. 9 shows this case.

Figure 9: Only pillars supporting the collar beam

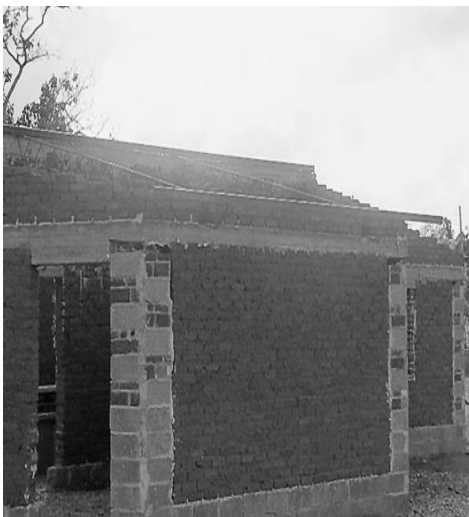
In the last case, when the collar beam is supported only by the wall, crack appearing is not probable because the settlement of the wall is uniform. To reach this kind of solution, the pillars must be almost 6 to 10 cm shorter than the wall. Fig. 10 and 11 show this situation.

Figure 10: Only wall plural o singular supporting the collar beam

After settlement has finished, the free space between wall and pillar must be filled using the same mortar.

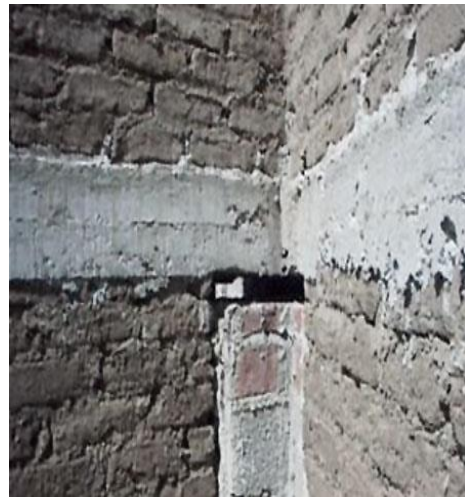
Figure 11: Pillar plural o singular 10 cm shorter than the wall

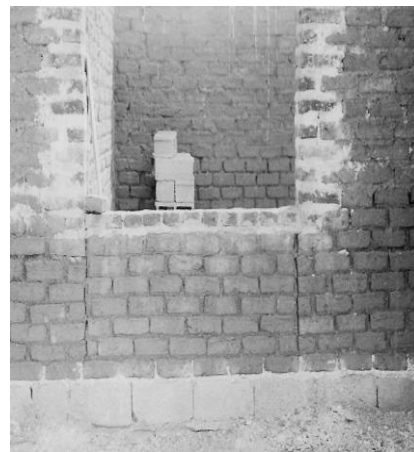
When there are no lintels at the lower part of the windows, it is very important to distribute the bricks to reach an independent small piece of wall under the window. In this case, the cracks will appear following the vertical joints as Fig. 12 shows. This solution leads to serious aesthetical and maintenance problems.

Figure 12: Fissure opening at the lower part of the wall, under the window

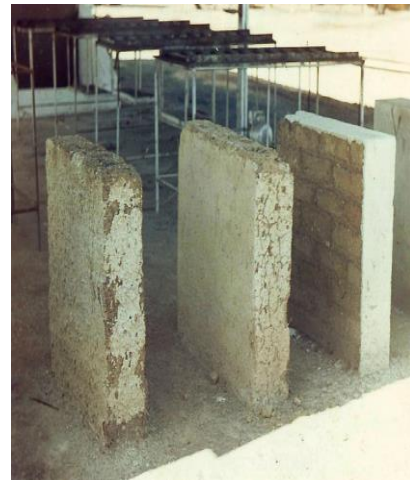
Fig. 14 shows three prototypes of wall, coated by dosage number 11 for the thick (internal) coating, and different kinds of thin (external) coating.

Dosage number 2 of Table 3 was used for left sample, number 14 for central element and number 12 for the right sample. Fig. 15 shows the big difference between an uncoated wall and a wall coated using dosage number 11 for the internal coat, a 1:3 coating for the external one.

Figure 14: Different kinds of coating

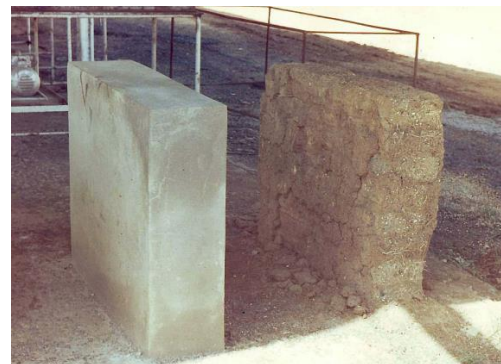
It is easily visible, the difference between coated and uncoated walls.

Figure 15: Difference between coated and uncoated walls
