Conservar Património, núm. 9, junio, 2009, pp. 5-11

Alteration of azurite into paratacamite at the St. Alessandro Church (Lasnigo, Italy)

Giovanni Cavallo

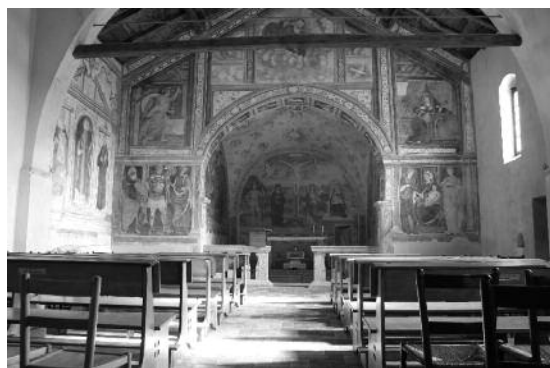
Fig. 1 St. Alessandro church (Lasnigo, Italy): 16th century wall paintings.

The pigment azurite was used to paint the blue drapes on the 16th century wall paintings (fig. 1) in the St. Alessandro Church at Lasnigo (Como, North Italy).

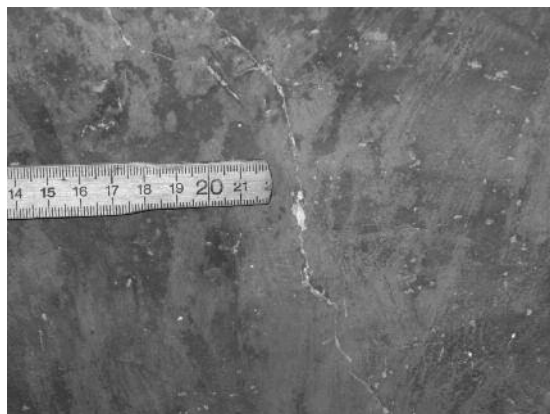
The Crucifixion scene on the east wall of the presbytery painted in 1513 by Andrea De Passeri retains traces of the original pigment. The blue drapes in the Re Magi scene on the north wall of the presbytery painted by Magister Jeronimus in 1547 show the pigment unaltered. The decoration of the chancel arch painted by the latter Master in 1547 revealed an irregular green alteration (fig. 2).

Fig. 2 Irregular and inhomogeneous alteration of azurite into paratacamite.

The south part of the chancel arch presents an important structural crack moving from the roof down to the painted surface where the azurite alteration is evident. Archive documentation indicates that, during the 1970s, there was an infiltration of water along this crack. This water caused the passage of the chlorine into the solution. As regards the origin of the chlorine, many causes can be responsible: the addition of chlorides inside original and repair mortars [8], the use of chlorides-bearing products during past restoration works [9], the presence of chlorides as *natural source* inside the wall.

The surface where paratacamite is present is cyclically heated by the direct solar radiation entering the window located on the south wall of the church. This heating could have played an active role in the mechanism governing the nucleation and precipitation of paratacamite during evaporation processes.
