The long post-closure period of a kaolin mine

Rem: Revista Escola de Minas, vol. 66, núm. 3, julio-septiembre, 2013, pp. 363-368

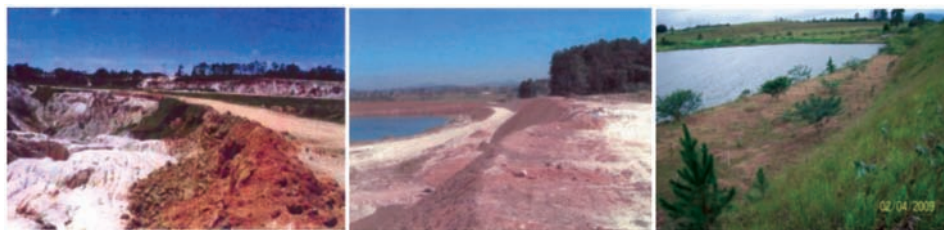
Figure 1
São Caetano pit at operation (L),
decommissioning in 2003 (M)
and under rehabilitation in 2009 (R).

The actions described in the rehabilitation plan and the additional requirements resulting from governmental review were implemented by the company, which hired the services of various environmental consulting firms. In 2001, the company “RAS do Brasil” prepared three “Technical Reports on the Implementation of Works from the Prad” respectively in February, April and June. These reports cover the period from December 2000 to May 2001, therefore after mine closure. The following actions are reported: slope

abatement in the São Caetano pit, fencing the area with barbed wire, planting seedlings, revegetating the slopes, soil fertilization and building runoff drains. All services were performed by a contractor.

Also in 2003, a DEPRN team performed a site inspection and determined a new Statement of Commitment for Environmental Rehabilitation – TCRA (no. 277/03). In August of that year, the implementation of the Multigeo plan started. A “Report on the Progress of Rehabilitation Works in the Mined Area” was prepared and in November of that year, services were completed and the consulting company issued the “Final Report of Mine Rehabilitation,” reporting the actions implemented. By the time of completion, new national regulations had been issued on the protection and the restoration of riparian vegetation (National Environment Council – Conama – Resolution 302/2002), which includes pit lake margins. Therefore, rehabilitation included planting seedlings of native trees in the flooded pit margins. Figures 1 and 2 show views of both pits at the end of the operational phase, featuring earthmoving

works for recontouring and slope stabilization and after the establishment of grass cover and tree seedling planting.

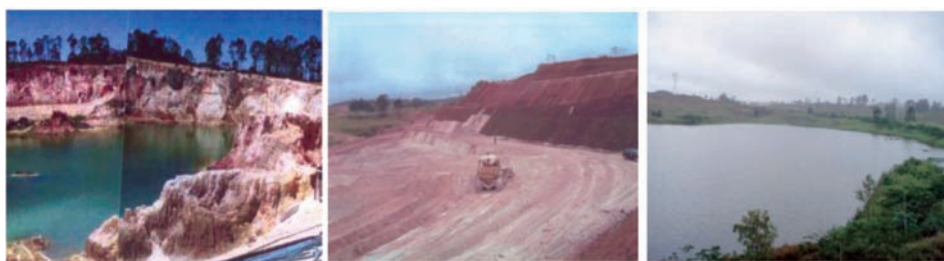
Figure 2
Bianchi pit at operation (L),
decommissioning in 2003 (M)
and under rehabilitation in 2009 (R).

In the post 1981 period, extraction was performed by hydraulic mining in two open pits, called São Caetano and Bianchi. The mineral pulp was pumped from the bottom of the pit to a coarse screening installation (50.8 mm), which separated grit and gravel, used for the maintenance of internal roads, from the ore. The undersize passed through a separator wheel, 1.52 m in diameter, which removed the coarse sand (particle size larger than 3 mm). The finer pulp

was pumped into a set of hydrocyclones (172 mm) to remove the fine sand fraction (underflow), initially pumped to a tailings dam and then disposed at the depleted Bianchi open pit. The cut in this step was 200#. The overflow of the hydrocyclones was pumped into a spider assembly in parallel with hydrocyclones (76 mm), where separation occurred at 37 μ m. The coarse kaolin fraction (underflow from the second hydrocyclones set) was transferred to a ball mill, whose product was fed back to the 172 mm hydrocyclones. The fraction of fine kaolin (overflow) was pumped into a battery of horizontal vibrating screens, in parallel, with a 63 μ m deck. The oversize was discarded as waste and the undersize was transferred to sedimentation tanks with capacities of 15000 m³, to thicken the kaolin. The next step in the process was bleaching the kaolin, which averaged 64% in brightness, attacking it with a sodium hydrosulfite solution, transforming insoluble trivalent iron into soluble
