Numerical modeling of buckling failure in a mine slope

Rem: Revista Escola de Minas, vol. 67, núm. 1, enero-marzo, 2014, pp. 81-86

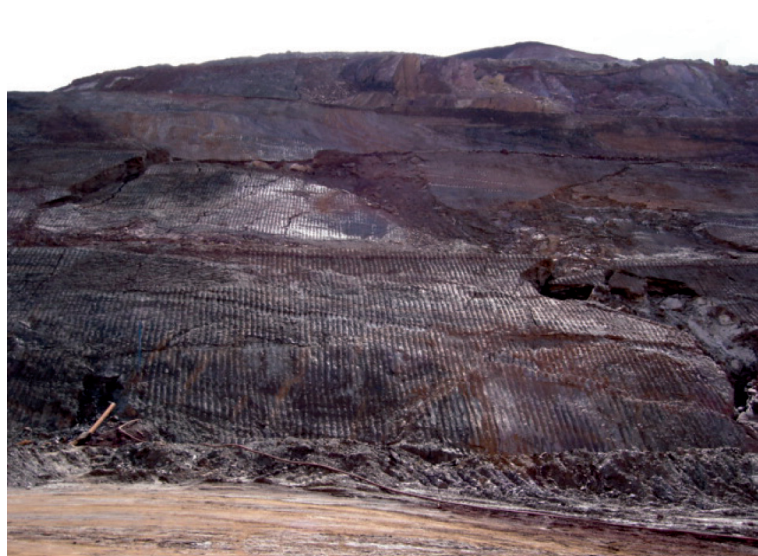
Figure 4
Buckling failure observed at Pau Branco Mine in 2002

In Pau Branco iron mine buckling failure reached many benches of phyllite rock slope (see Figure 4). This failure is studied in this work through numerical

Buckling failure occurred as a global failure mechanism, affecting many benches. Large deformations were observed; see Figure 4. A stress-strain analysis is the best method for evaluating slopes affected by this mechanism because it considers the deformations of the rock mass.

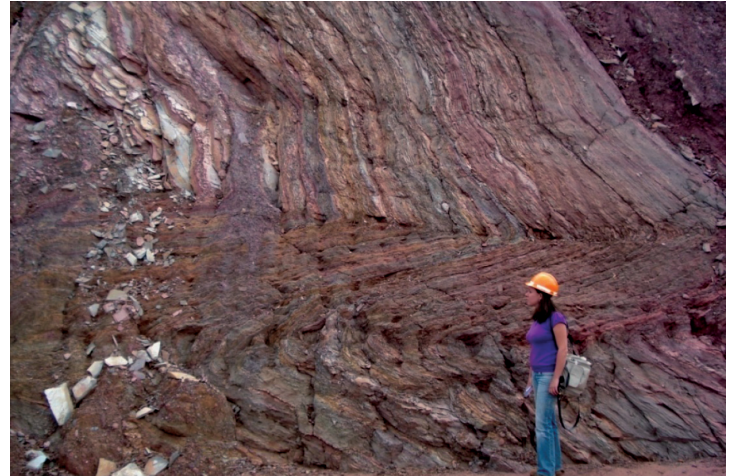
Figure 5
Folding with direction axis E-W, in the West Slope.

folding event, N-S. A second folding event, with axis nearly perpendicular to the major one, E-W, seems to be responsible for the winding pattern of the layers and for relatively abrupt changes in the general strike of foliation (Figure 5).
