Grossi, Danielle; Del Lama, Eliane Aparecida
Ultrasound technique to assess the physical conditions of the Monument to Ramos de
Azevedo, city of São Paulo, Brazil
Rem: Revista Escola de Minas, vol. 68, núm. 2, abril-junio, 2015, pp. 171-176
Universidade Federal de Ouro Preto
Ouro Preto, Brasil

Ultrasound technique to assess the physical conditions of the Monument to Ramos de Azevedo, city of São Paulo, Brazil

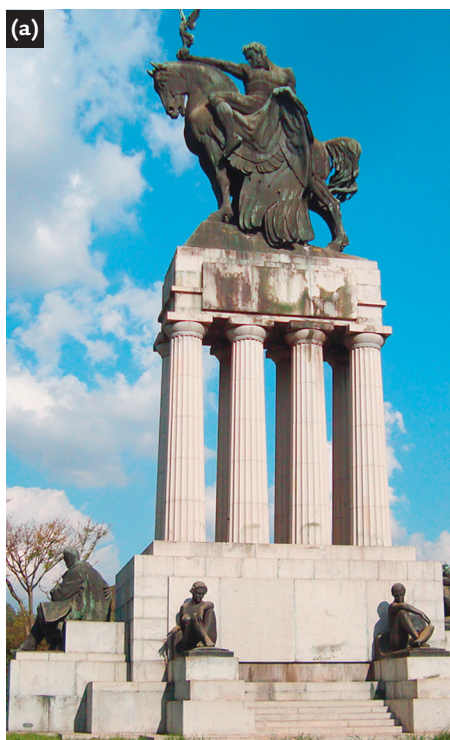
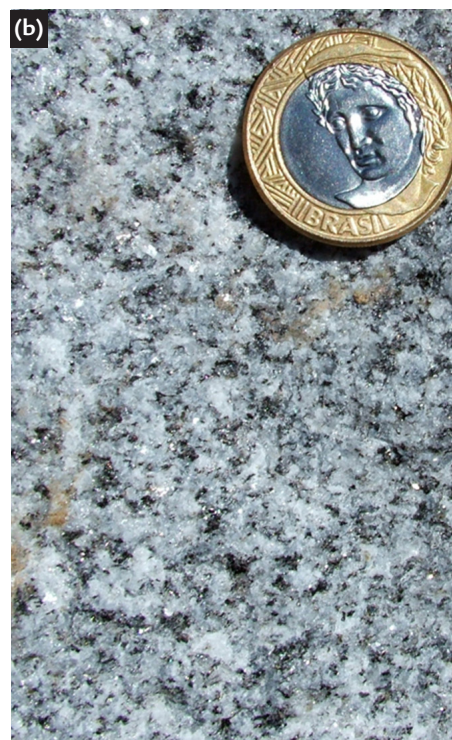
Figure 2
(a) Monument to Ramos de Azevedo, Face NW,
(b) Itaquera Granite in detail.

Cemetery and in the Monument to Ramos de Azevedo (Figure 2a). Gradually, the use of this stone decreased and it was replaced by Mauá Grey Granite (Del Lama *et al.*, 2009). It is unknown why this substitution occurred, but the probable cause is the better performance of Mauá and the depletion of the Itaquera Quarry in 1999. In fact, this quarry hasn't been extracting blocks for ornamental stones and parallelepipeds for years and in the last years it has produced only crushed stone.

The petrographic analysis of Itaquera Granite is found in Del Lama *et al.* (2009). It has gray color, serial inequigranular granulation, and crystals ranging from 0.2 to 2 mm (Figure 2b). Locally, centimetric crystals of potassium feldspar occur. The granite has low anisotropy due to its slightly oriented structure. It is called biotite monzogranite and its composition is: oligoclase (38%), microcline (33%) quartz (18%) and biotite (9%). Titanite (1%) is an accessory mineral; zircon,
