de Faria, Geraldo Lúcio; Barbosa Godefroid, Leonardo; Nery, Fernando Victor
Damage evolution in a tensile specimen of a ductile stainless steel
Rem: Revista Escola de Minas, vol. 69, núm. 2, abril-junio, 2016, pp. 175-183
Universidade Federal de Ouro Preto
Ouro Preto, Brasil

Damage evolution in a tensile specimen of a ductile stainless steel

Abstract

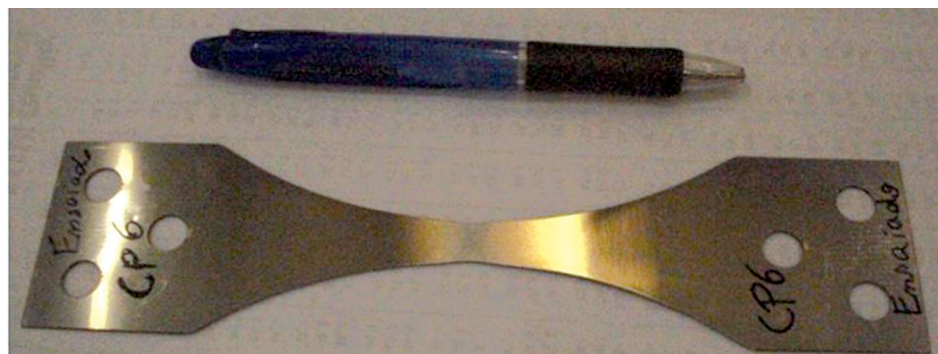
Tensile specimens with continuous radius between ends were prepared with the following dimensions: total length = 50mm; minimum width = 12.5mm;

thickness = 0.5mm. Figure 1 shows an example of this geometry. This type of geometry was chosen to facilitate the monitoring of strain along the gage length and to ensure the fracture in the center of the specimen. The specimens had three holes in their heads, for coupling with the grips of the mechanical testing machine.

Figure 1
Tensile specimen geometry.

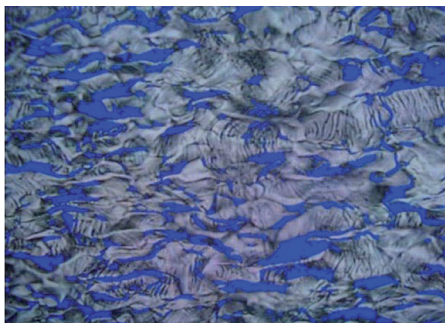
In this context, the DRI parameter was defined as the area fraction with diffuse reflection in an optical microscope image obtained with a fixed magnification, i.e., the percentage of observed image that is not in focus due the roughness of the surface. Figure 2

exemplifies this procedure. Ten images with 200X magnification were captured at the middle of the strained specimens

and the not focused areas were automatically identified and blue painted. Using the Q-WIN software, the blue

areas were quantified by image analysis and the DRI index was calculated applying Equation 1.

Figure 2
Q-Win Software application to determine the strain roughness of a tensile specimen. Blue regions are the not focused areas.

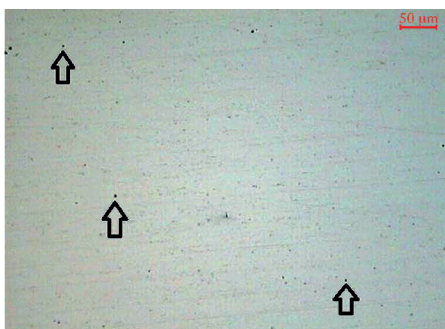
Figure 3 presents an image (optical microscope) of a sanded and polished surface of the studied steel, without etching. It is possible to see a fine distribution

of inclusions (small black points). Cracks and other volumetric defects, which could affect the structural integrity of steel, were not observed. Figure 4 presents the ferritic

Figure 3
Microstructure of steel UNS S44400 without chemical attack.

specimen strain (very low roughness), in an observation at the optical microscope with magnification of 200X, it is possible to observe that all the points in the field view were in focus, because all of them had a distance from the objective lens inside the field depth distance (Figure 3). However, as the specimens were strained and the roughness has increased, the topographic changes on sample surface create trough and crest areas that go out from the field depth distance, getting out of focus with a strong diffuse reflection profile.

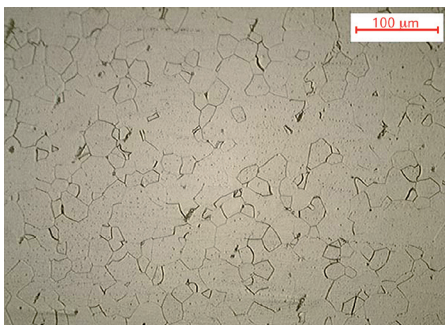
structure of the studied steel after etching with the modified Villela reactive. It is possible to observe a heterogeneous ferritic grain size distribution.

Figure 4
Microstructure of steel UNS S44400 with chemical attack.

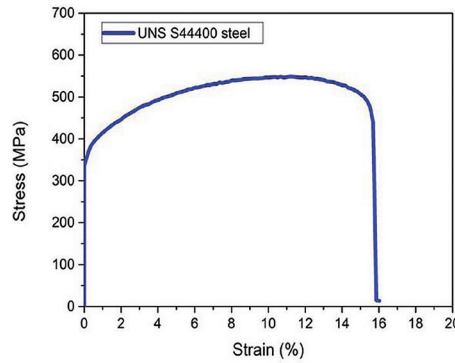
Figure 5 presents the conventional tensile test curve with average values obtained from three tests. Table 2 presents the main properties obtained from this test for this steel. It is important to comment that

the obtained total strain is below the value specified by the manufacturer (APERAM, 2012), because the specimens used in this work do not followed the ASTM E8 standard for tensile test. The sheet was machined

with a continuous concordance radius aiming to promote a strong stress concentration in the middle of the specimen. The specimen type was inspired by the ASTM E466 for fatigue test on metallic materials.

Figure 5
Tensile curve of the studied steel.

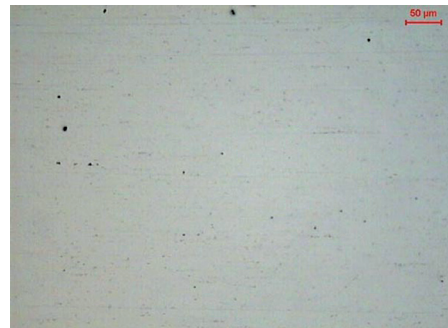
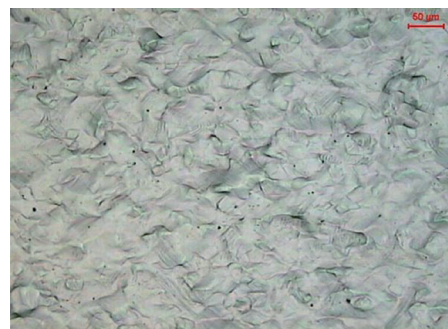
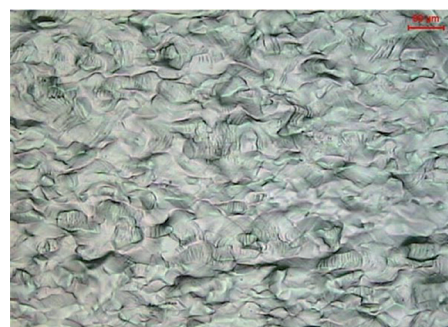
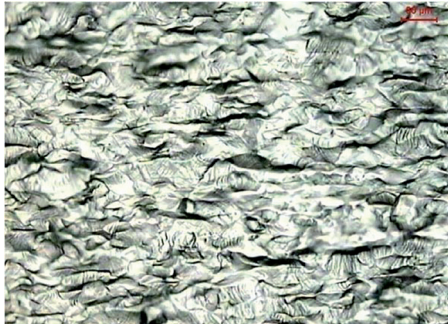
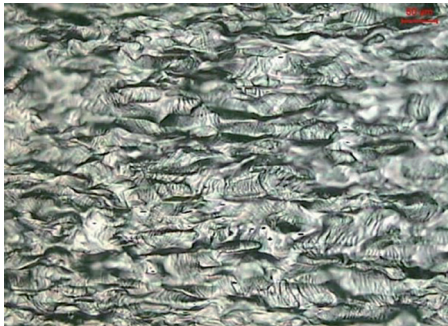
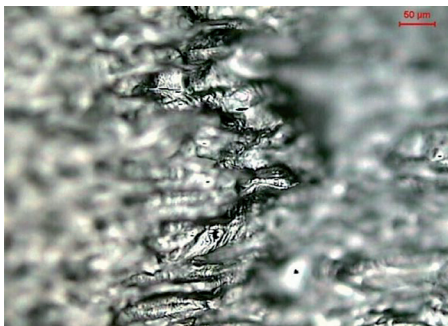
The lateral surface of all tested specimens was analyzed by optical microscope. Figures 6-11 show the corresponding micrographs. It is

possible to see that the increase of deformation in the specimen causes a greater roughness on its surface. There is also an increase in the quantity and

thickness of slip lines, arising from the slipping of crystallographic planes in the grains of the material.

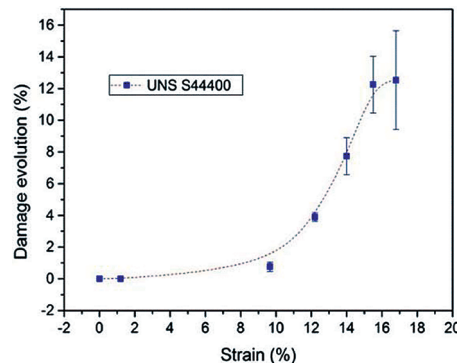
Figure 12 presents the damage evolution indirectly measured by the Diffusion Reflection Index (DRI) as a function of specimen deformation, using the surface roughness of the specimens. The specimen without deformation (0%) corresponds to the as-received material, so it does not present damages. The 1.2% deformed specimen also did not present significant damages. Specimens with higher deformation presented significant superficial damages, especially for deformations higher than 10%.

From this level of strain, the tensile strength of the material is being achieved, the necking process begins to operate in the specimen, and local roughness is evident.

deformation, the higher the standard deviation obtained in experimental procedures. This occurs due to the higher deformation, more intense and localized is the deformation effects on surface (necking). As the proposed method for DRI determination consists in scanning different fields of view under an optical microscope; if the deformation signals are more localized, the DRI measured for each field is not very similar. As a consequence, the standard deviation is higher.

Figure 12
Damage evolution as a function of strain.

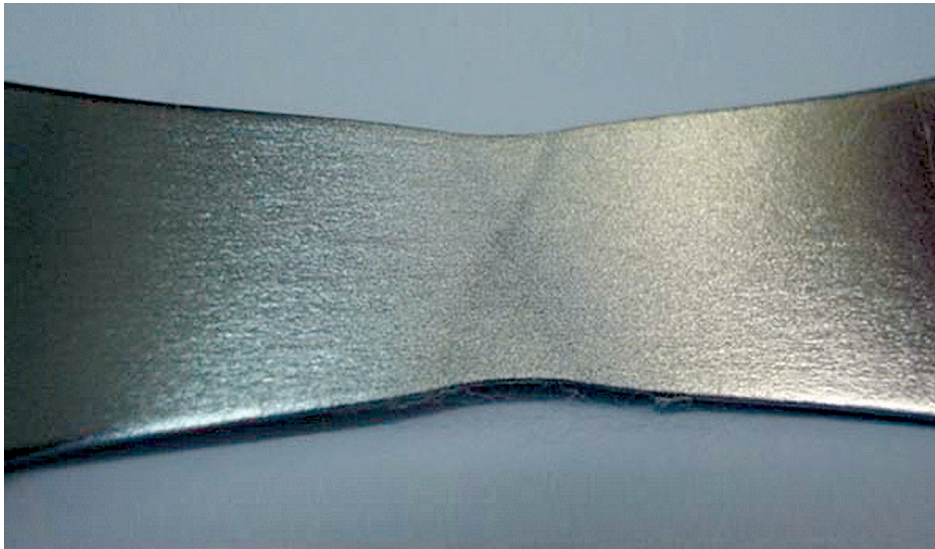
Figure 13 shows an example of the necking development, for 14% of deformation. No significant differences were observed between samples with 15.5% and 16%, due to the evolution stage of necking caused by the advanced degree of microvoids coalescence. It is possible to observe that the higher the

Figure 13
Superficial damage in the necking region of a tensile specimen strained by 14%.

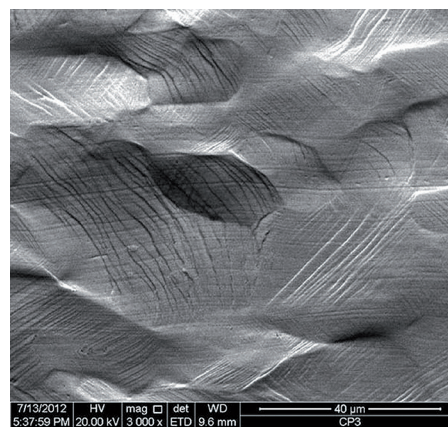
Figure 14
Specimen 9.7% strained.

Figure 14 shows sets of deformation lines, each set with a specific orientation. This is due to each material grain presenting a well defined crystalline orientation and a preferential slip plan that may slip according to its position at solid bulk and applied force.

Samples submitted to higher deformations were analyzed in a scanning electron microscope. Figures 14-17 present images obtained with SEM for 9.7%, 12.2%, 14% and 16% strained specimens, respectively.

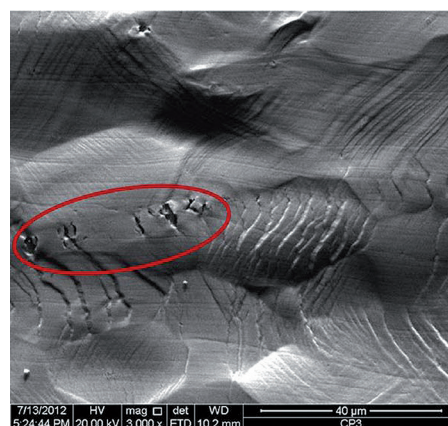
Figure 15
Specimen 12.2% strained.

Figure 15 presents deformation lines and microvoid nucleation (red circles). This Figure corresponds to 12.2% strained specimen, which is already plastic deformed in a non-uniform field. It is possible to note that for the studied stainless steel, the microvoid nucleation starts mainly in the deformation lines. Other researchers as Puttick (1959), Rogers (1960), Chen (1961) and Beevers & Honeycomb (1962) founded similar results for other metallic materials. They pointed out

the deformation lines as a potential structural defect where voids can preferentially nuclei.

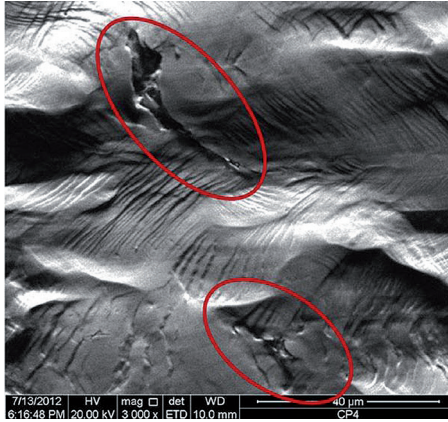
Figure 16
Specimen 14% strained.

Figure 16 (14% strained specimen) shows large voids, that are formed by the coalescence between smaller voids, as described in literature.

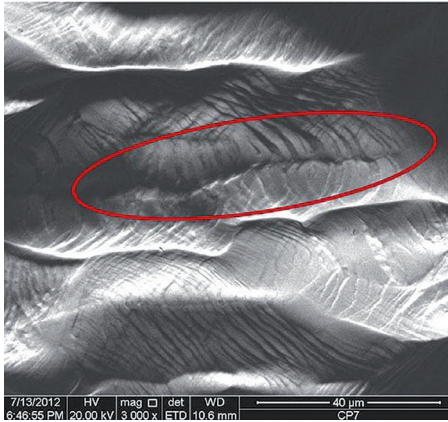
Figure 17
Specimen 16% strained.

Figure 17 (16% strained specimen) presents a crack initiation due to microvoids coalescence. These observations confirm that the ductile fracture mechanism is nucleation, growth and coalescence of microvoids, in accordance to literature.

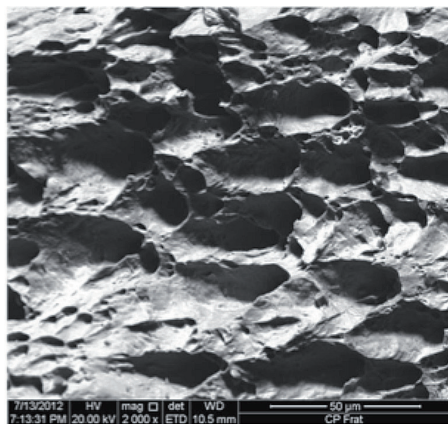
tested samples until failure were analyzed in a scanning electron microscope for a fractograph analysis. Figure 18 presents images of fracture surfaces where dimples

are present, confirming the mechanism of nucleation, growth and coalescence of microvoids as the main way of the ductile fracture in UNS S44400 steel.

Figure 18
Fractographies of tensile
test specimens. SEM - 2000X.
