Geofísica Internacional, vol. 42, núm. 3, july-september, 2003, pp. 419-428

## Effect of El Niño on the subaerial beach Playas de Rosarito, B.C., Mexico

Extensive beaches located near the Mexico-USA border play an important role in the economy of the city of Playas de Rosarito, Mexico. Intense beach erosion occurred during the winter 1998 as a result of a very energetic wave regime associated to ENSO-El Niño event, in combination with high water levels. The severity of these conditions caused flooding and destruction of several houses on the beach. Recreational and protection capabilities of the beach were severely diminished. Profile comparison showed that maximum volume of sand removed from the subaerial beach was  $66.9 \times 10^{-3} \text{ m}^3/\text{m}/\text{day}$  with an average recession of 2.3 m/day. The maximum shoreward displacement along the study period was 66 m. The profile height was up to 3.5 m lower than the initial profile, so a long period of mild wave conditions is needed to restore the initial profile height. The role played by the highly mobile gravel deposit along the northern portion of the study area need to be assessed.

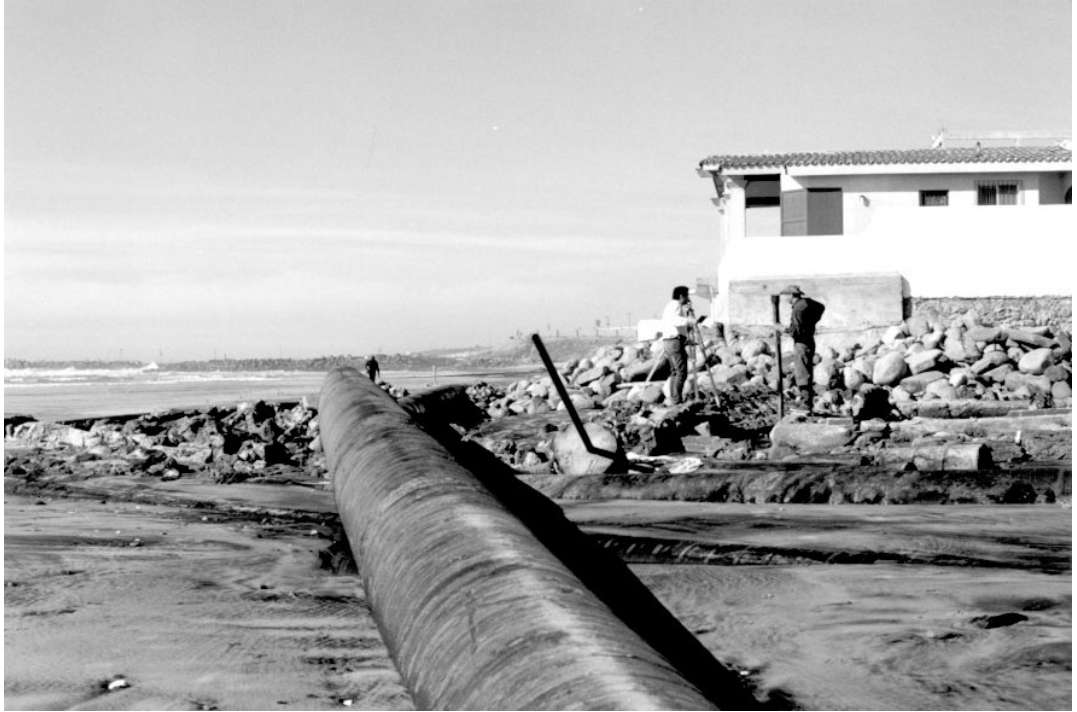
Fig. 8. Large debris from the energy industry and old wrecked residences in the area of Colonia Obrera (BN6) emerged after the arrival of the extreme wave episodes of January-February 1998.

Another significant effect of the erosion was the vertical displacement of nearly 4 m of the beach profile and as a result of the removal of sand, old wrecked residences as well as large debris from energy industry in the area were uncovered (Figure 8), making the beach useless for recreational purposes. The large waves combined with high tide caused flooding of several residences and destruction of others in the southern portion. Days prior to February 10, heavy rain caused the arroyo Rosarito, near benchmark BN11, to bring large amounts of wooden debris whose accumulation on the beach formed a 1 to 2 m high scarp (Figure 9) that helped to reduce further recession of the beach. It should be noted that most recreational activities that support the local economy take place on the beach stretch from Hotel Rosarito to a few hundreds meters south from the CFE's water intake, but this beach segment is precisely the

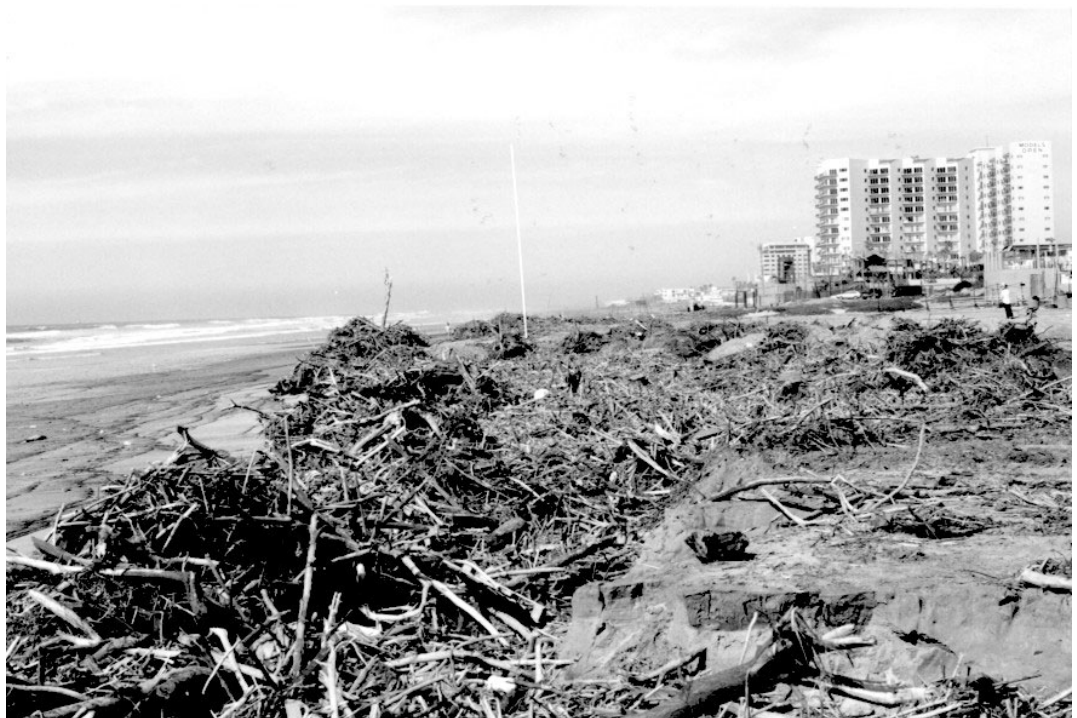
Fig. 9. Accumulation of wooden debris brought up from the basin of the Arroyo Rosarito helped reduce beach recession off the Hotel Rosarito beach (BN11).
