Fuscaldi, Romeu; Silveira, Fernando H.; De Conti, Alberto; Visacro, Silvério
Power Quality Problems Caused by Termites on 138-kV Underground Cables
Ingeniería e Investigación, vol. 31, núm. 2, octubre, 2011, pp. 148-152
Universidad Nacional de Colombia
Bogotá, Colombia

Power Quality Problems Caused by Termites on 138-kV Underground Cables

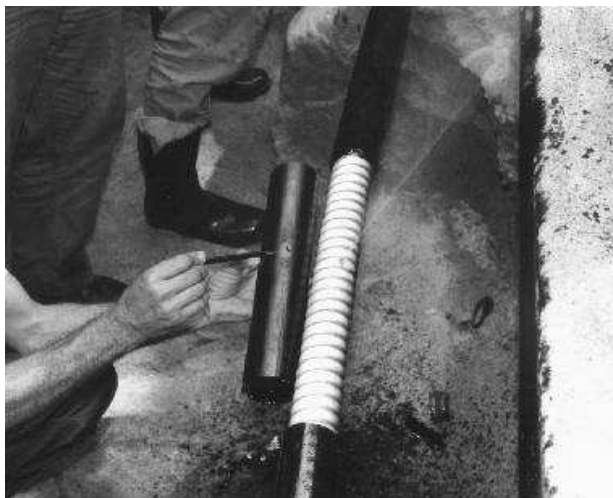
Since 1986 termites have been causing serious damages to 138-kV underground cables installed in Belo Horizonte. For reasons yet to be determined, they create punctures in the PVC layer covering the cable. This leaves the corrugated aluminum sheath exposed, which ultimately leads to a corrosion process that culminates with oil leakage to the ground. If a significant volume of insulating oil is drained out of the cable, a short circuit may occur. This event has devastating consequences to the system operation, leading to outages and requiring very long and expensive maintenance service. Fig. 4 illustrates the oil leakage caused by a puncture due to termites on a 138-kV transmission line.

Fig. 4. Oil leakage found in the maintenance of the 138 kV transmission line Adelaide – Carlos Prates in 1997.

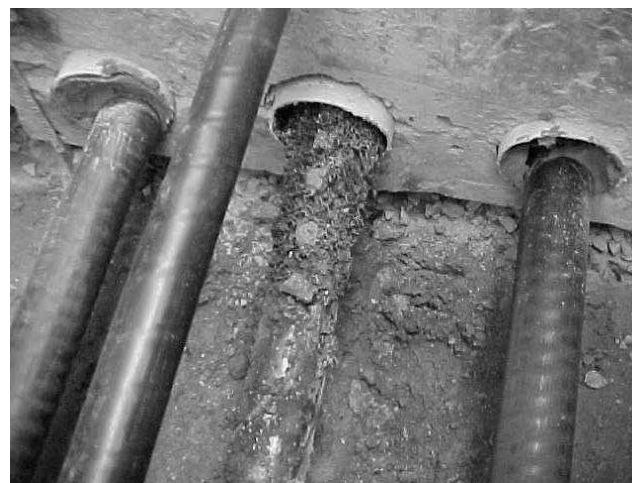
of the cables, biologists have been investigating possible reasons for the attacks performed by these insects. Two possible explanations are currently discussed: (i) termites are attracted by the paper (organic material) inside the cable, which serves as food; (ii) termites are likely to build their houses in the vicinity of cables because of the higher temperatures on the external surface of the cable. Fig. 5 illustrates a colony of termites found on the external surface of a 138-kV underground cable.

Fig. 5. Typical colony of termites found around the cables.

Regardless of the cause, it is not possible to avoid termite attacks to underground cables already in operation. In the case of new projects, an alternative would be the use of a lead armor, which is more resistant to the corrosion process than aluminum.
