Capelini, R. M.; Adami, J. F.; Martinez, M. L. B.; Parentoni, M. F. C.
Development of a system for detecting and locating damaged insulator strings with signals collected at
substations

Ingeniería e Investigación, vol. 35, núm. 1, abril, 2015, pp. 43-48

Development of a system for detecting and locating damaged insulator strings with signals collected at substations

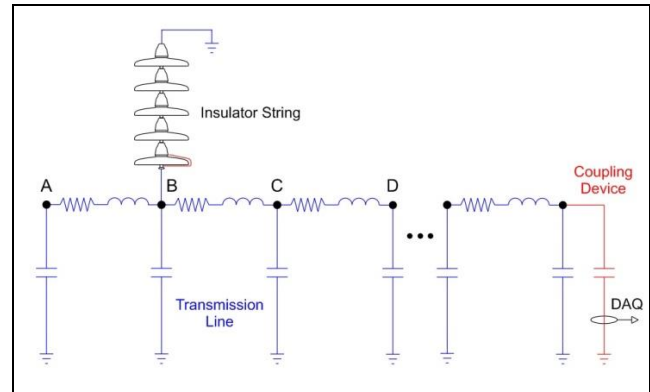
Figure 1. Transmission line with damaged insulator string.

Each signal generated on the insulator strings has some particular characteristics that depend on the electrical circuit between the point where the signal is generated and the one where it is recorded. In other words, these signals have a unique signature. For example, consider the transmission line theoretical π model shown in Figure 1. It has four points (A, B, C and D) where the insulator strings can be connected. If an insulator string containing one damaged insulator, in this case the first one, is connected to one of these points surface or corona discharges may occur on this insulator. When the string is connected to point A, high frequency signals are acquired by the data acquisition system (DAQ), which is installed at one of the ends of the transmission line. These signals present a typical signature. When the connection point is changed from A to B, the signature is changed as well. The same occurs if the string is connected to points C and D.

As the signature changes with the electrical circuit between the signal source and the data acquisition system, then it is possible to associate the signatures of the recorded signals with their location

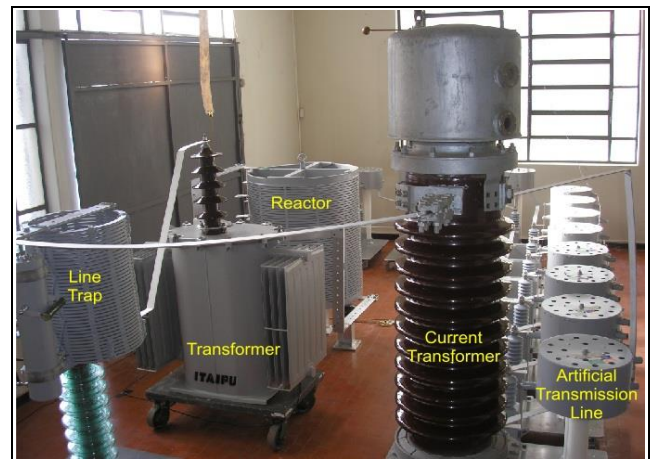
Figure 2. Main view of the laboratory system.

From Figure 2, it is possible to observe that the single-phase artificial transmission line is fed by a variable autotransformer (0 – 240V) connected to a power transformer (240 V – 35 kV). This artificial transmission line is composed of eleven complete π sections and represents a real 69 kV transmission line with a length of 48 km. As the transmission line mock-up has no load, a reactor is used for reactive power compensation, reducing the laboratory power demand. There are 48 connection points along the transmission line, one point per kilometer, where the insulator strings can be connected.

A coupling device is connected to the feeding point of the mock-up. It provides a way for high frequency signals to be acquired by the data acquisition system. A line trap is installed between the transformer and the line model end to block high frequency signals from leaving and entering the transmission line. An 8 bit and 100

MS/s data acquisition board and a computer are responsible for digitalizing the noise signals. A high frequency current transformer (HFCT) was developed specifically for this application and installed at the grounding cable of the coupling device. Its output is connected to the data acquisition board through a protective device. At the beginning of this research, a HFCT capable of working until 10 MHz was applied, covering the most important frequency components observed in laboratory. With the development of the acquisition system for real transmission lines, where important higher frequency components were detected, it was designed a new HFCT. This new HFCT covers frequency components until 50 MHz and was applied in laboratory as well.

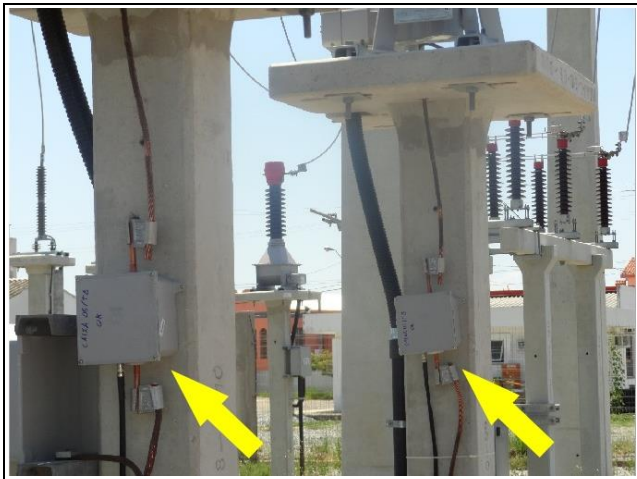
Figure 3. Enclosures containing current sensors and surge protectors installed at the grounding cables of CTs.

From the results of the simulations, new types of current sensors were studied. After simulating and testing new configurations of sensors, among them Rogowski coils (Robles et al, 2008) and HFCTs (Birlasekaran et al, 2007; Luo and Zhang, 2010; Mallikarjunappa and Ratra, 1990) assembled with different material cores, the HFCT was chosen. Although no important frequencies were observed beyond 10 MHz in the simulations, it was decided to apply a HFCT responding to higher frequencies in order to verify the possible existence of frequency components in the field that were not detected in laboratory and in the simulations. For the new sensor, an iron powder core (Magmattec MMT02T4416) was chosen and the transformer ratio was the same applied in the simulations, resulting in a 50-turn secondary. The current sensor was mounted in a metallic enclosure, which also contains the surge protector, and submitted to frequency response tests carried out with a Fr analyzer®. Once verified other units were manufactured in laboratory and installed at the grounding cables of the CTs in two substations located at the ends of the transmission line, as it can be observed in Figure 3. The current sensors are connected to the PicoScope 3206® data acquisition board through RG213 coaxial cables, that are much more adequate for field application

when compared to the cables used in laboratory (RG58). The data acquisition board is operated by a computer, that contains the acquisition and pattern recognition software modules.
