Vojnotehnicki glasnik/Military Technical Courier, vol. 62, núm. 1, 2014, pp. 112-129  
University of Defence

# HIDRAULIC HAMMER EXCAVATOR FAILURE DUE TO SOLID PARTICLE CONTAMINATION

FIELD: Mechanical Engineering  
ARTICLE TYPE: Original Scientific Paper

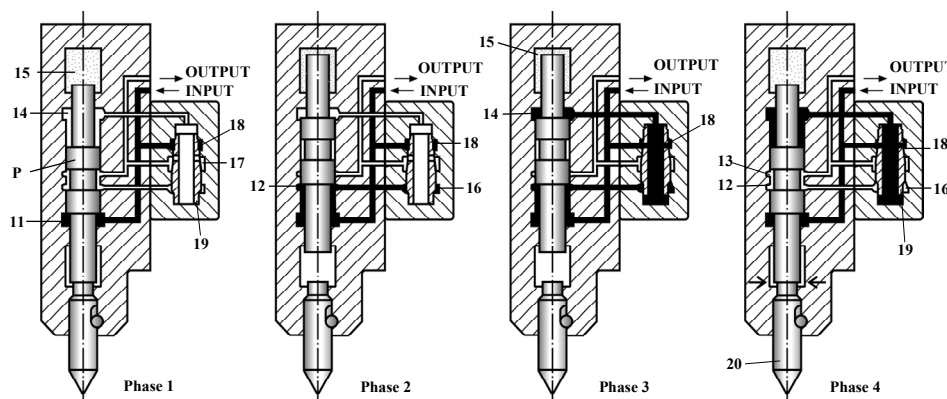
The cross-sectional view (Figure 2) illustrates the operation of the hydraulic hammer which is performed in phases as follows:

The hydraulic oil from the pressure line enters the chambers labeled by positions 11 and 18. The regulating valve (19) is pushed into the lower end position. The hammer working piston moves upwards compressing the gas into the compression chamber (15). The working fluid from chamber 14 is released towards the chamber (17) through the hole in the regulating valve (19), and from there, the oil is sent directly to the reservoir through the return line and the filtering system.

When the oil under pressure is pushed into the chamber (11), the hammer working piston moves upwards to the position when the chambers (12) and (16) are filled with oil. At the moment when the pressures are equal due to the difference in the surfaces affected by the pressure, the regulating valve (19) moves into the upper end position joining the chambers (18) and (14).

When the chambers (14) and (18) are joined, the force which acts on the upper ring-shaped surface of the working piston in the chamber (14) together with the force created by the compressed gas the storage space of the chamber (15) moves the hammer working piston (P) into the lower working position.

When moving downwards, the working piston (P) hits the chisel (20). At that moment, the middle part of the piston joins the chambers (12) and (13) and, as a result, the chamber (16) on the lower side of the regulating valve (19) unloads as well. The force on the lower side of the regulating valve is smaller than on the upper side causing the regulating valve to return to the lower end position.

Figure 2 – Crossectional view of the hydraulic hammer and the operational phases

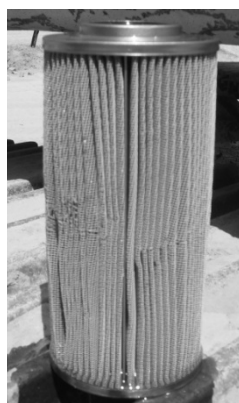
The third cause of contamination is the inadequately designed system of the hammer return line, especially the filter block (Figure 1 - position 6). During the monitoring process, it was noticed that there were some sudden rises of pressure in the filter housing which causes the tearing of the steel filter mesh (Figures 3 and 4) and the penetration of filth in the form of solid particles.

*Figure 3* – Filter cartridge embedded in the return line of the hydraulic hammer system  
*Slika 3* – Filterski uložak, ugrađen u povratnom vodu hidrauličnog sistema čekića

The solution to the problem was achieved in agreement with the excavator supplier who performed an adequate replacement of damaged components in the hydraulic system and fixed the defect in the hammer return line filter block by installing a filter with appropriate fineness of 4  $\mu\text{m(c)}$  and by setting the pressure relief valve in the filter block to the value of 1.5 bars. In addition, the hammer was replaced with another hammer with an appropriate structural design with an improved sealing system that prevented the excessive penetration of solid particles into the interior of the hammer. Also, a secondary filtering system was installed on the main reservoir of the hydraulic excavator system, with the capacity of 10% of the capacity of the main hydraulic pumps. A permanent solution was thus provided for additional filtering of the hydraulic working fluid and for keeping its pureness at the required level.

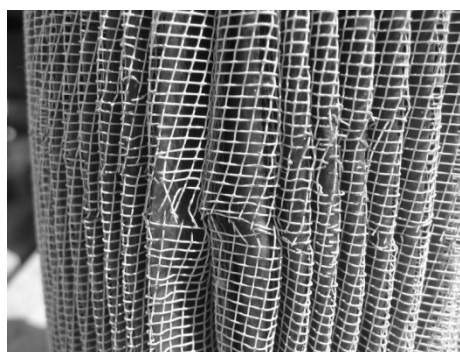
*Figure 4* – Visible damage in the steel mesh and the filter medium  
*Slika 4* – Vidljiva oštećenja na čeličnoj mrežici filterskog uložka

enormous force was generated leading to bending and twisting of the medium and steel protection of the filter cartridge. Due to the cyclic loading, the steel mesh became worn out and torn and the filter cartridge medium was splitted (Figures 3 and 4). This phenomenon was also identified after replacing the old filter cartridge with a new one. After only 250 operating hours, the same phenomenon and the damage happened again. Due to mechanical damage, the filter cartridge no longer performed its role and the contaminants that passed through clearances between the seals and the working piston went directly into the reservoir of the hydraulic system.

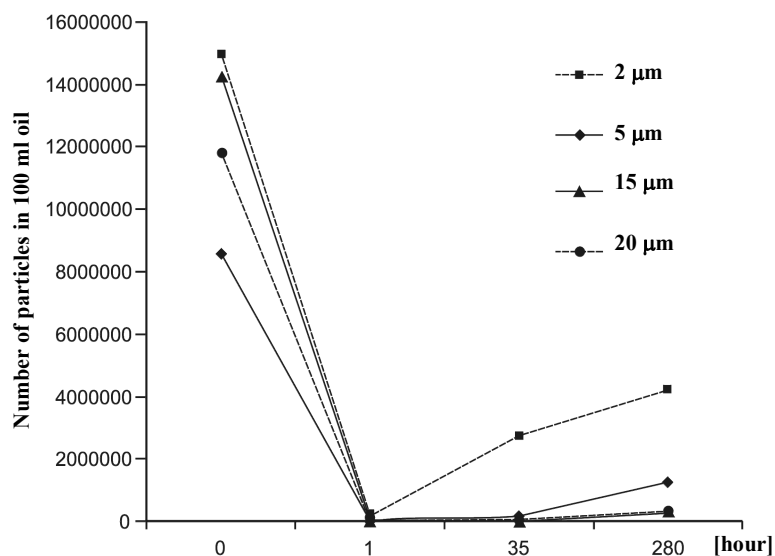
As it can be noticed, the content of contaminants in the form of solid particles in the working fluid increased from satisfying purity class NAS 7 to unpermitted class NAS 10 for a very short period of operating time (35 hours) of the excavator in the extremely contaminated environment (cement industry environment). After 280 operating hours, the oil purity class increased to NAS 13 which represented a class of contamination at unpermitted level (Figure 5).

Figure 5 – Increase in the oil contamination level in 280 operating hours  
Slika 5 – Povećanje kontaminacije ulja za 280 radnih časova

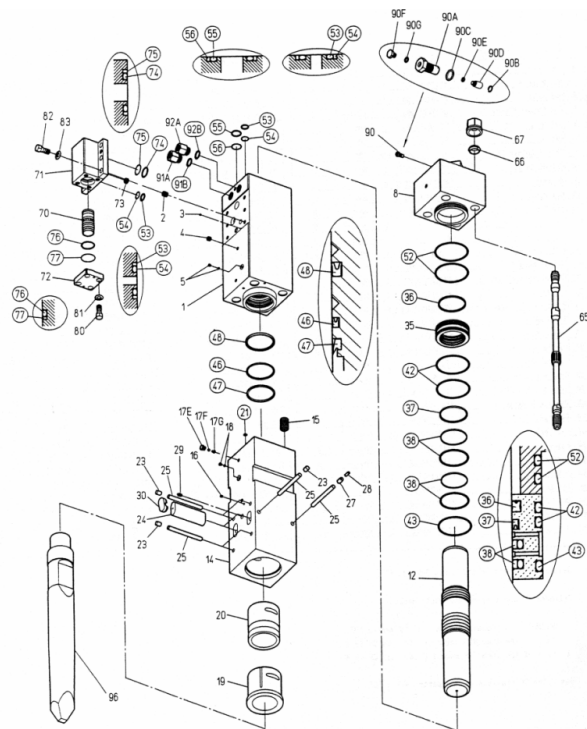
Due to a poor design of the hammer sealing system, where there is only one seal for dust removal (Figure 6 – position 47), a great quantity of solid particles from the atmosphere of the cement industry work environment penetrated the housing of the hammer (Figure 6 – position 1). Solid particles that penetrated the interior of the hammer were washed down by the working fluid and sent to other parts of the hydraulic system, all the way to the reservoir, and after that the pump sent them again to the executive part and other components of the excavator hydraulic system. In this way, the level of contamination cyclically increased in the working fluid.

Figure 6 – Explosion scheme of the hydraulic hammer  
Slika 6 – Detaljna šema hidrauličnog čekića

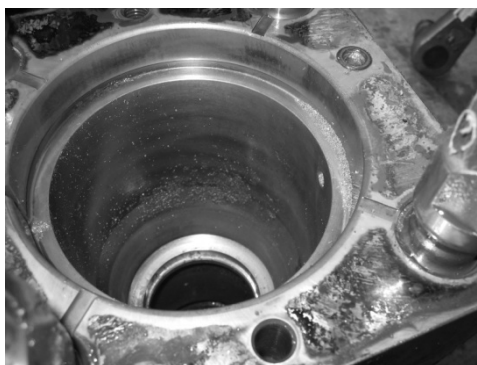
Due to the penetration of solid particles into the housing, damage occurred in the form of metal particles, as in Figure 7 which presents the interior of the hammer housing (Figure 6 - position 1) with the products of wear that occurred as a result of primarily abrasive wear and partially due to vibration. Figure 8 shows an enlarged image of the housing with the presence of particles and Figure 9 shows the assembly of the piston and the housing with the presence of accumulated solid particles after disassembling the hydraulic hammer. In the presented housing (Figure 9), there is a driving part of the hammer piston (Figure 6 - position 12) which is also presented in Figure 10 with visible traces of abrasive wear resulting from the performance of solid particles from the environment. Due to

Figure 7 – Housing of the hammer with particles  
Slika 7 – Kućište čekića sa vidljivim čvrstim česticama

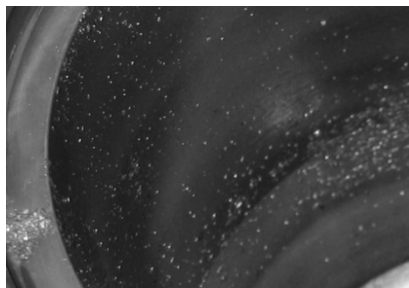
*Figure 8 – Enlarged image of the housing with the mass of metal particles*  
*Slika 8 – Uvećan prikaz kućišta sa metalnim česticama*

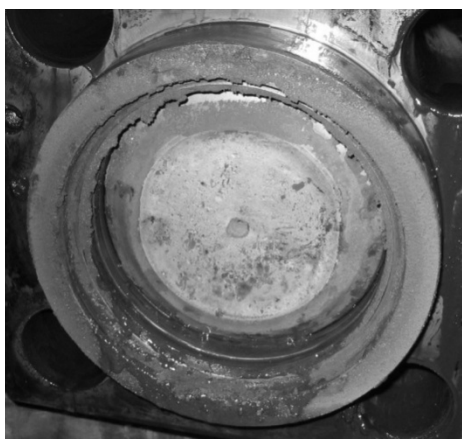
*Figure 9 – The assembly of the housing and the piston of the hammer with solid particles*  
*Slika 9 – Sklop kućišta i klipa hidrauličnog čekića sa vidljivim čvrstim česticama*

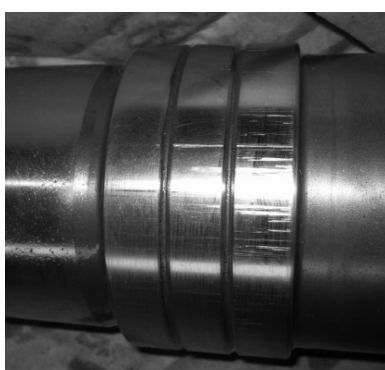
the presence of contaminants, significant damage is visible on the hammer piston in the form of longitudinal scratches that occurred as a result of the abrasive impact of solid particles present in the oil and vibrations that occurred during the operation of the hammer.

*Figure 10 – Abrasive damage on the hammer piston*  
*Slika 10 – Abrazivna oštećenja na klipu čekića*

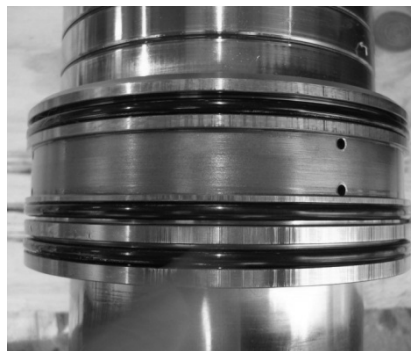
Solid particles present in the working fluid also caused the abrasive wear damage on the piston of the hammer regulating valve (Figure 6 – position 70) and it is shown in Figure 11.

Figure 11 – Abrasive damage of the regulating valve piston  
Slika 11 – Abrazivna oštećenja na klipu regulacionog ventila

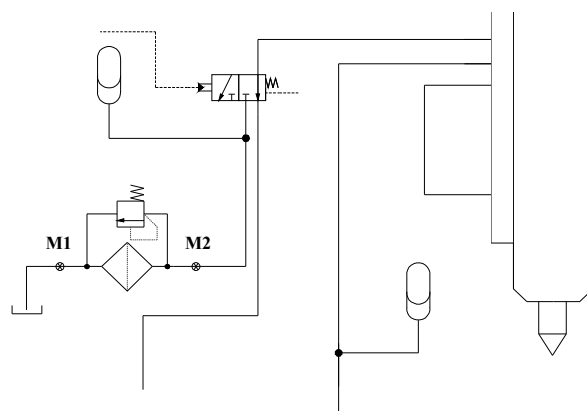
In the hydraulic hammer system, on the return line that takes the oil out of the hammer housing through the filter block (Figure 1 - position 6), the sensors for measuring the pressure (Figure 12) were set up on the measuring points M1 and M2. Based on the measured values obtained through the multy handy diagnostic unit 2045 (Hydrotechnik UK, 2012), it was determined that when the hammer chambers 12, 13 and 16 were unloaded in phase 4 (Figure 2), the pressure dropped in the return line between the inlet (M2) and the outlet (M1) of the filter housing, to the value of  $\Delta p=3.5$  bars (Figure 13). According to the manufacturer's recommendation, the pressure relief valve embedded in the housing of the filter was adjusted to open after the pressure had reached the value of  $\Delta p_{max}=1.5$  bars. Due to the impact of variable pressure values of  $\Delta p=3.5$  bars on the filter cartridge, or more specifically on the mesh and the filtering medium,

Figure 12 – Measuring points in the filter block of the hydraulic hammer system return line  
Slika 12 – Merna mesta na filterskom bloku u povratnom cevovodu hidrauličnog sistema

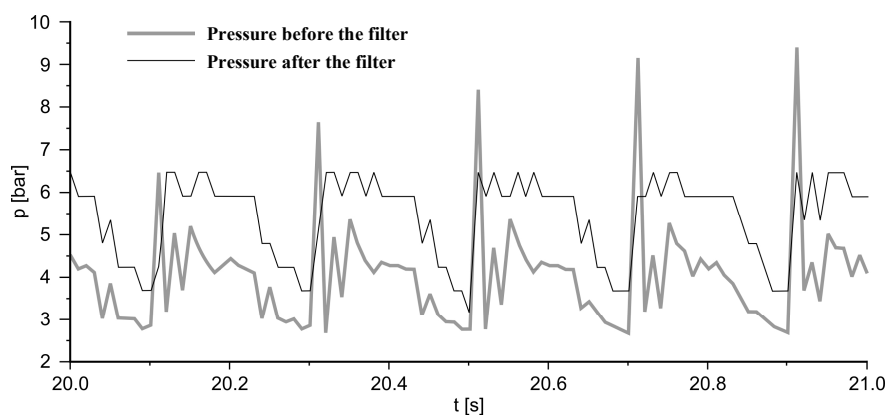
Figure 13 – Changes of pressure values in the filter block of the hammer return line  
Slika 13 – Izmerene promene pritiska na filterskom bloku

After the monitoring process, the main cause of damage in the filter cartridge was determined and after that the source of contamination of the whole system was determined as well.
