Ciencia y Sociedad, vol. XXXVI, núm. 2, abril-junio, 2011, pp. 256-275

METODOLOGÍA PARA LA EVALUACIÓN DE LA VULNERABILIDAD SÍSMICA DE EDIFICACIONES DE HORMIGÓN ARMADO EXISTENTE

(Methodology for the evaluation of seismic vulnerability in reinforced concrete buildings)

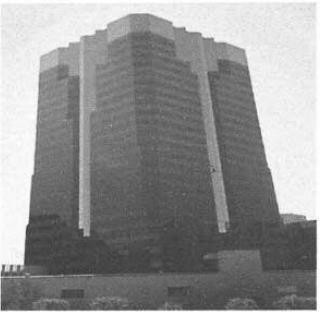
Building Identifier	Photograph	Basic Structural Hazard Score	Characteristics and Performance
S1 Steel moment-resisting frame

$H = 2.8$ $M = 3.6$ $L = 4.6$	<ul style="list-style-type: none"> Typical steel moment-resisting frame structures usually have similar bay widths in both the transverse and longitudinal directions, around 20-30 ft. The floor diaphragms are usually concrete, sometimes over steel decking. This structural type is used for commercial, institutional and public buildings. The 1994 Northridge and 1995 Kobe earthquakes showed that the welds in steel moment-frame buildings were vulnerable to severe damage. The damage took the form of broken connections between the beams and columns.
S2 Braced steel frame

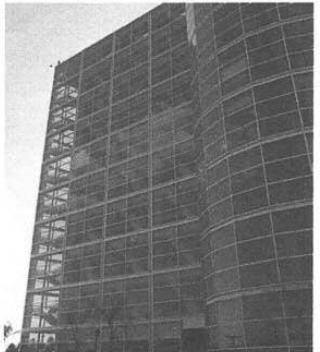
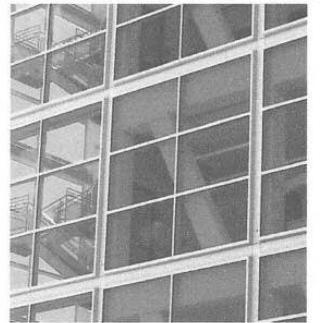
$H = 3.0$ $M = 3.6$ $L = 4.8$	<ul style="list-style-type: none"> These buildings are braced with diagonal members, which usually cannot be detected from the building exterior. Braced frames are sometimes used for long and narrow buildings because of their stiffness. From the building exterior, it is difficult to tell the difference between steel moment frames, steel braced frames, and steel frames with interior concrete shear walls. In recent earthquakes, braced frames were found to have damage to brace connections, especially at the lower levels.

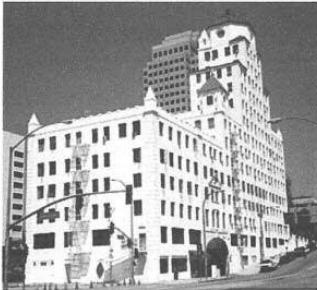
$H = 2.8$ $M = 3.6$ $L = 4.8$	<ul style="list-style-type: none"> Lateral loads are resisted by shear walls, which usually surround elevator cores and stairwells, and are covered by finish materials. An interior investigation will permit a wall thickness check. More than six inches in thickness usually indicates a concrete wall. Shear cracking and distress can occur around openings in concrete shear walls during earthquakes. Wall construction joints can be weak planes, resulting in wall shear failure below expected capacity.

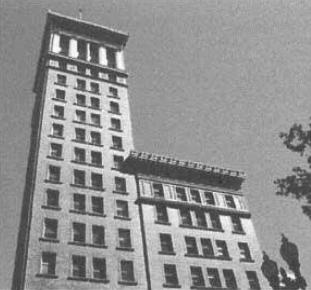
<i>Building Identifier</i>	<i>Photograph</i>	<i>Basic Structural Hazard Score</i>	<i>Characteristics and Performance</i>
S5 Steel frames with unreinforced masonry infill walls

H = 2.0 M = 3.6 L = 5.0	<ul style="list-style-type: none"> Steel columns are relatively thin and may be hidden in walls. Usually masonry is exposed on exterior with narrow piers (less than 4 ft wide) between windows. Portions of solid walls will align vertically. Infill walls are usually two to three wythes thick. Veneer masonry around columns or beams is usually poorly anchored and detaches easily.
C1 Concrete moment-resisting frames

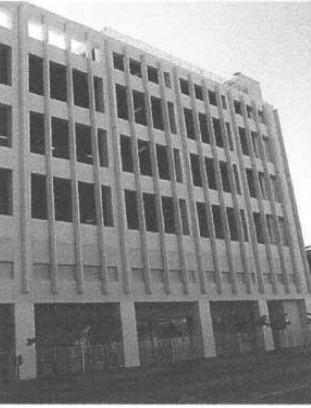
H = 2.5 M = 3.0 L = 4.4	<ul style="list-style-type: none"> All exposed concrete frames are reinforced concrete (not steel frames encased in concrete). A fundamental factor governing the performance of concrete moment-resisting frames is the level of ductile detailing. Large spacing of ties in columns can lead to a lack of concrete confinement and shear failure. Lack of continuous beam reinforcement can result in hinge formation during load reversal. The relatively low stiffness of the frame can lead to substantial nonstructural damage. Column damage due to pounding with adjacent buildings can occur.

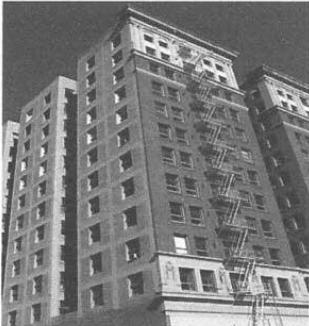
$H = 1.6$ $M = 3.2$ $L = 4.4$	<ul style="list-style-type: none"> • Concrete columns and beams may be full wall thickness and may be exposed for viewing on the sides and rear of the building. • Usually masonry is exposed on the exterior with narrow piers (less than 4 ft wide) between windows. • Portions of solid walls will align vertically. • This type of construction was generally built before 1940 in high-seismicity regions but continues to be built in other regions. • Infill walls tend to buckle and fall out-of-plane when subjected to strong lateral out-of-plane forces. • Veneer masonry around columns or beams is usually poorly anchored and detaches easily.

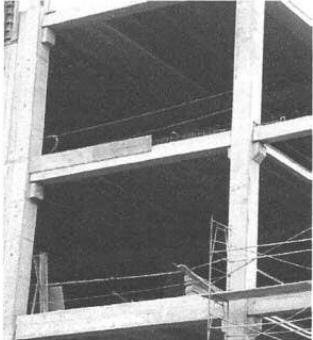
<i>Building Identifier</i>	<i>Photograph</i>	<i>Basic Structural Hazard Score</i>	<i>Characteristics and Performance</i>
PC2 Precast concrete frame buildings

Building under construction

Detail of the precast components

Building nearing completion	$H = 2.4$ $M = 3.2$ $L = 4.6$	<ul style="list-style-type: none"> ● Precast concrete frames are, in essence, post and beam construction in concrete. ● Structures often employ concrete or reinforced masonry (brick or block) shear walls. ● The performance varies widely and is sometimes poor. ● They experience the same types of damage as shear wall buildings (C2). ● Poorly designed connections between prefabricated elements can fail. ● Loss of vertical support can occur due to inadequate bearing area and insufficient connection between floor elements and columns. ● Corrosion of metal connectors between prefabricated elements can occur.

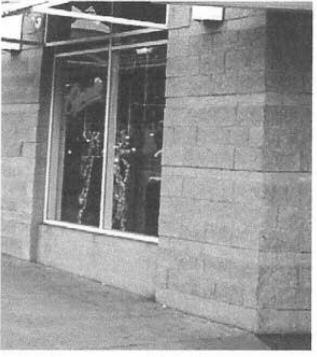
<i>Building Identifier</i>	<i>Photograph</i>	<i>Basic Structural Hazard Score</i>	<i>Characteristics and Performance</i>
RM1 Reinforced masonry buildings with flexible diaphragms

<p>Truss-joists support plywood and light-weight concrete slab</p>

<p>Detail showing reinforced masonry</p>	$H = 2.8$ $M = 3.6$ $L = 4.8$	<ul style="list-style-type: none"> • Walls are either brick or concrete block. • Wall thickness is usually 8 inches to 12 inches. • Interior inspection is required to determine if diaphragms are flexible or rigid. • The most common floor and roof systems are wood, light steel, or precast concrete. • These buildings can perform well in moderate earthquakes if they are adequately reinforced and grouted, with sufficient diaphragm anchorage. • Poor construction practice can result in ungrouted and unreinforced walls, which will fail easily.

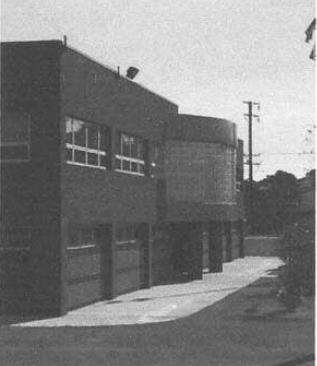
<i>Building Identifier</i>	<i>Photograph</i>	<i>Basic Structural Hazard Score</i>	<i>Characteristics and Performance</i>
RM2 Reinforced masonry buildings with rigid diaphragms

H = 2.8 M = 3.4 L = 4.6	<ul style="list-style-type: none"> Walls are either brick or concrete block. Wall thickness is usually 8 inches to 12 inches. Interior inspection is required to determine if diaphragms are flexible or rigid. The most common floor and roof systems are wood, light steel, or precast concrete. These buildings can perform well in moderate earthquakes if they are adequately reinforced and grouted, with sufficient diaphragm anchorage. Poor construction practice can result in ungrouted and unreinforced walls, which will fail easily.
URM Unreinforced masonry buildings
