Gallardo-Saavedra, Sara; Hernández-Callejo, Luis; Duque-Pérez, Óscar
Analysis and characterization of PV module defects by thermographic inspection

Revista Facultad de Ingeniería Universidad de
Antioquia, no. 93, 2019, October-December, pp. 92-104
Facultad de Ingeniería, Universidad de Antioquia

Analysis and characterization of PV module defects by thermographic inspection

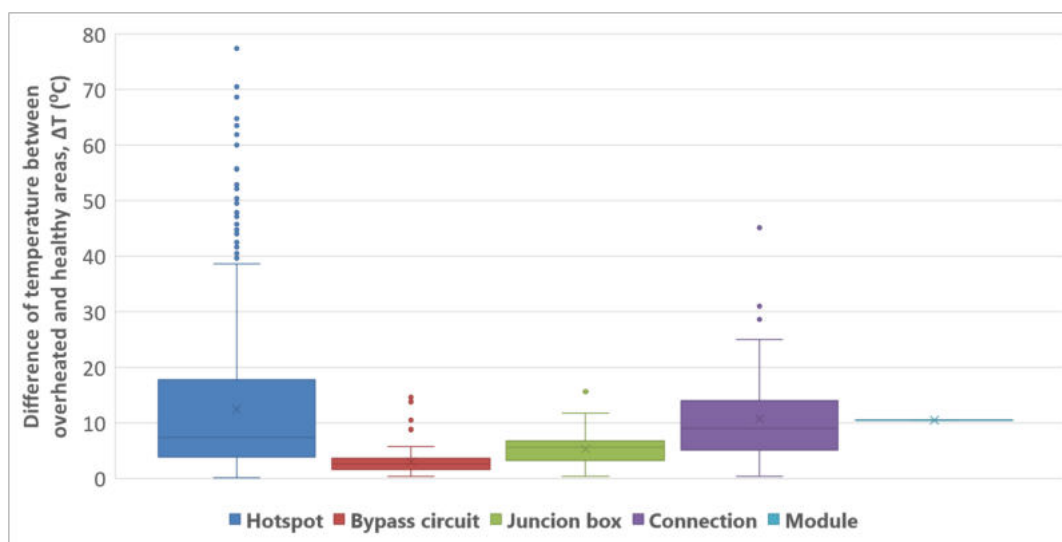
Figure 3 Box chart showing the difference of temperature between overheated and healthy areas, ΔT , grouped by defect type for each of the 1,140 defective modules detected

the severity of the anomalies for manual thermal inspection proposed in [17]. Differences higher than 30°C are considered as severe failures, from 10°C to 30°C are considered as medium severity failures, and lower than 10°C as minor failures. According to [23], temperature gradients lower than 10°C are normally considered as unproblematic and do not have to be listed separately. Temperature gradients from 10°C to 20°C are unproblematic in the current stage, although they have to be reported and observed in subsequent regular thermal inspections as they can increase during the operation of the PV power plant [23]. Differences of temperature above 20°C are expected to cause degradations of panel output and eventually, the material compound may even degrade, resulting in a safety issue. Table 3 summarizes the severity of all defects detected, grouped by defect type or affected component.

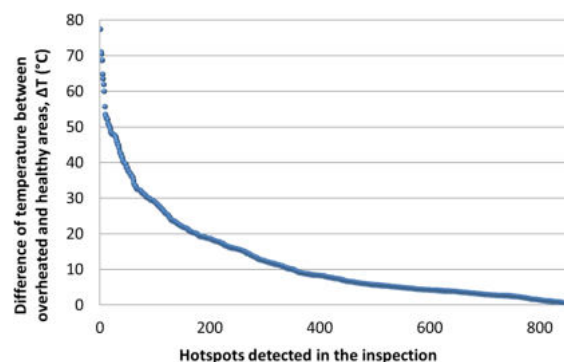
Reviewing all cells hotspot defects, it has been concluded that the pattern of this fault is an overheated cell, of approximate $15 \times 15 \text{ cm}^2$ depending on the module manufacturer, located in any cell along the module. The analysis performed does not reveal any preference of appearance of the overheated cell in any of the three strings circuits. The following figure, Figure 7, presents the ΔT of each of the 859 cell hotspots detected in the inspection in descending ΔT order, obtaining an average temperature of 12.4°C with a standard deviation on 12.8°C . Other relevant statistical values are the median, 7.4°C , and the first and third quartile, 3.8°C and 17.8°C , respectively. As it can be seen in Figure 7, the highest ΔT detected in the tests is 77.4°C , which supposes a cell hotspot

Figure 7 ΔT of each hotspot detected during the inspection in order from the highest to the lowest

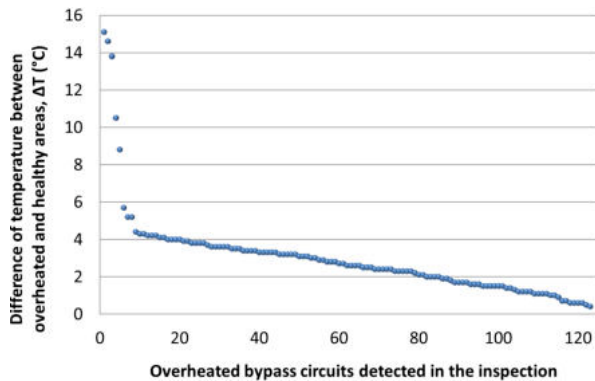
circuits detected in the inspection in descending ΔT order, obtaining an average temperature of 3.0°C with a standard deviation on 2.3°C. As it can be seen in the figure, most of these defects present a ΔT under 4°C. Only 8 modules (which supposes a 6.5%) present a ΔT over 4°C and only 4 modules (3.25%) have a ΔT over 10°C. The maximum ΔT detected has been 15.1°C. Other relevant statistical values are the median, 2.6°C, and the first and third quartile, 1.7°C and 3.6°C, respectively.

Figure 9 ΔT of each bypass circuit overheated detected during the inspection in order from the highest to the lowest

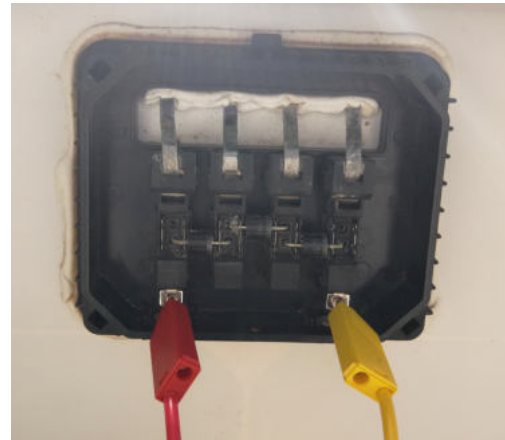
Figure 10 Module junction box open, showing conducting strips, which connect the bus ribbon to the bypass diode terminal, three bypass diodes and terminals

The main thermal abnormalities in that case are overheated bypass diodes, as the temperature of the diode when it is active is higher than the inactive diodes, reducing the power output of the module when the diodes are active. Two examples of overheat detected in the junction boxes are showed in Figure 11 and Figure 12 As it can be seen in the images, the defect is more pronounced in the back image than in the front, as the junction box is in the back and the difference measured in the front is only due to the heat transfer from conduction from the junction box. Therefore, to detect this kind of defects, it would be recommendable performing the inspection to the back of the modules; however, it is more complicated due to the PV structures tilt, as detailed before.

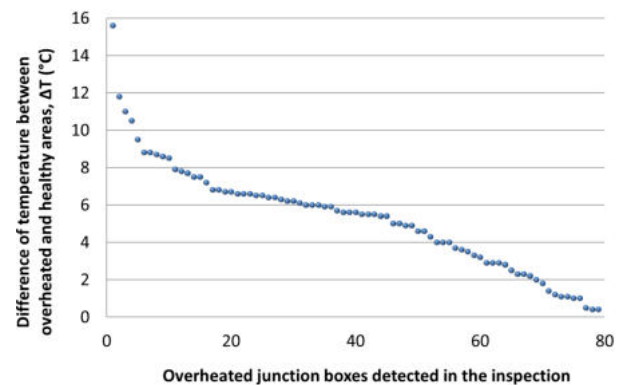
In relation with the pattern this kind of defects present, it has been shown that they are revealed as an overheated point in the middle part of the shorter side in which the box is located. This overheated point habitually appears in the middle of two different cells. In the PV plant in which the research has been performed, the modules of the upper row have the junction box underneath while the modules of the second row have the box in the upper part, as it can be seen in Figure 11 and Figure 12. The location of junction boxes along rows must be considered if a software must classify automatically the defects. The following figure, Figure 13, presents the ΔT of each of the 79 overheated junction boxes detected in the inspection in descencing ΔT order, obtaining an average temperature of 5.3°C with a standard deviation on 2.8°C. The maximum ΔT detected has been 15.6°C. Other relevant statistical values are the median, 5.6°C, and the first and third quartile, 3.3°C and

Figure 13 ΔT of each junction box detected during the inspection in order from the highest to the lowest

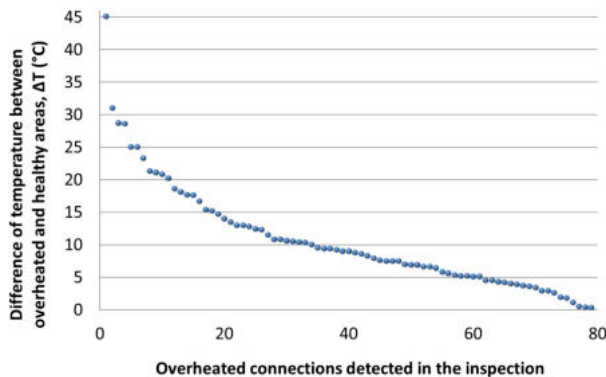
Reviewing all connection defects, it has been concluded that the pattern of this fault is an overheated point, generally smaller than a cell, located next to the frame in the same side in which the junction box is placed. The following figure, Figure 15, presents the ΔT of each of the 78 overheated connections detected in the inspection in descending ΔT order, obtaining an average temperature of 10.9°C with a standard deviation on 8.1°C. The maximum ΔT detected in this case has been 45.1°C. Other relevant statistical values are the median, 9.0°C, and the first and third quartile, 5.2°C and 13.8°C, respectively.

Figure 15 ΔT of each overheated connections detected during the inspection in order from the highest to the lowest
