Bermúdez-Castañeda, Angela; Esguerra Arce, Johanna; Esguerra-Arce, Adriana; Vargas-Pabón, Sofia Valentina; Ortiz-Martínez, Juan Guillermo; Blanco-Estupiñán, David Leonardo; Castaño, Juan Guillermo; Mischler, Stefano  
A comparative surface analysis of explanted hip joint prostheses made of different biomedical alloys

Revista Facultad de Ingeniería Universidad de Antioquia, no. 100, 2021, July-September, pp. 35-47  
Facultad de Ingeniería, Universidad de Antioquia

# A comparative surface analysis of explanted hip joint prostheses made of different biomedical alloys

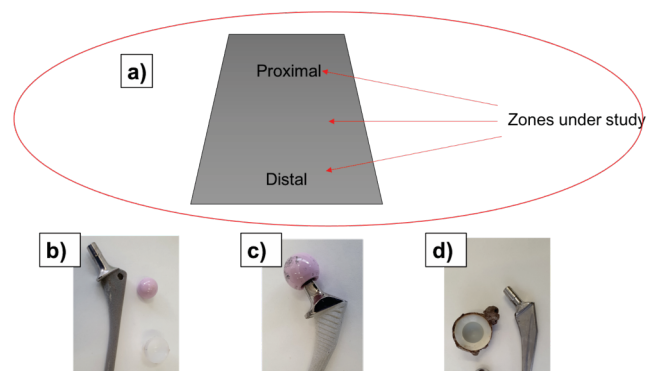
1 year for the CoCr trunnion, around 10 years for the 316SS, while the Ti6Al4V trunnion was implanted for 8 years, approximately. All of them were removed because of infection and pain. Once explanted, the hardness of the trunnions was measured at the surface and in the bulk. Also, the chemical composition was determined by means of energy dispersive X-ray (EDX). In order to analyze wear on the trunnion surfaces, a scanning electron microscopy (SEM) was carried out using a Zeiss GEMINI 300 scanning microscope at a high vacuum environment, and optical profilometry was performed. All SEM images were made using an acceleration voltage of 3 kV and a working distance of 6 mm. 3D profiles were taken using a Laser Scanning Confocal Microscope, Keyence VK-X200 Series 3D. Data analysis was developed using the MultiFileAnalyzer 1.3.0.115 software. Figure 1 shows the prostheses under study and the analyzed zones: proximal, distal, and intermediate zones.

**Figure 1** Schematic diagram a) the zone under study, and analyzed prostheses showing trunnion/head pairs b) CoCr / alumina, c) Ti6Al4V/Alumina and d) Stainless Steel/CoCr

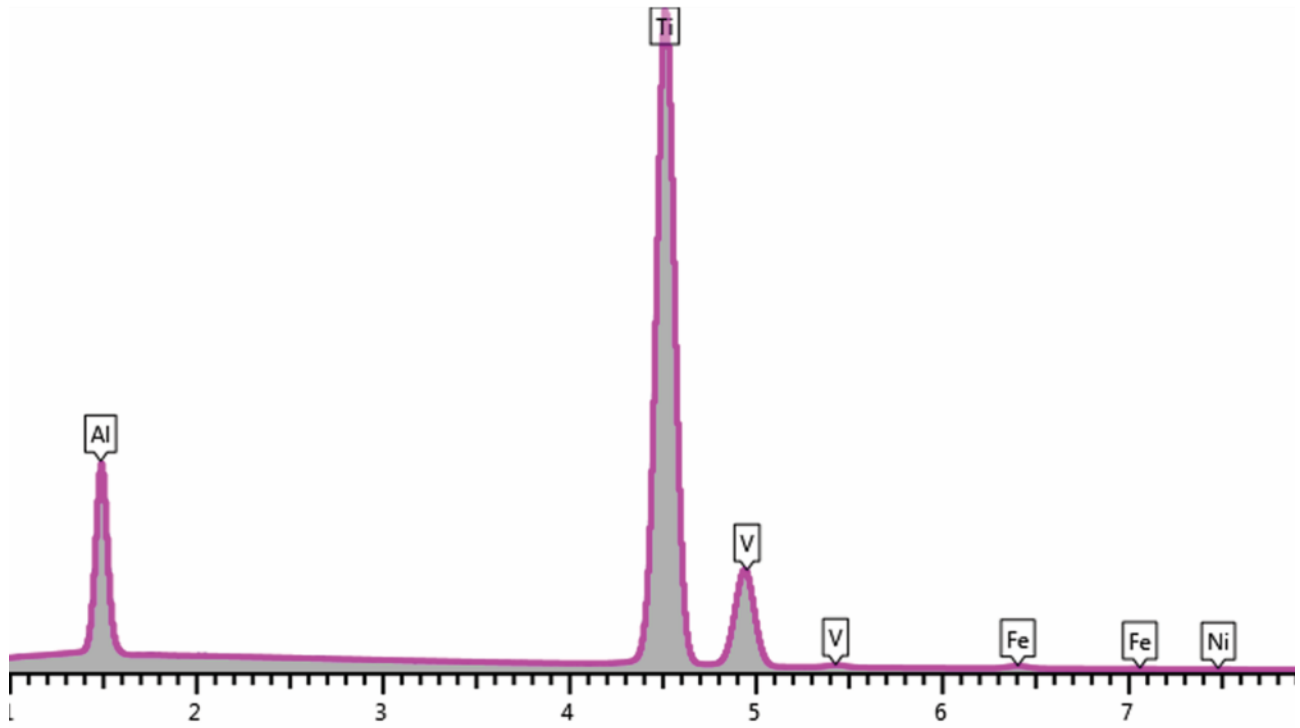
Titanium alloy explant showed the composition indicated in Table 2, and the EDX spectrum is shown in Figure 2. A conventional  $\alpha + \beta$  - Ti-6Al-4V alloy was identified [21], even though Fe and Ni are slightly high.

**Figure 2** EDX spectrum of Ti6Al4V surface trunnion

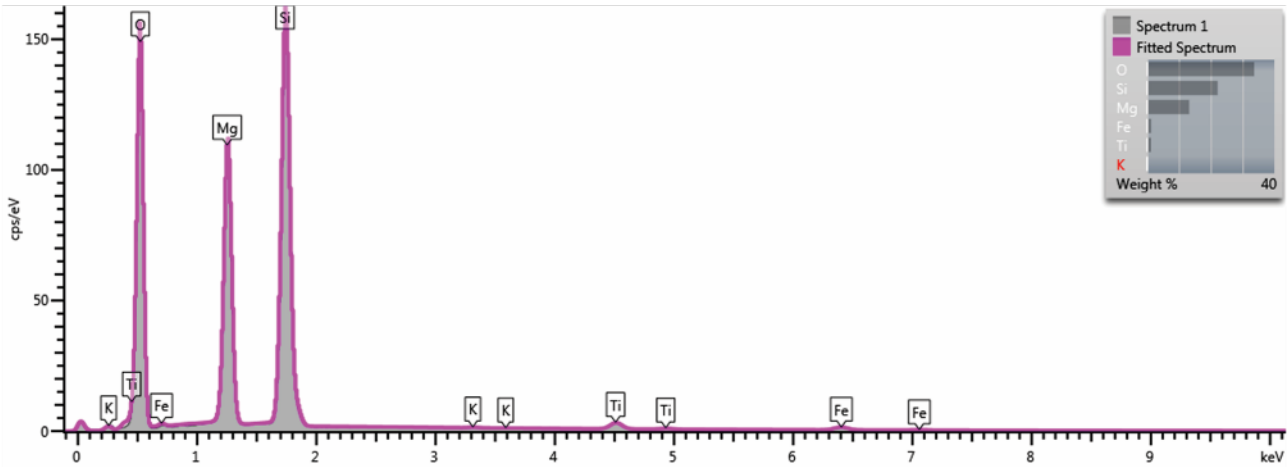
Images from the middle part of the trunnion show ploughing, although to a less severe degree than in the distal area. Moreover, some particles of organic material (biofilms), which composition is shown in Table 3 and Figure 4, can be found at this distance, as shown in Figure 3 **d)**. The entry of this material shows that even if the obstruction is produced at the entrance, material and particles can pass through the length of the trunnion.

Figure 4 EDX spectrum of biofilm on Ti6Al4V surface trunnion

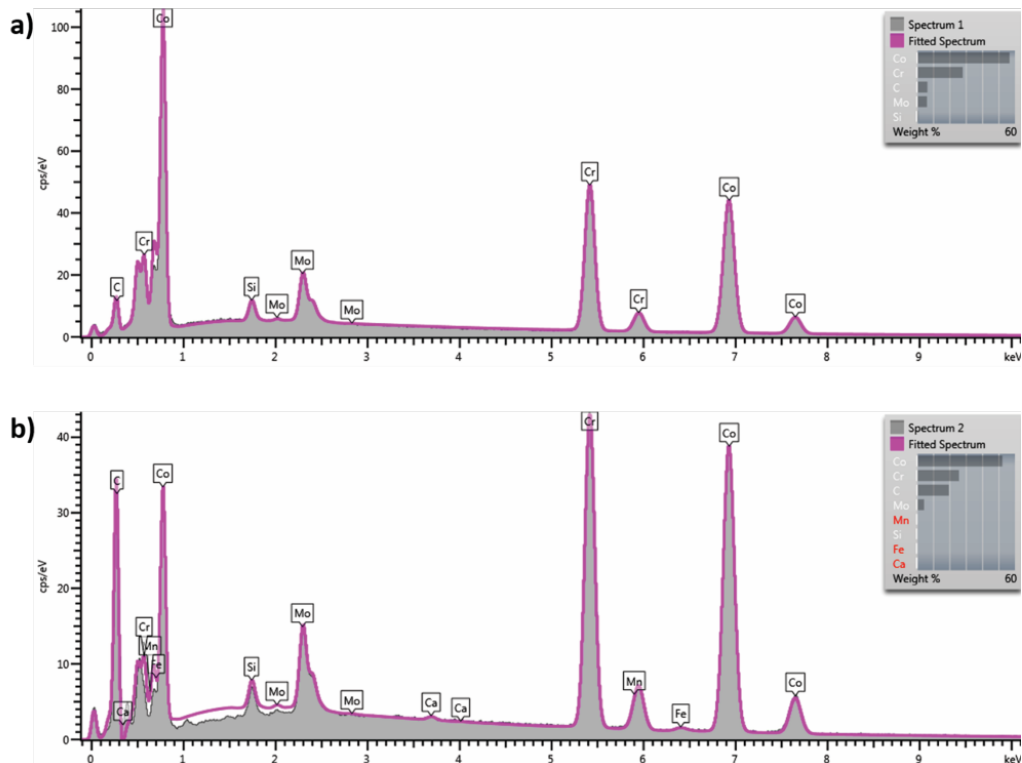
The trunnion made from CoCr alloy was characterized through EDX analysis. The corresponding spectra are shown in Figure 7, and the composition from different parts is indicated in Table 4. According to the literature, the identified composition corresponds to a typical CoCr biomedical alloy [22]. Despite this, elements such as Co, Cr, and C show higher concentrations, which may correspond to material transfer and body fluids. Taking into account that the femoral head was made from CoCr, as the trunnion, the material transfer cannot be successfully identified.

**Figure 7** EDX spectra from a) distal part, and b) proximal part of CoCr explanted prosthesis

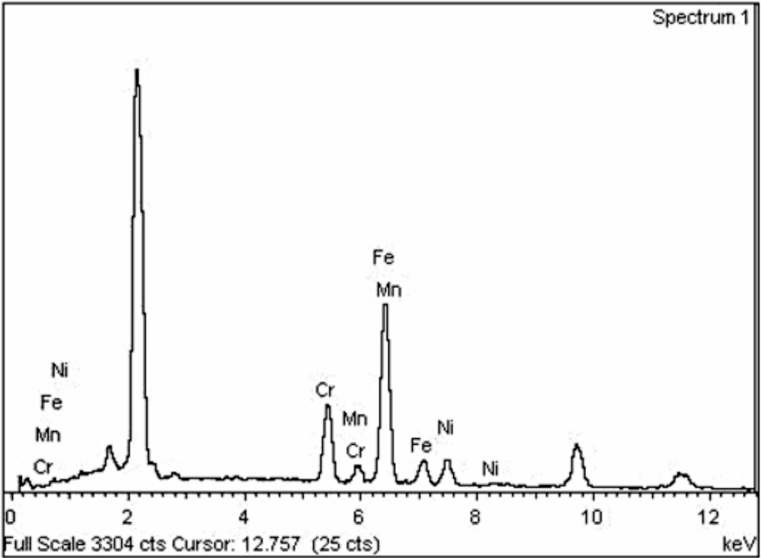
The explanted stainless-steel trunnion, as well as the Ti-6Al-4V and CoCr prostheses, are subjected to surface texturization to promote adhesion, as can be seen in Figure 10 **a)** and **c)**. The chemical composition by EDX is shown in Table 5, the spectrum shown in Figure 11. SEM images of each part of the trunnion are shown in Figure 10. The distal part exhibits a higher intensity of damage than the proximal part. Tribocorrosion phenomena are evident in the SEM analysis. Abrasion lines are observed along the length

Detached particles can be observed in Figure 14. These particles have the same chemical composition as the SS prosthesis. Moreover, no oxygen is observed, which indicates the presence of metallic material. In addition, EDX analysis in Figure 15 shows a material layer formed on the material surface similar to those reported in previous studies [16, 25], [26]. These films, known as a tribofilm, are formed by the oxidized and metallic material worn from both interfaces in contact. The layer was found on the explanted trunnion of 316L stainless steel, which was paired against a Co-Cr alloy head. The alloy contains an average of 18.55% of Cr, according to EDX (see Table 5 and Figure 11). However, the chemical analysis of the surface

**Figure 11** EDX spectrum of SS surface trunnion
