# EVALUATION OF PERFORMANCE AND EARLY DEGRADATION OF A 180.8 KWP ROOFTOP ON A GRID-CONNECTED PHOTOVOLTAIC SYSTEM IN A COLOMBIAN TROPICAL REGION ENVIRONMENT

This study presents the results of the performance and early degradation assessment of a 180.8 kWp rooftop on a grid-connected photovoltaic system, installed in Barranquilla, city located in northern Colombia, during its first year of operation. Two methods were used to assess the performance and early degradation: i) Estimation of solar conversion efficiency, and ii) visual inspection. The first method includes a cross analysis between climatic conditions, irradiance levels and the generated energy downstream inverters. To calculate the plane irradiance, a correction factor is proposed, using the global irradiance. In addition to a cost analysis aimed at identifying how much money the non-generated energy represents. The second method consists of periodical visual inspections of installed modules to observe if there is any of the following degradation modes: Discoloration, delamination, busbar corrosion, cracking of solar cell, glass breakage, anti-reflection coating and solder bond. The results show the solar conversion effic

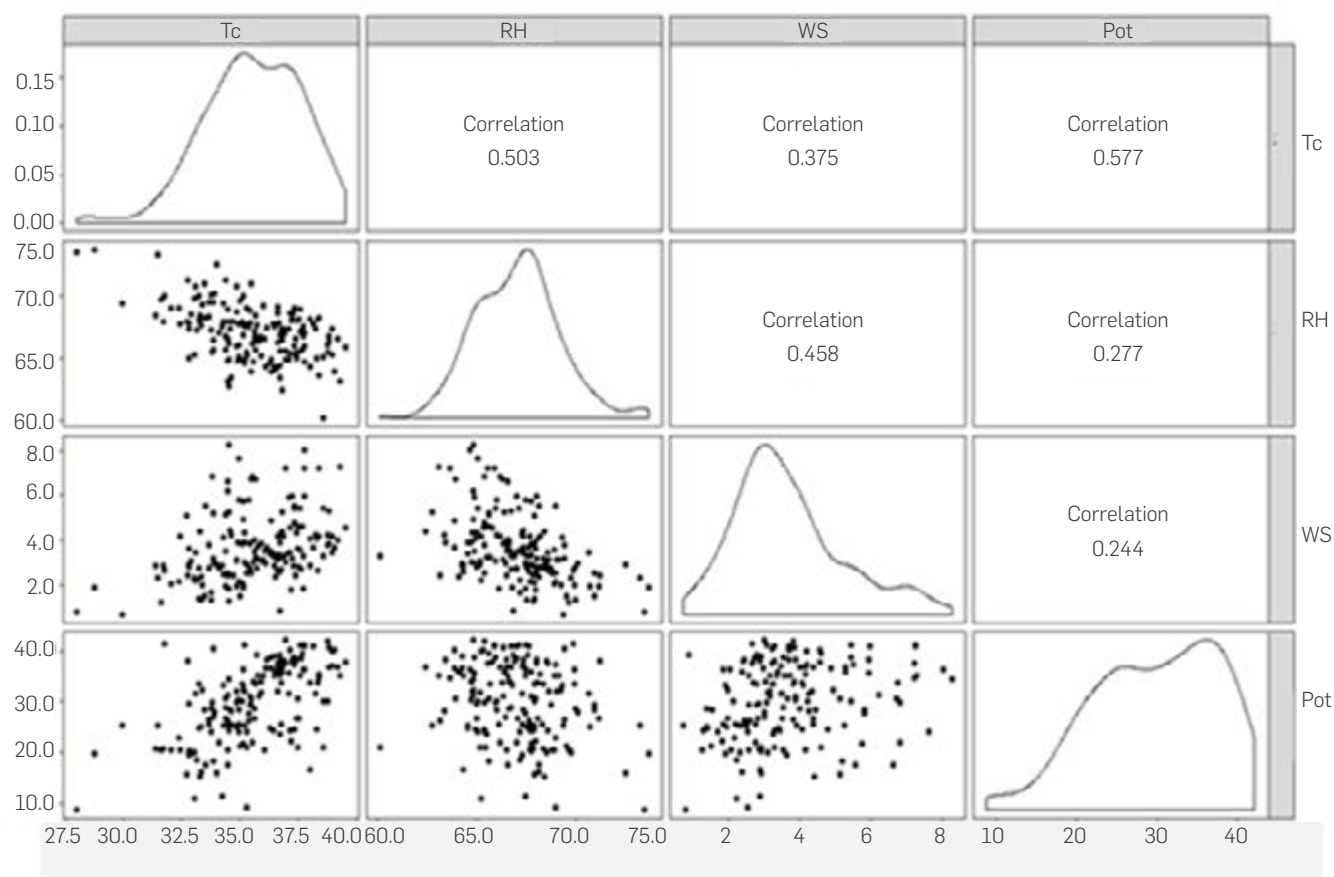
**Figure 9.** Correlation matrix for power, cell temperature, relative humidity and wind speed

The effect of the cell temperature, wind velocity, and relative humidity was also checked during the research. Six months of data were used to assess the effect of wind velocity, relative humidity, and cell temperature over panels energy production. The correlation analysis was conducted by such means **Figure 9** shows the correlation matrix, with the last column including the correlation between power generated and cell temperature, relative humidity, and wind velocity. Here, "Pot" stands for power, "Tc" for cell temperature, "RH" for relative humidity, and "WS" for wind speed.

The coefficients were significant, and the statistical assumptions were met, but the R2 value was only 0.3292. It can be stated that even when the correlation between power and cell temperature is not minimal, the cell temperature fails at predicting power behavior. In other words, more variables are needed to describe the power.

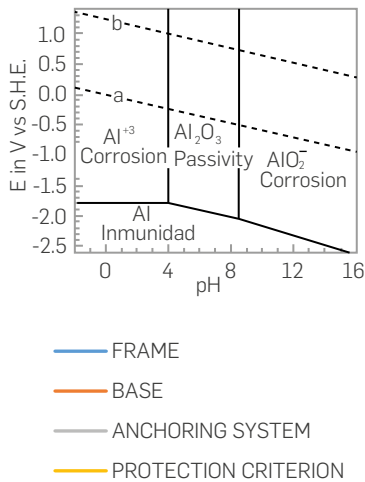
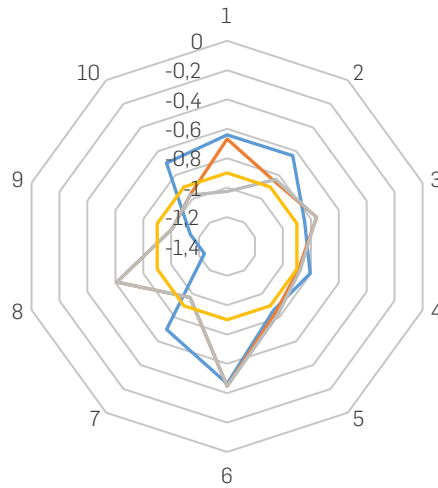
**Figure 10.** Photovoltaic panels corrosion potential (Based on [24])

The galvanic series is the location of different types of materials with respect to their electrochemical potential. In the specific case of aluminum, potential measurements are obtained against a Cu/CuSO<sub>4</sub> electrode, allowing the identification of the tendency of corrosion, immunity or passivation of the material relative to the pH of the surrounding environment [22]. According to the cathodic protection criteria of the NACE RP 0169 standard, the aluminum metal structure is protected with more negative potentials of -0.9 volts [23]. **Figure 10** presents the potential measurements for the selected panels showing active corrosion processes, which is favored with the pH range between 4-8. This shows the formation of a protective layer of Al<sub>2</sub>O<sub>3</sub>. For the particular case of residues gathered in the selected points, the average pH measured was 7.06; therefore, the formation of passivating film is stable.

The atmospheric characterization is carried out in the presence of relative humidity greater than 70 %, which facilitates the condensation on metal surfaces, promoting the formation of a wet film that may contain contaminants such as chlorides and sulfides that accelerate the corrosion process [25]. **Figure 11** shows the reports of the concentration of chlorides and sulphides identified

According to ISO 9223 [26], it is possible to categorize outdoor atmospheric corrosivity into 5 levels: very low (C1), low (C2), medium (C3), high (C4) and very high (C5) according to the content of  $\text{SO}_2$  and chloride type contamination [27, 28]. Given the results of the dust samples obtained, the sulfide concentration exceeded  $30 \mu\text{m}^3$  and levels up to  $2500 \text{ mg/m}^3$ , placing it in a high corrosivity category (C4). With this information, it is then estimated that the degradation of the aluminum structures of the photovoltaic panels is generated by the loss of mass between  $2\text{-}5 \text{ mg/m}^2$  year assuming uniform corrosion, which must be frequently evaluated to identify localized corrosion faults.
