Rocha, Joaquin Humberto Aquino; Ibarra-Villanueva, Rolando
Identification and analysis of pathological defect appearance in
superstructures of reinforced-concrete bridges in Chapare region, Bolivia
DYNA, vol. 88, no. 216, 2021, January-March, pp. 15-21
Universidad Nacional de Colombia

Identification and analysis of pathological defect appearance in superstructures of reinforced-concrete bridges in Chapare region, Bolivia

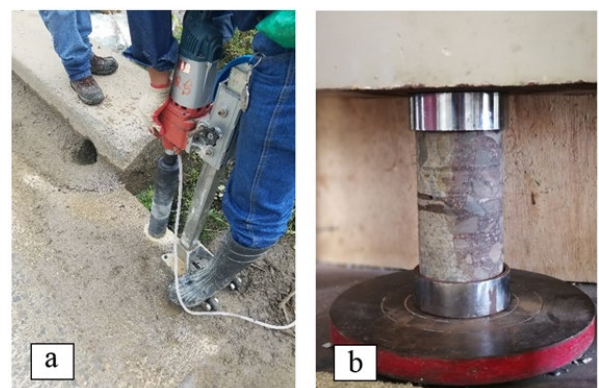
Compression resistance is high in cores, greater than 30 MPa. These values are appropriate and recommended for this type of structure [37], but carbonation presence is evident in almost every extracted core.

Fig. 10 shows both core extraction and compression testing. In the case of N2-E8 for Roquemayu Bridge, compression test was performed according to C42/C42M-04 recommendations [15]. This core presented iron and oxidation products (Fig. 11).

Figure 10. a) Core extraction, and b) Compression Test – Ronquito Bridge
Source: The authors.
