### Extreme Testing of Guard Cables with Fiber Optics: A Case Study

Erick-Alejandro González-Barbosa<sup>1</sup>

**Context:** Optical fiber ground wires (OPGWs) sometimes melt and rupture when exposed to extreme conditions, such as atmospheric discharges, short circuits, and corrosive agents, that affect their electrical and mechanical properties. These conditions depend on the geographical area where the cable is installed, with the most critical being industrial and coastal zones as well as marine and mountainous environments. This research analyzes a cable rupture due to lightning strikes from a coastal zone.

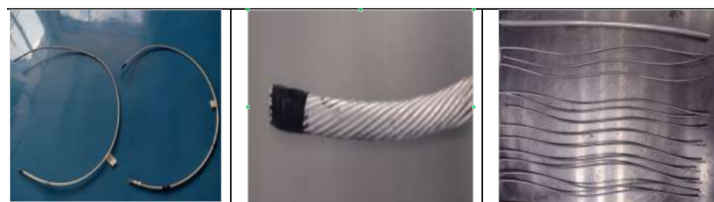
Fig. 8 shows two cable sections (class 0, 0.30 m in length, as stipulated by the E1000\_21 specification for stress testing). The elastic modulus (E) of the analyzed cable is around 116 Gpa. Table II analyzes the

**Figure 8.** 0.30 m long OPGW cable for tension tests, aluminum tube containing the optical fibers and their 12 test wires
