Geofísica internacional

# Electrical Resistivity Tomography for the detection of subsurface cavities and related hazards caused by underground coal mining in Coahuila

José A. Batista Rodríguez\*, Marco A. Pérez Flores, Yuri Almaguer Carmenates and Maximiliano Bautista Hernández

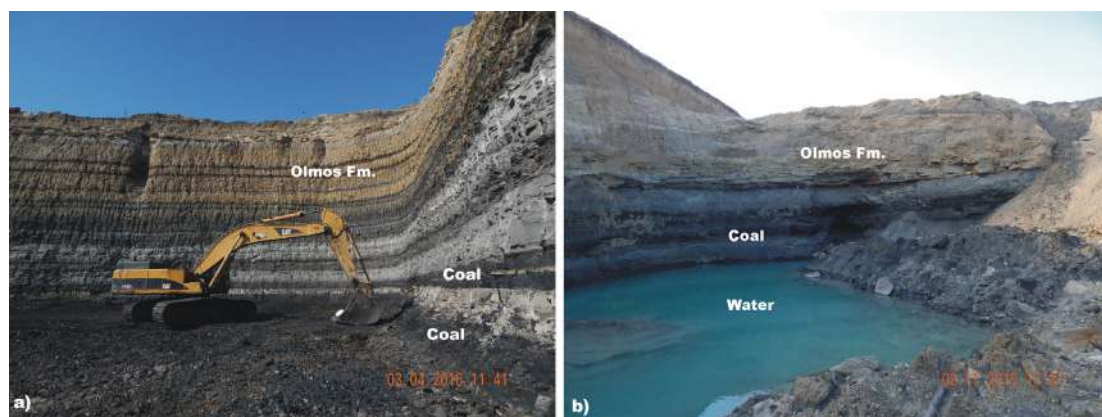
The second aquifer system is of great significance to the study of the cavities generated by mining activity, because some coal seams in the Olmos Formation are located below the static level (Figure 2b), which indicates flooding of the underground galleries.

**Figure 2.** Coal open pit mines in Sabinas basin. a) Coal seams in the Olmos Fm. b) Aquifer cutting coal seams in the Olmos Fm.

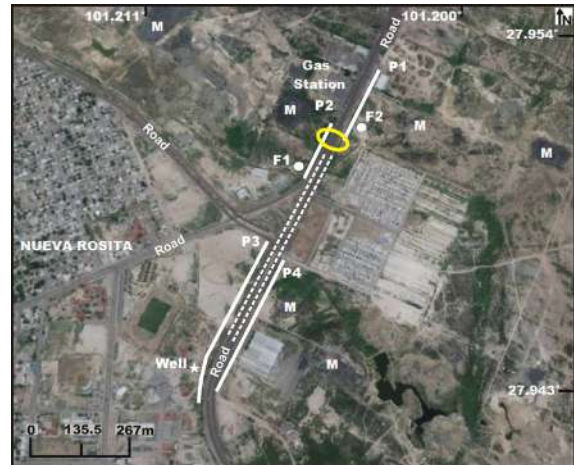
**Figure 5.** Study Sector 1. M indicates mining zones. Continuous black lines indicate location of the measurement profile (P1, P2, P3 and P4). Dashed black lines indicate location of the bridge. F1 and F2 indicate the reference point for the photographs shown in figures 9b and 9c. Yellow ellipse indicates a subsidence zone on the road (view photograph in Figure 9a). Star indicates well.

This sector contains both a road and a bridge support (Figure 5), with subsidence found on the road at the northeast end (Figure 9a), which could be related to the underground coal mining (Peng, 2008) due the shallower mining activities in this sector and its surroundings.

In order to locate and characterize the subsidence-related hazard zones, four ERT profiles (referred as P1, P2, P3 and P4) measured on both sides of the road and at the beginning of the bridge support (Figure 5). The profiles ran on a NE-SW direction of the sector, covering the areas of the road affected by subsidence (profiles 1 and 2, with lengths of 270 m) and other areas where this geological process is not observed (profiles 3 and 4). Conglomerates were found to outcrop in the four profiles (Figures 1, 10 and 11).

While profiles 1 and 2 run paralleled on both road sidewalks, but they have an offset each other (Figure 5). They only coincide until  $x=60$  m in P2 (Figure 10). For this reason, it is not possible to assess whether the cavities continue on another sidewalks.

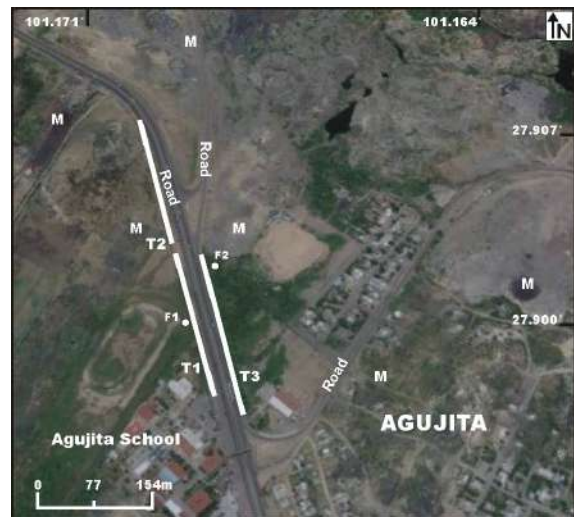
**Figure 6.** Study Sector 2. Continuous white lines indicate location of the measurement profile (T1, T2 and T3). F1 and F2 indicate the reference point for the photographs shown in figures 13a and 13b.

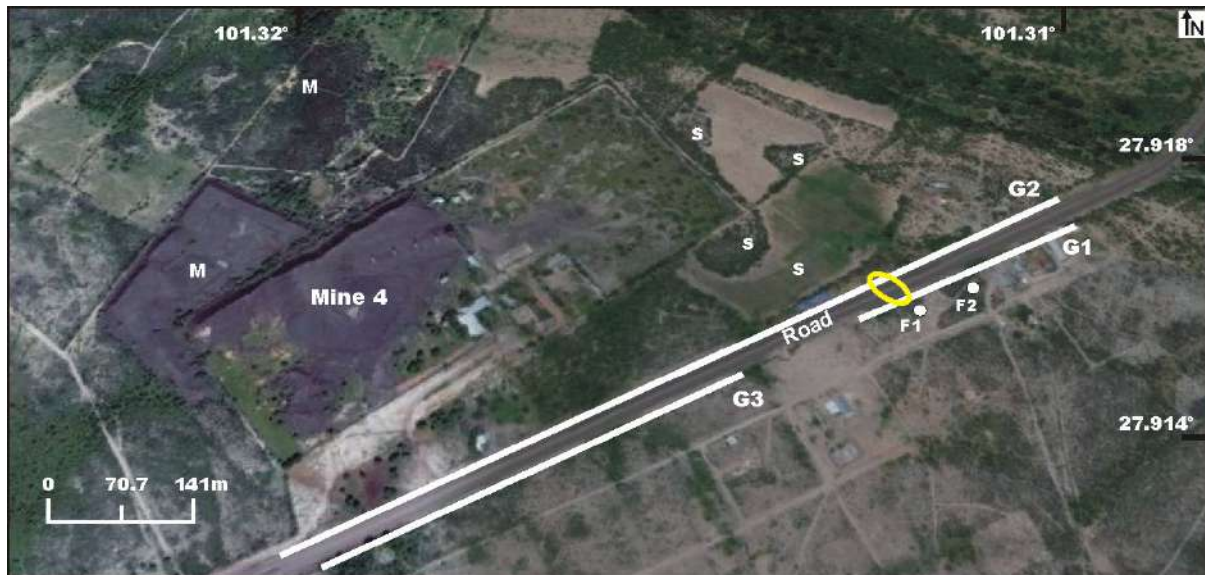
**Figure 7.** Study Sector 3. Continuous white lines indicate location of the measurement profile (G1, G2 and G3). S indicates areas with a sinkhole. F1 and F2 indicate the reference point for the photographs shown in figures 14c and 14d. Yellow ellipse indicates a subsidence zone on the road (view photography in Figure 14a).

An overlap on the data profiles was created between the lines in P2 on Sector 3 (Figure 7) in order to ensure the continuity of the model and attain a length greater than 540 m. This overlap was achieved using the Roll-along technique, in which the electrode cable advance forward along the measurements profile by moving your cable sections in a leap-frog way. Subsequently, the joint inversion of the three arrays was performed using EarthImager 2D resistivity inversion software developed by Advanced Geosciences, Inc. The software uses a finite element algorithm to compute the estimated real resistivity (model) thought the apparent resistivity data (AGI, 2009), from which a geological explanation for every 2D resistivity model was found (Huebner and Thornton, 1995). The geophysical inversion gives us the resistivity model with a very low or the lowest Root Mean Square (RMS) error value, according the imposed inversion parameters. This RMS error quantifies the difference between the apparent resistivity measured in the field and the apparent resistivity obtained from the response of the 2D resistivity model estimated. In this way, a single resistivity model was obtained for every profile with three datasets (schlumberger, wenner and dipole-dipole).
