Conservation of cultural heritage buildings: Methodology and application to case studies.

P. B. Lourenço ¹

¹University of Minho, ISISE, Department of Civil Engineering, Portugal, E-mail: pbl@civil.uminho.pt,
Web: <http://www.civil.uminho.pt/masonry>, <http://www.isise.net>.

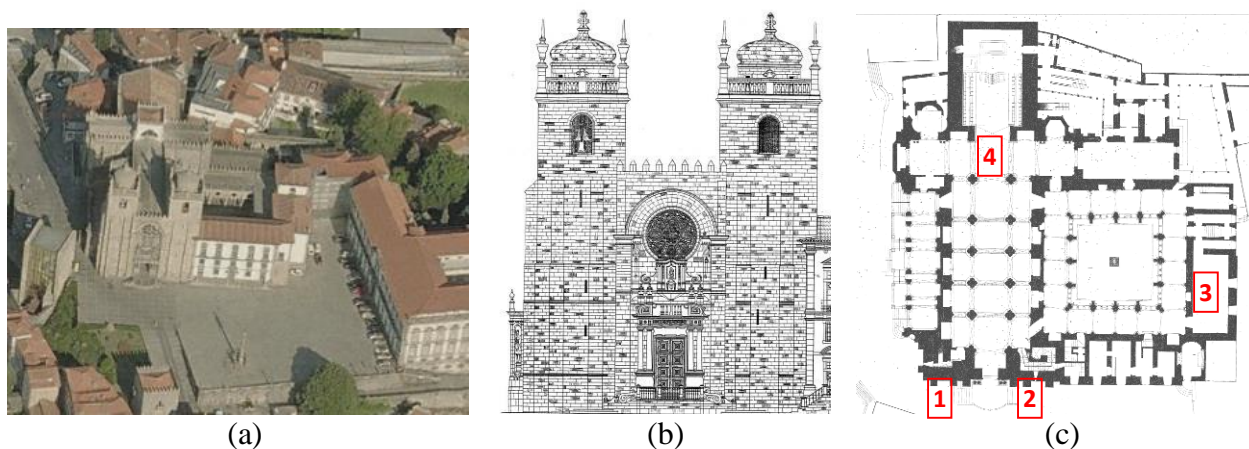
Figure 3 shows selected views of the compound of the Cathedral, which has dimensions about 60 × 60 m² in plan, with a maximum height of the towers about 35 m. The compound includes the church, a gothic cloister on the south side, side chapels, a gallery on the north side, a sacristy, several chapels and other annexes. The church has a typical Latin cross, with three naves and five spans, and two rectangular towers facing west.

Figure 3. Aspect of the Cathedral: (a) Aerial View; (b) Façade; (c) Plan.

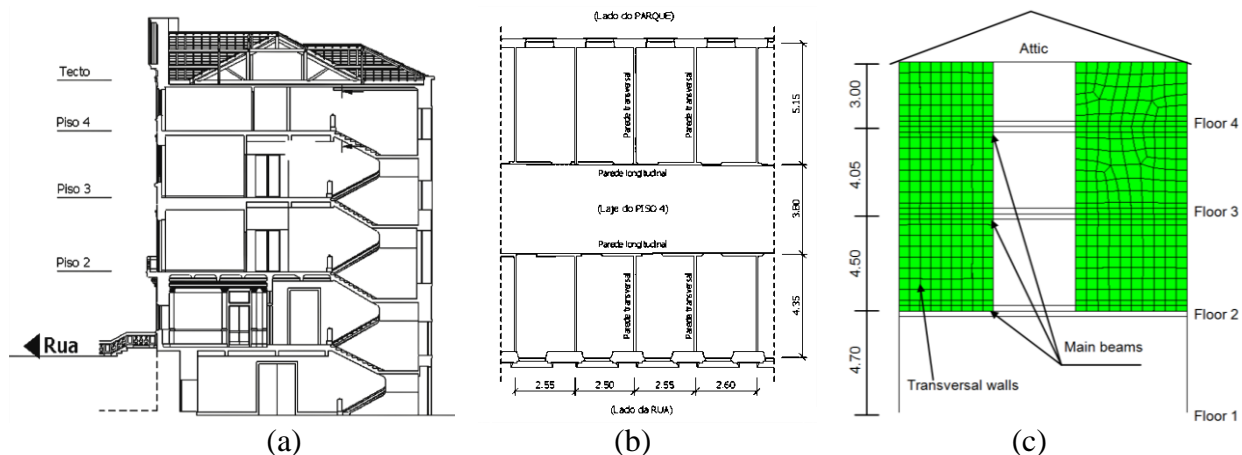
Figure 9. Theological school: (a) Vertical section; (b) Plan; (c) Main transversal structure.

Figures 9b,c present the geometrical survey of the building and the main structure. Cores and steel samples were obtained from the building in order to characterize the materials used. The transversal walls are separated each 2.6 m, with asymmetric location of the longitudinal walls. The thickness of the external masonry walls varies between 0.30 and 0.60 m. The transversal beams have cross sections of $0.25 \times 0.50 \text{ m}^2$ (floors 3 and 4) and $0.30 \times 0.60 \text{ m}^2$ (floor 2). The thickness of the slabs is 0.12 m and the internal walls have a thickness of 0.06 m. The concrete strength found was 24.6 N/mm^2 (slabs) and 11.9 N/mm^2 (walls). All the reinforcement found is unribbed and mild steel. The slabs have a single layer of reinforcement with $\phi 3/8''@0.125$ for the main reinforcement and $\phi 3/8''@0.25$ for the secondary reinforcement. The walls have also a single layer of reinforcement with $\phi 3/16''@0.25$ in the vertical direction and $\phi 5/32''@0.25$ in the horizontal direction. The lower reinforcement in the transversal beams is $3\phi 1''$ (floors 3 and 4) and $4\phi 1\frac{1}{4}'' + 4\phi 1''$ (floor 2). Besides the dead load, for the current use of the building the live load according to the Portuguese code is 3.0 kN/m^2 in general with 5.0 kN/m^2 is the access zones. With the new use, the planned live load is 14.8 kN/m^2 for floor 2, 13.5 kN/m^2 for floor 3 and 11.0 kN/m^2 for floor 4.
