CENTRIFUGAL FAN IMPELLER FAILURE ANALYSIS USING FINITE ELEMENTS
Ingeniería. Revista de la Universidad de Costa Rica, vol. 16, núm. 2, 2006, pp. 55-62

CENTRIFUGAL FAN IMPELLER FAILURE ANALYSIS USING FINITE ELEMENTS

This article shows the failure analysis assisted with finite element modeling of a centrifugal fan impeller that was originally part of the burner of a 1175 kW [120 bhp] saturated steam boiler. The linear stress and vibration modes model pointed to the origin of the apparently sudden failure.

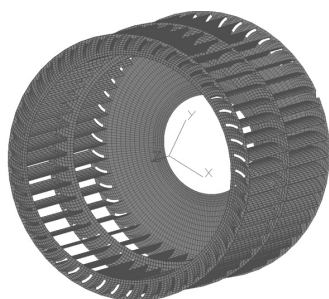
Figure 3. FEA meshing for the impeller²

The dimensions were taken directly from the failed impeller and reproduced by means of a manually meshed computer model using *Algor*[®] v. 12,01, as shown in figure 3.
