Ponce L., Ernesto; de la Vega, José
Restoration of ancient bronze bells. Part I: powder metallurgy
Ingeniare. Revista Chilena de Ingeniería, vol. 22, núm. 4, octubre, 2014, pp. 460-468
Universidad de Tarapacá
Arica, Chile

Restoration of ancient bronze bells. Part I: powder metallurgy

Ernesto Ponce L.¹ José de la Vega¹

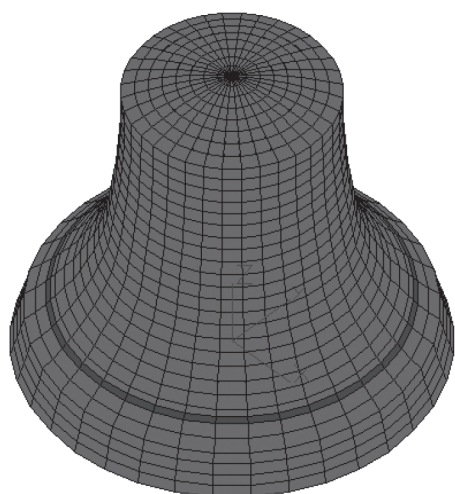
A model of stress in an elastic medium, computed with ALGOR (now Autodesk) finite element software package, which includes a Cu-Sn repair ring, is shown in Figures 4, 5, and 6. Input data represent density and modulus of elasticity of the materials involved. The clapper is simulated striking from the inside of the piece with a force of 408 N. Usual impact forces tend to be lower than that measure. Predictions are Von Mises stresses in N/m². Conditions at the edge were calculated considering free rotation in the dome central nodes in the same direction as the strike, simulating the piece hanging from the upper base. The geometry of the bell was taken from the actual model. The model used 2160 3D elements brick type, 8 nodes per element. The filled crack used 120 small elements (for greater precision). Three meshes were tested, leaving us with the most accurate.

Figure 4. Bell model with a Cu-Sn repair ring.
