Ponce L., Ernesto

Restoration of ancient bronze bells. Part II: welding

Ingeniare. Revista Chilena de Ingeniería, vol. 23, núm. 1, enero, 2015, pp. 30-37

## Restoration of ancient bronze bells. Part II: welding

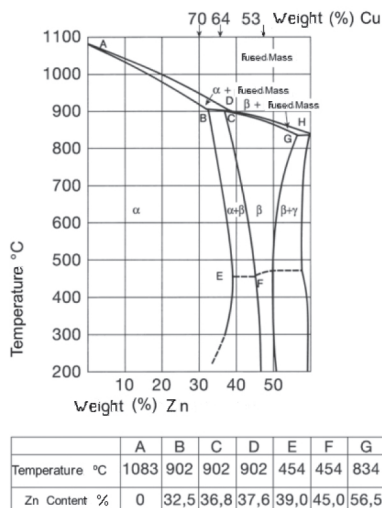
Figure 10. Phase diagram of the binary system Cu-Zn [8-9].

“A copper-zinc alloy composed solely of  $\alpha$  phase crystals (Figure 10 left) may become deformed rather cold, but is problematic for machining (this is not the case analyzed). Only the copper-zinc alloys with more than 54% of copper weight are technically significant. Therefore, only a copper-rich part of the Cu-Zn phase diagram is described in the figure. Above the ADH line in the region of complete dissolution, the mixture of the two components, the copper and zinc molten predominates. On the left side of the diagram, up to 67% of copper, the domain of  $\alpha$  phase predominates. To the right are the regions corresponding to phases ( $\alpha + \beta$ ) and  $\beta$ ” [8-9], which may occur by rapid cooling. In our study we have  $\alpha$ -phase only, given that the welding

was slowly cooled and the alloy used has 77.1% Cu and 14.4% Zn. The alpha phase is ductile; thus, there would be no danger of brittle crack generation, which is the case of the beta phase when sudden cooling occurs.

In the copper-zinc phase diagram, the right of the ABE line corresponds to precipitates (Figure 10). Aging in this area is apparent, but the line is far from being 14.4% zinc, which is the  $\alpha$  phase. In the  $\alpha$  phase there is no aging. This is the case of our bell and its restoration.

For this 14.4% Zn model, the method was good. For those bells that are over 30% Zn methodology should be reviewed, because over this percentage  $\alpha + \beta$  phase appears (may have lower ductility and aging, Figure 10). Oxyacetylene is advisable to change the system by TIG and Argon (tungsten inert gas) because it generates lower temperatures avoiding losses of Sn and Zn [6].

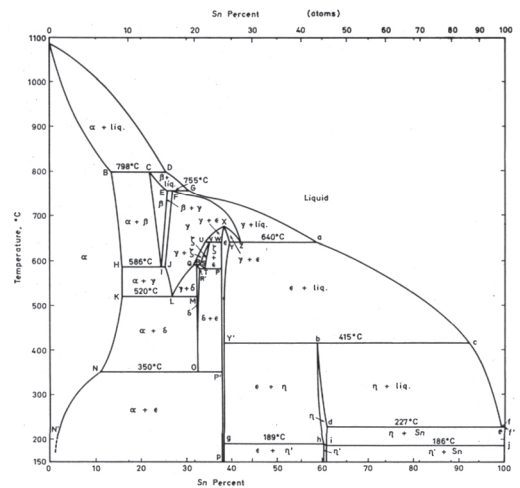
Figure 11. Phase diagram of the binary system Cu-Sn [8, 10-12].

In the copper-tin phase diagram, there is a 4.49% Sn. The phase diagram of Figure 11 (left lower side) corresponds to the  $\alpha + \epsilon$  phase, which would also be ductile.
