Rivera-González, Oscar Daniel; Rodríguez Van Gort, Mary Frances Teresa  
Urban risk mapping for geological faults in urban areas, prevention, and  
analysis with Geographic Information Systems, Mexico City, Mexico \*

Entramado, vol. 20, no. 1, 2024, January-June, pp. 1-12

# Urban risk mapping for geological faults in urban areas, prevention, and analysis with Geographic Information Systems, Mexico City, Mexico \*

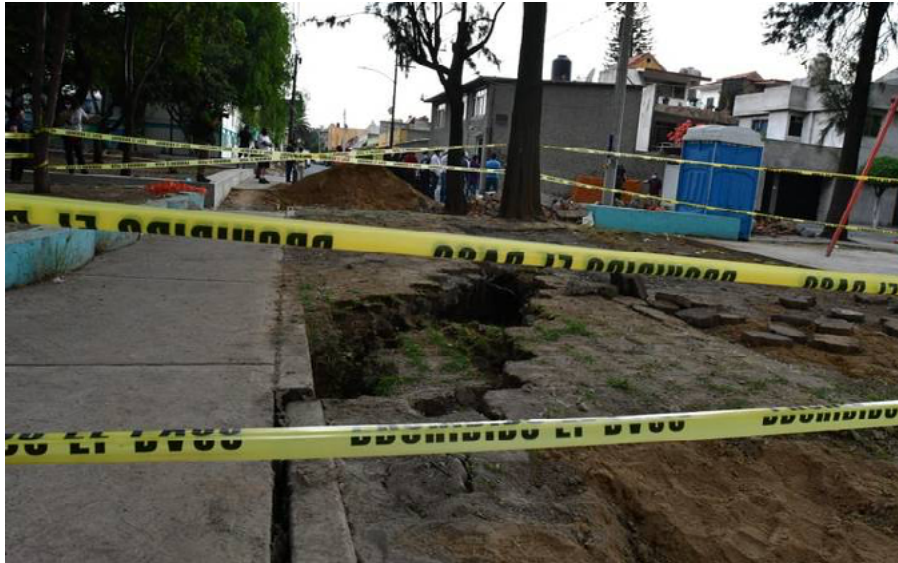
Figure 5. Geological fault Quinta Cerrada avenida 503, Colonia San Juan de Aragón 1ra Sección.  
Source: [Mendoza, 2021](#)

According to the sample in [Figures 5 and 6](#), the initial geological breakdown of the study area is observed, therefore, the attention of experts in geophysics, geology, and geography, with the scoop to establish studies with fissurometers, portable electronic equipment of high sensitivity and radon gas detectors, identifying the houses that have a high and very high level of risk to a possible collapse of buildings.

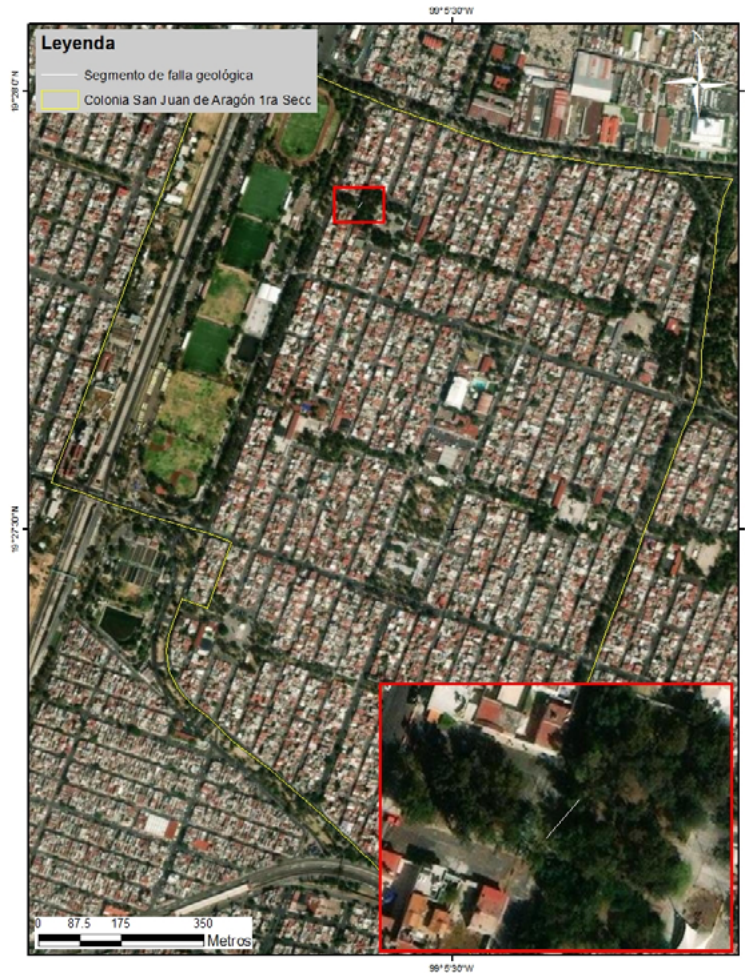
Figure 6. Cartographic location of the geologic fault in Quinta Cerrada Avenida 503, Colonia San Juan de Aragón 1ra Sección.

According to journalistic reports, the crack began in Quinta Cerrada de la Avenida 503, damaging 14 houses and extending approximately to Avenida 505 ([Mendoza, 2021](#)), therefore, the crack was empirically located with the support of photo interpretation, pointing out that according to neighbors in the area, it extended even more visually ([Figure 5](#)), specifying that its internal non-visual extension may be even significant in terms of its length, affecting a greater number of houses in the future; The failure zone also includes the Nepal primary school and the San Juan de Aragón Health Center ([Figure 6](#)).
