The importance of underpaint corrosion caused by damage to paint on steel structures

Revista de la Asociación Latinoamericana de Control de Calidad, Patología y Recuperación de la Construcción, vol. 10, no. 3, 2020

In this context, the objective of this study was to evaluate the impact of varying the DFT on underpaint corrosion in steel plates obtained from the floor of an offshore oil platform.

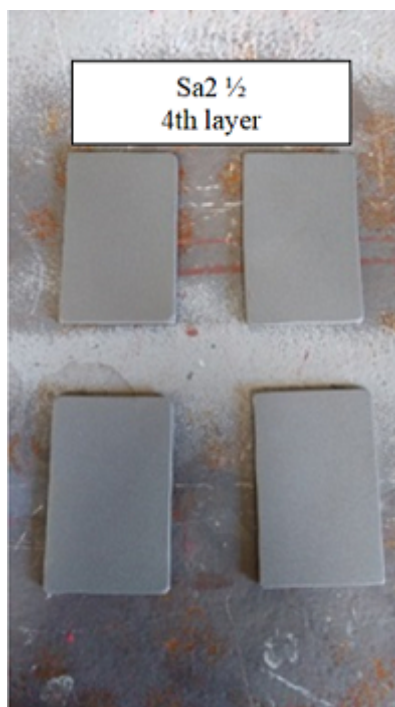
FIGURE 1
Plates prepared with a Sa2½ abrasive jet (Ribeiro Filho, 2018)

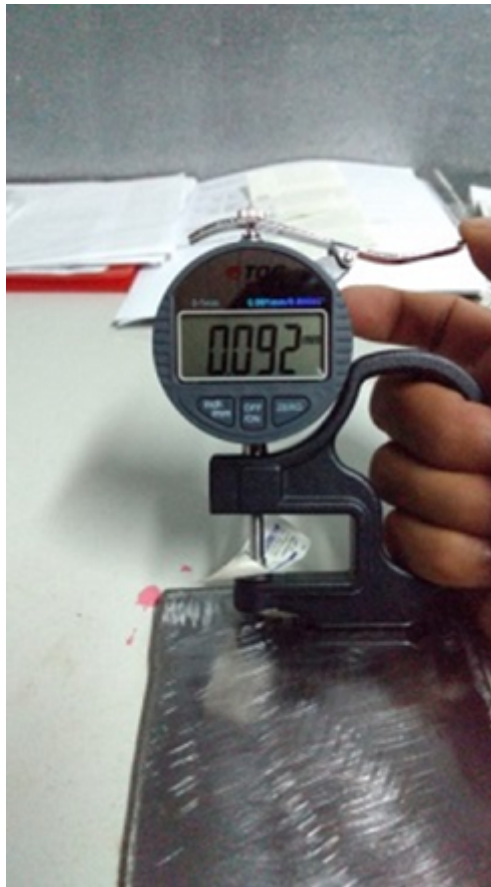
FIGURE 2

Roughness meter used to measure the roughness of a St3 standard plate (Ribeiro Filho, 2018)

Six groups of specimens were prepared, where groups 1 to 5 were composed of four specimens each (named A, B, C and D), and group 6 was composed of only two specimens (named A and B). All specimens were previously washed with clean water. The specimens from groups 1 and 2 were previously subjected to St3 and Sa2½ surface preparation methods, respectively, according to standard ISO 8501-1 (ISO, 2007) and standard NBR 10443 (ABNT, 2008), respectively, and were then subjected to a small thickness coating system. Groups 3 and 4 were subjected to St3 and Sa2½ surface preparation methods, respectively, and a complete paint system was used to apply the paint to the atmospheric zone^[1] (Table 1); according to the painting procedure used for the project, which expects a DFT between 445 µm and 600 µm, the DFT was measured for each layer. Prior to painting, the roughness of all specimens was measured after the Sa2½ preparation method was performed to verify if the DFT requirement of 50 µm to 100 µm, as predicted in the painting procedure of the project, was met (Figure 2).

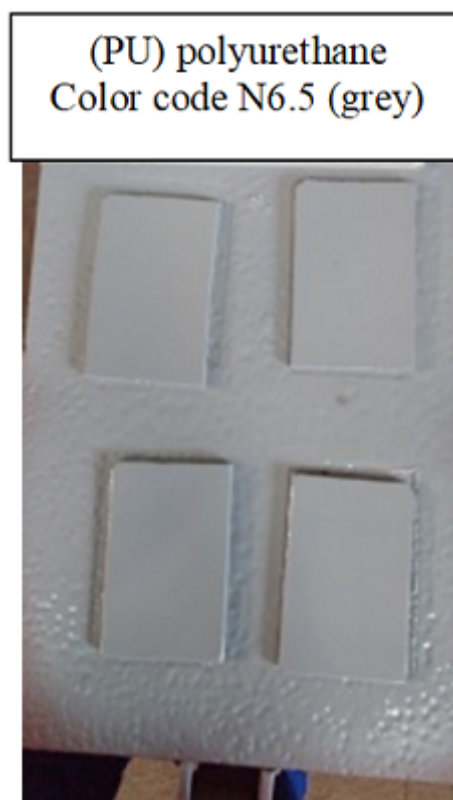
FIGURE 3
Finishing the paint.
(Ribeiro Filho, 2018)

to the standard NBR 15239 (ABNT, 2005). After each paint coating, the DFT was measured according to the standard NBR 10443 (ABNT, 2008), and the results of the preparation method are presented in Table 2. Figures 3 and 4 show images of the paint and the DFT measurement.

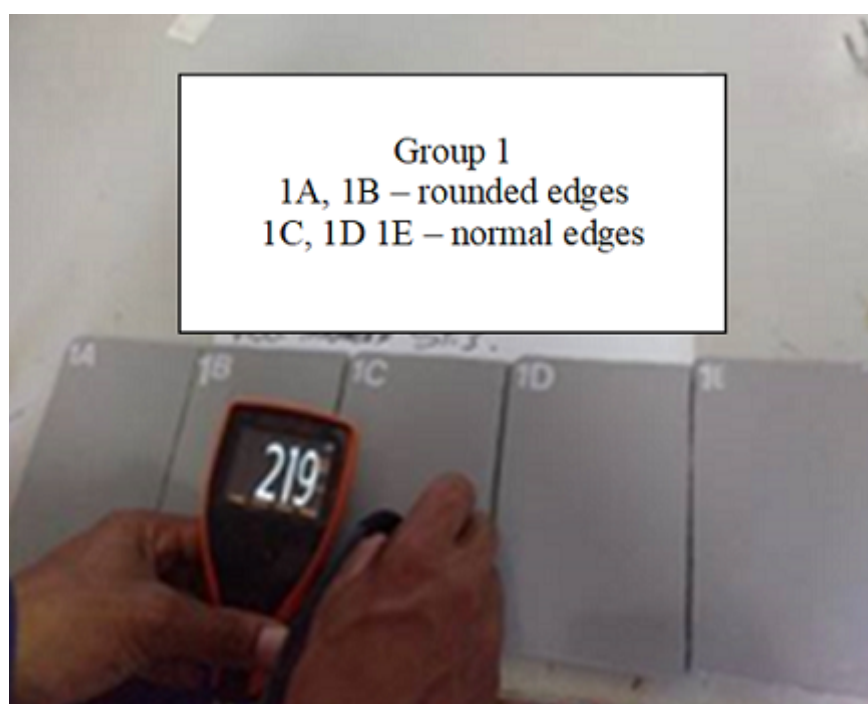
FIGURE 4
Measuring the total DFT.
(Ribeiro Filho, 2018)

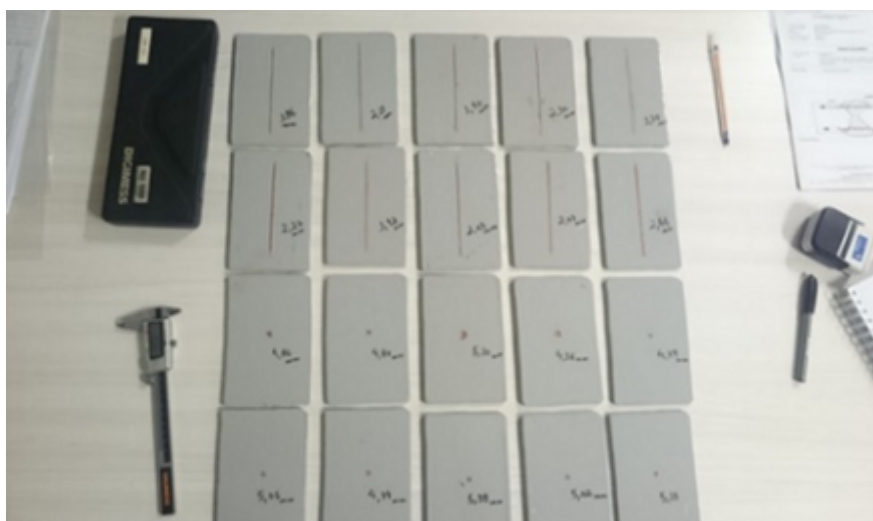
FIGURE 5
Specimens with experimentally damaged paint
(Ribeiro Filho, 2018)

After painting, the paint layers were carved to simulate experimental damage/defects in the paint applied to the specimens from all groups; some of the carvings were longitudinal, and some were puncture carvings with 5 mm diameters, as shown in Figure 5.

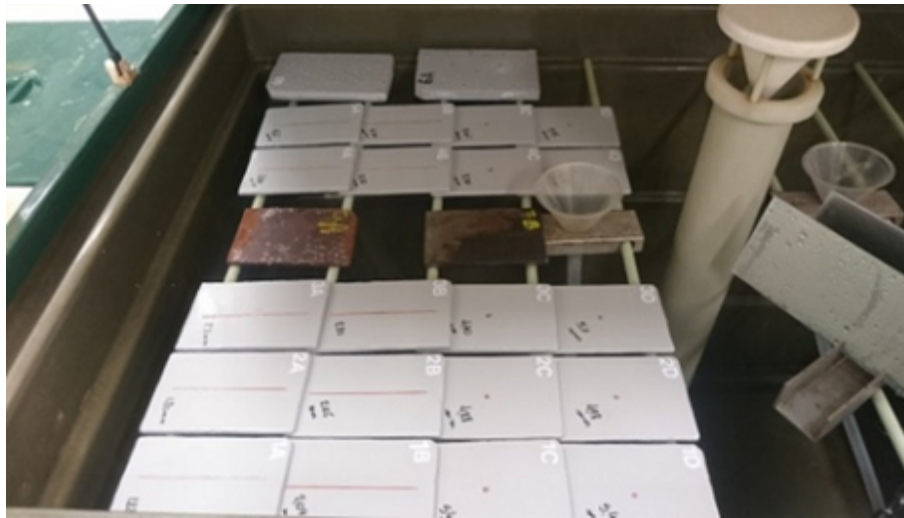
FIGURE 6
Specimens in the salt chamber before exposure to the mist
(Ribeiro Filho, 2018)

All specimens were subjected to a salt spray chamber (Figure 6) with a 5% sodium chloride (NaCl) saline mist, in which the mist was uniformly sprayed at a controlled temperature, according to ISO 9227 (ISO, 2012), NBR-8094 (ABNT, 1983) and B117-16 (ASTM, 2001). The temperature was maintained within the interval of 35 ± 2°C, and the specimens remained in the salt spray chamber for 1550 h.

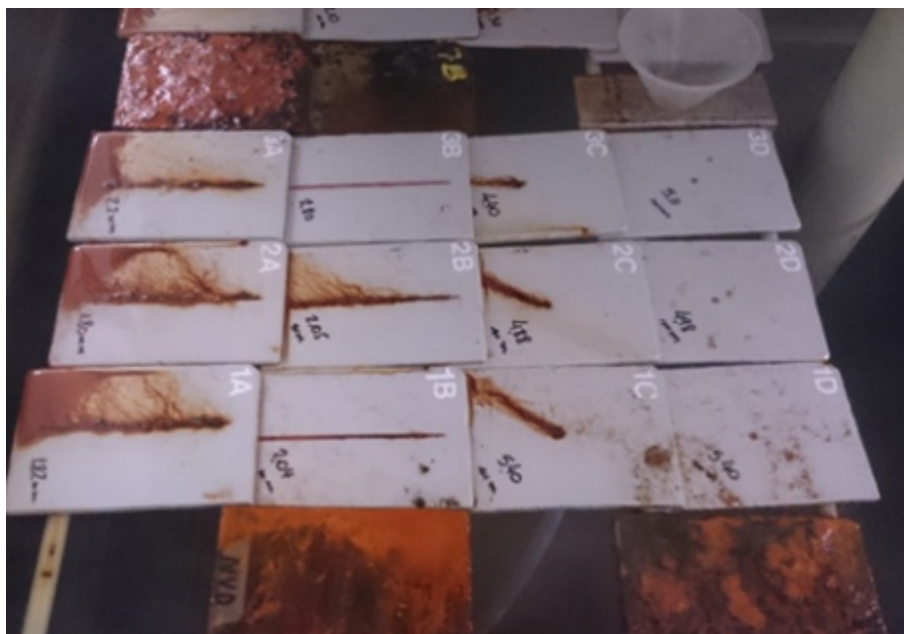
FIGURE 7
Specimens after the 1550 h exposure
(Ribeiro Filho, 2018).

After removing the specimens from the saline chamber (Figure 7), the specimens were washed with clean running water at room temperature ($<40^{\circ}\text{C}$) to remove the salt deposits and immediately dried. Subsequently, the specimens were subjected to a penetrant liquid (PL) test, according to the standard NBR 9583 (ABNT, 1997), and the points of higher corrosion incidence were determined (Figures 8 and 9).

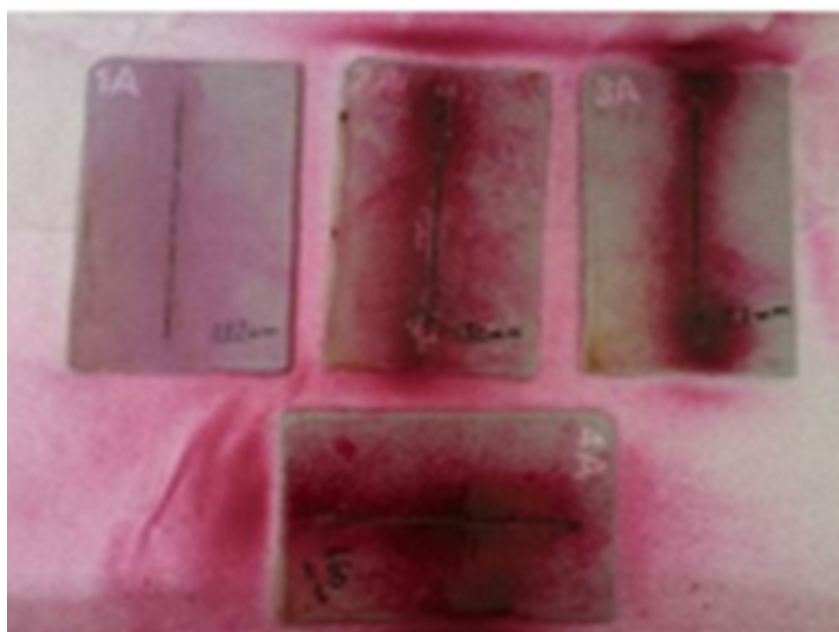
FIGURE 8
PL test awaiting development
(Ribeiro Filho, 2018).

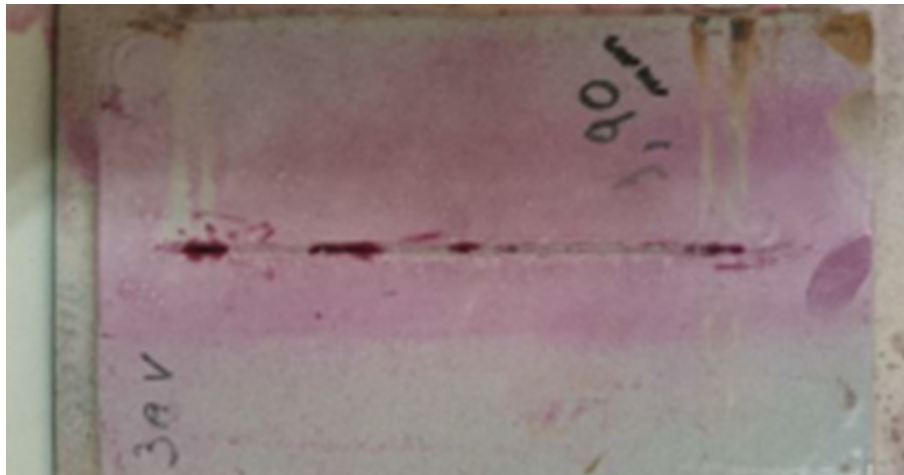
FIGURE 9
Specimen awaiting development
(Ribeiro Filho, 2018).

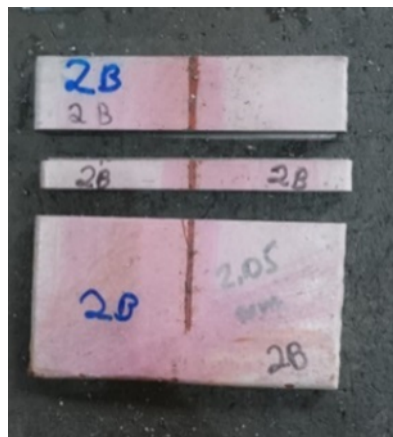
FIGURE 10
Specimen sectioned for microscopy observation
(Ribeiro Filho, 2018).

These points were selected, and the specimens were cross-sectioned at those points (Figure 10). The cross-sections were observed under an LBM-044 microscope/stereoscope to measure the extent of the underpaint corrosion.

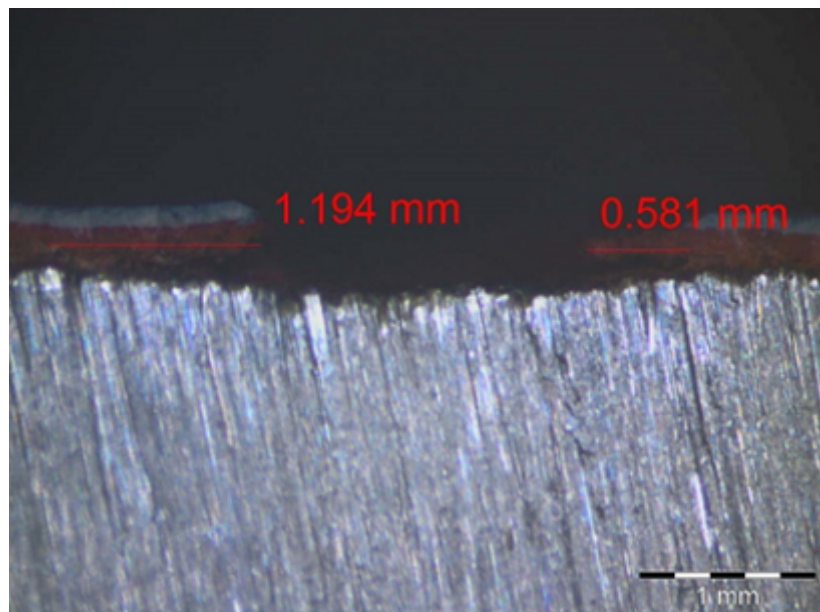
FIGURE 11
Underpaint corrosion measurement performed on specimen 2A
(Ribeiro Filho, 2018).

For example, the observations made using a microscope, as illustrated in Figures 11 and 12, showed that in cases where the paint damage reached the substrate, corrosion occurred in both of the complete paint schemes (specimen 4A) and the thin-thickness scheme (specimen 2A), both of which used surface preparation treatment Sa2½, which offers greater adherence.

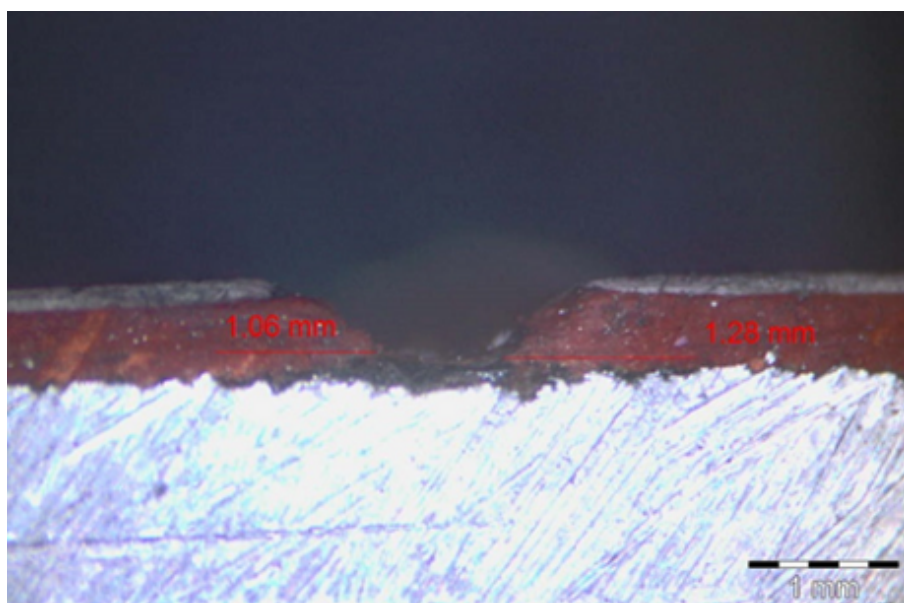
FIGURE 12
Underpaint corrosion measurement performed on specimen 4A
(Ribeiro Filho 2018).

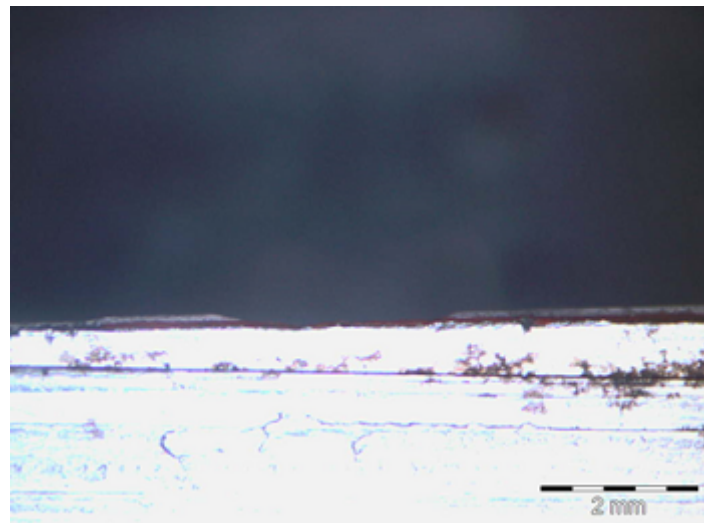
FIGURE 13
Underpaint corrosion measurement performed on specimen 1B
(Ribeiro Filho, 2018)

In contrast, specimen 1B (Figure 13), which was prepared with a thin DFT and received previous paint damage but had the bottom paint layer preserved, exhibited corrosion after 1550 h. For similar cases, there was an exception only for specimens 2B, 4D and 5B, where reduced corrosion was observed, and this occurred only in one of the three measurements shown in bold in Table 3. It was therefore concluded that when the surface preparation treatment (the standard St3 or Sa2½ treatment) is well performed, the electrolyte tends to access the substrate by the discontinuous paint if the paint exhibits a low permeability and porosity and receives a low peak exposure, as was the case for the specimens prepared for this study, and the resulting corrosion rate is similar for all the cases presented, even when the paint thicknesses are significantly different for the considered exposure time (1550 h).

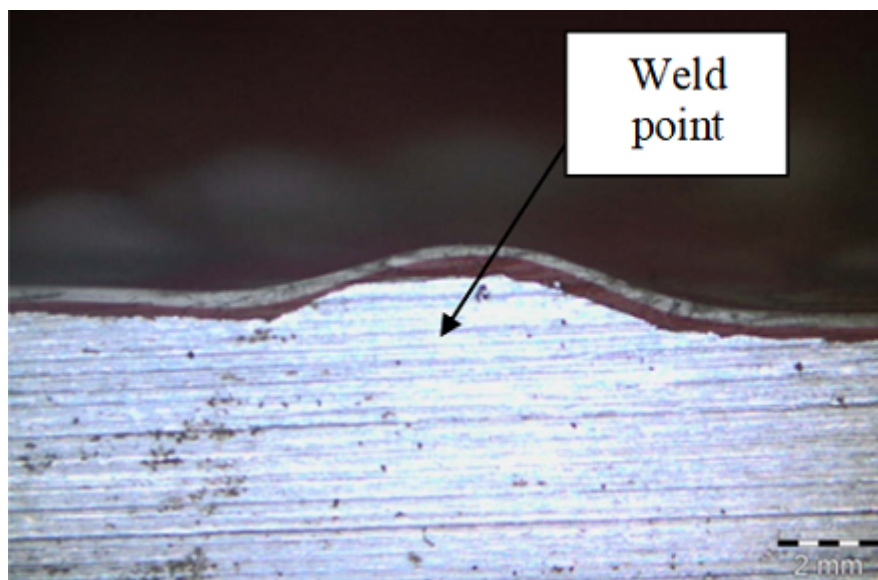
FIGURE 14
Cross section of specimen 6A
(Ribeiro Filho, 2018).

Figure 14 shows the image of specimen 6A, in which the paint thickness on a welded point varied significantly. However, due to its integrity, the anticorrosion protection of the system was preserved, even with a film thickness of 283 µm.

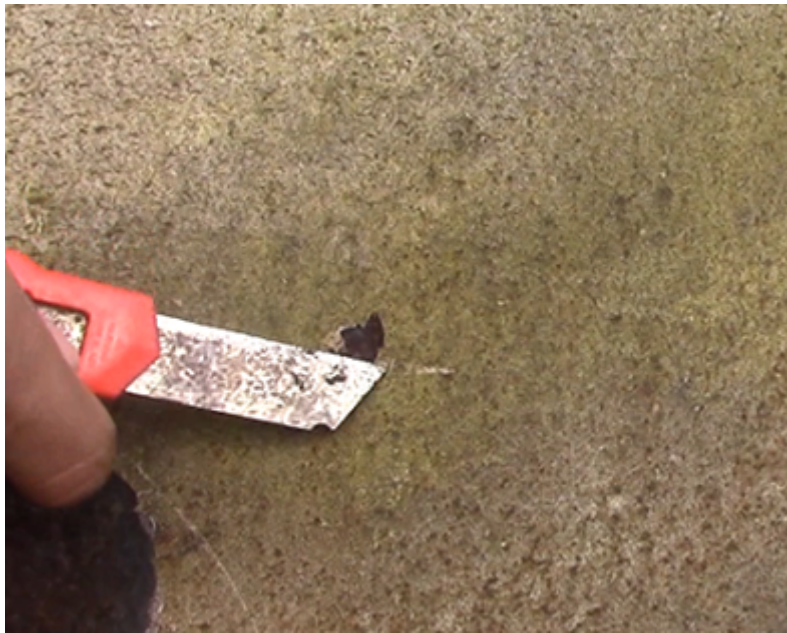
FIGURE 15
Mechanical damage to the field paint
(Ribeiro Filho, 2018).

To compare the results obtained in the laboratory with those of a real platform situation, a surface with intact paint, except for a single isolated region of mechanical damage throughout the film, was identified during the field visit. By radially removing the paint from this central point, the limits of corrosion exhibited a circumferential configuration, denoting that equal corrosion occurred in all directions, which can be verified by the existence of sandblasting steel without corrosion, exhibiting a Sa2½ pattern from the limits of the corrosion edge, which reached a radius of 21 mm (Figures 15 and 16).

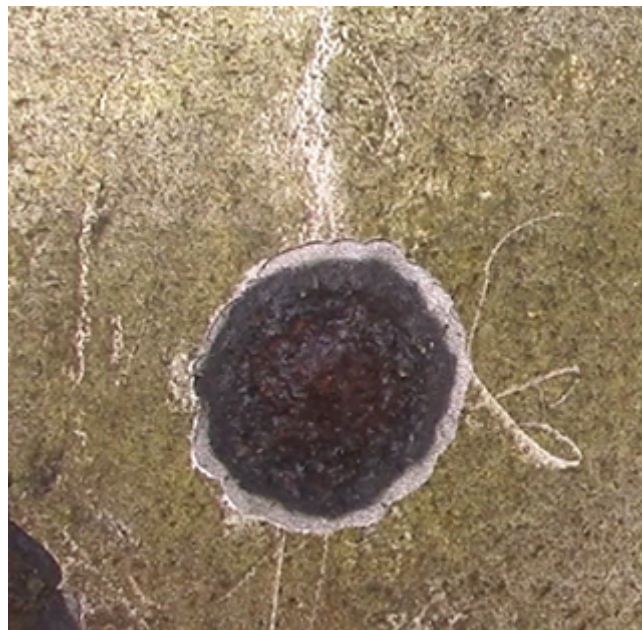
FIGURE 16
Edge of the corroded area and the area without corrosion
(Ribeiro Filho, 2018).

Considering that the exact date of the damage or the beginning of the exposure is not known and that, in the worst scenario, the damage occurred on the day of the platform shutdown, which represents a period of approximately three years (3×8760 h), the mean corrosion rate was 8×10^{-4} mm/h, which is considered close to the value found in the laboratory (6.5×10^{-4} mm/h).
