Fernandes, Bruno; Masiero Gil, Augusto; Longhi Bolina, Fabrício; Fonseca Tutikian, Bernardo
Thermal damage evaluation of full scale concrete columns exposed to high
temperatures using scanning electron microscopy and X-ray diffraction
DYNA, vol. 85, no. 207, 2018, October-December, pp. 123-128
Universidad Nacional de Colombia

Thermal damage evaluation of full scale concrete columns exposed to high temperatures using scanning electron microscopy and X-ray diffraction

Bruno Fernandes ^a, Augusto Masiero Gil ^b, Fabrício Longhi Bolina ^b & Bernardo Fonseca Tutikian ^b

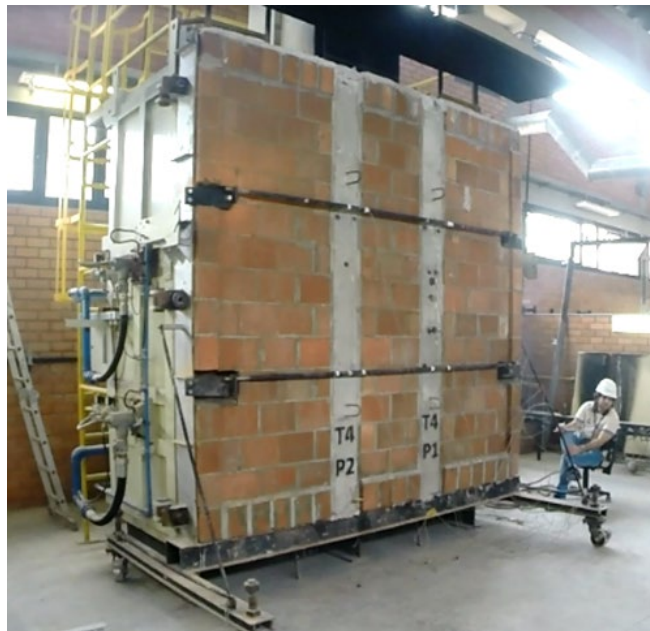
Figure 2. Experimental setup: columns embedded in masonry wall
Source: Authors

For the heating process, a vertical furnace was used. The inside of the furnace is 2.5 m tall, 2.5 m wide and 1.0 m long. The experimental model consisted of columns embedded in a masonry wall built within a frame, so that 45% of the cross section would be exposed to high temperatures, in three faces. Fig. 1 shows how the columns were tested, and Fig. 2 depicts the experimental setup.

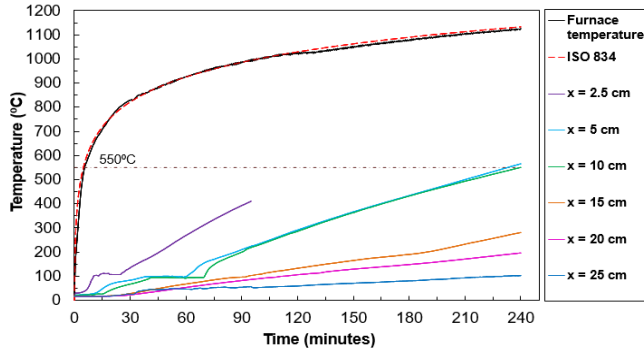
Figure 4. Temperature evolution in column P1
Source: Authors

Figs. 4 and 5 present the temperature evolution inside the furnace, for different depths of columns.

The furnace temperature followed the ISO 834 standard fire curve throughout both tests. The thermocouple at 2.5 cm depth on column P1 was expelled at 95 minutes. During both tests, usually 5 minutes after the start, at 100 °C, the temperature remained constant for a period due to concrete water vaporization. This phenomenon occurred up to the depth of 10 cm in both cases.

Overall, the temperatures of column P1 were lower, but the temperature of 550 °C was reached by the depth of 10 cm, which did not occur on P2. Concrete becomes structurally useless above 550 °C [3], which is the reason why 500 °C is the basis for one of the most used calculation methods for estimating safety of fire damaged structures [13].

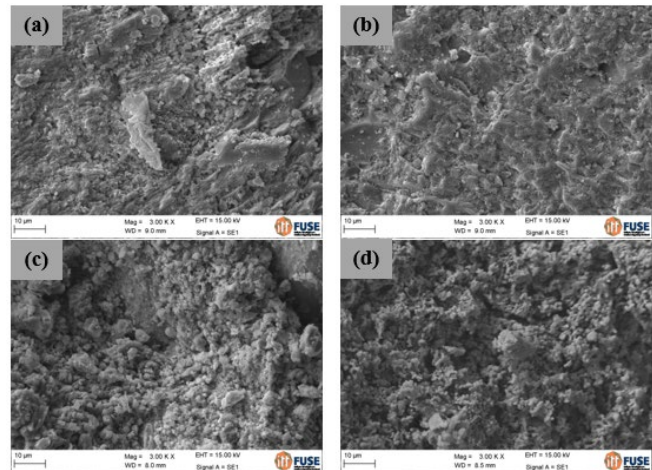
Figure 8. SEM micrographs of P1 (mag. 3000X): (a) reference sample, (b) 25 cm depth sample, (c) 5 cm depth sample and (d) 0 cm depth sample
Source: Authors

SEM micrographs of the reference concrete and 25 cm, 5 cm and 0 cm depth samples of both columns are shown in Figs. 8 and 9.

In both cases, SEM images of the 25 cm depth concrete did not present apparent morphological changes in comparison to the SEM image of the reference sample. This concerns the temperatures reached at this depth, which were 103 °C for P1 and 114 °C for P2. Increasing temperature at this level only causes dissociation of ettringite [18,19].

Lastly, the SEM micrograph of the 0 cm depth sample showed robust morphological changes, such as cracks and voids. The temperature reached at this point was 1128.8 °C for P1 and 1123.6 °C for P2, and cement paste begins melting at this temperature level [8].

- SEM micrographs presented robust morphological changes, such as coarsening of the cement paste, cracks and voids. This signalizes a significant mechanical degradation of concrete, due to dehydration of CH and C-S-H. Microstructural changes are more visible at temperatures above 420 °C, when portlandite starts decomposing.

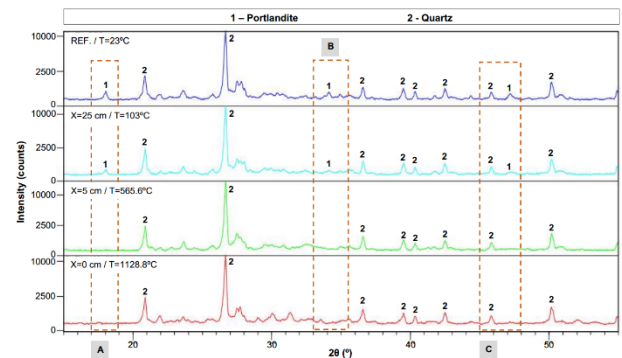
Figure 10. XRD diagrams 25 cm, 5 cm and 0 cm depth (P1 column)
Source: The authors

XRD diffractograms of the reference concrete and 25 cm, 5 cm and 0 cm depth samples of both columns are presented in Figs. 10 and 11. The transformations observed are highlighted.

- XRD diffractograms showed a reduction of portlandite and the presence of larnite as depth increases. This can be useful for estimating the temperature reached and the damage level, since CH dehydrates at temperatures above 420 °C and C-S-H decomposes into β -C2S above 700 °C. Portlandite reduction could also be observed during the main experimental program using XRD, so CH degradation can be used as the main indicator of thermal damage to concrete.

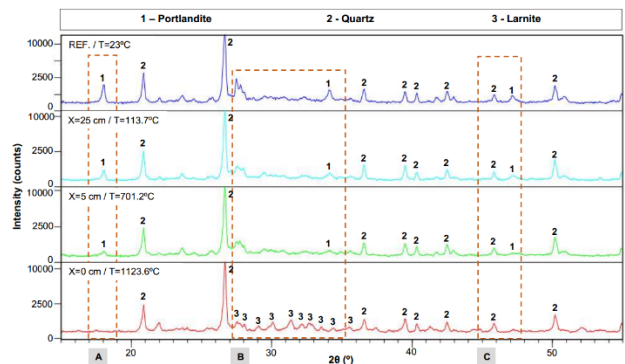
Figure 11. XRD diagrams 25 cm, 5 cm and 0 cm depth (P2 column)
Source: The authors

P2 samples displayed portlandite and quartz as well, but larnite was identified in the XRD diffractograms. Contrary to P1 samples, portlandite could be seen at the 5 cm depth, but not at 0 cm, where the temperature was 1123.6 °C. A similar behavior was observed by Kim, Yun and Park [14]. Furthermore, larnite (β -C₂S) was found at 0 cm depth, most likely as a result of the C-S-H disassociation, in accordance to what is pointed out by the literature [5,6,20].
