The Completion of the Church Roof of San Antonio de Valero

JAMES E. IVEY

## *The Completion of the Church Roof of San Antonio de Valero*

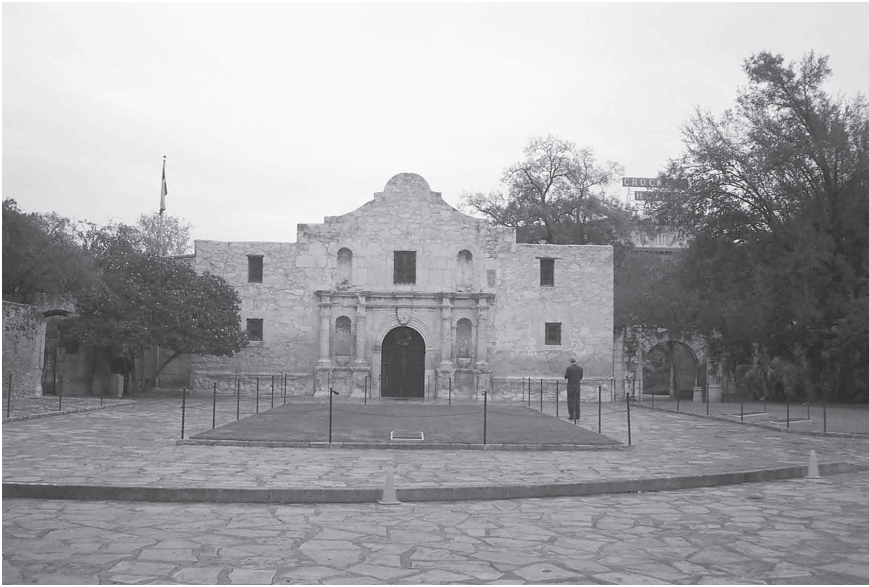
1. The mission church of San Antonio de Valero (the Alamo) today. The distinctive shape of the top of the façade is the result of the construction of a stone gable in 1850 to cover the end of the wooden roof built over the roofless building in that year by the U. S. Army so that it could be used as a military storehouse. Photograph by the author.
