Mantilla Carrasco, Edgar Vladimiro; Rocha Teixeira, Amanda  
Methodology for inspection of wood pathologie using ultrasonic pulses  
CERNE, vol. 18, núm. 3, julio-septiembre, 2012, pp. 479-486  
Universidade Federal de Lavras  
Lavras, Brasil

# METHODOLOGY FOR INSPECTION OF WOOD PATHOLOGIES USING ULTRASONIC PULSES

Edgar Vladimiro Mantilla Carrasco<sup>1</sup>, Amanda Rocha Teixeira<sup>2</sup>

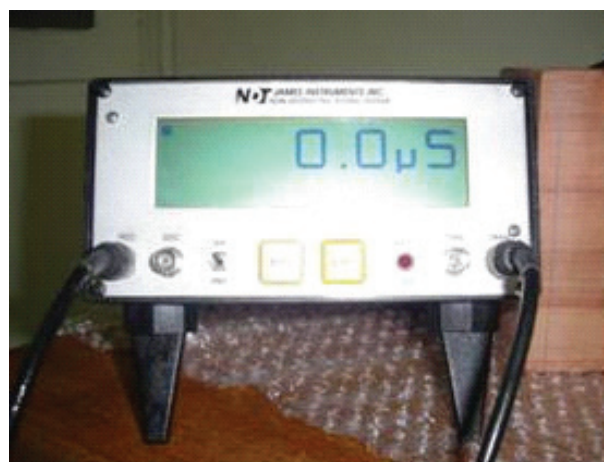
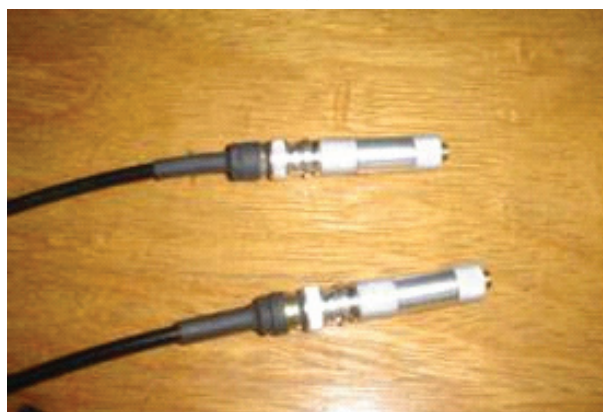
**Figure 4** – Ultrasound device (a) and transducers (b).

Materials used in the experiment included a glued laminated timber beam from species *Eucalyptus grandis* (Figure 3), a James Mark II ultrasound device with a pair of ultrasonic pulse transducers acting as the emitter and the receiver, at a 500 kHz frequency (Figure 4).

The recommended transducer frequency in this experiment is 500 kHz as it is sensitive to small openings (galleries made by termites or borers) and cracks on the interior of the wood piece. Detection of holes and cracks was done in the direction of the pulse path. This detection is directly related to the wavelength of the pulse in the laminate where propagation time is being measured. The longer pulse propagation time is, the lower the velocity and, consequently, the shorter the wavelength will be. Detection is only possible if dimension 'a' of the hole or crack follows a  $a \geq \lambda$  ratio, where  $\lambda$  is wavelength.

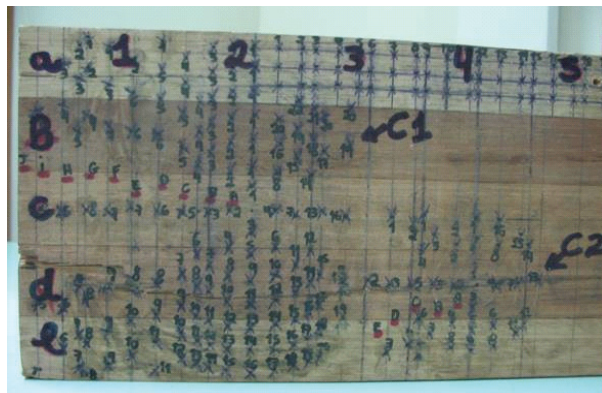
Figure 6 – Actual representation of the second grid.

The second grid pattern was based on the results of the first. Propagation times of pulses obtained with the first grid were compared with reference times of each laminate. Whenever pulse time readings from the first grid pattern exceeded reference time values, the area was considered one with high potential of degradation. The second grid pattern covered only such areas, as seen in Figures 6 and 7. Figures 8, 9 and 10 illustrate such areas in greater detail.

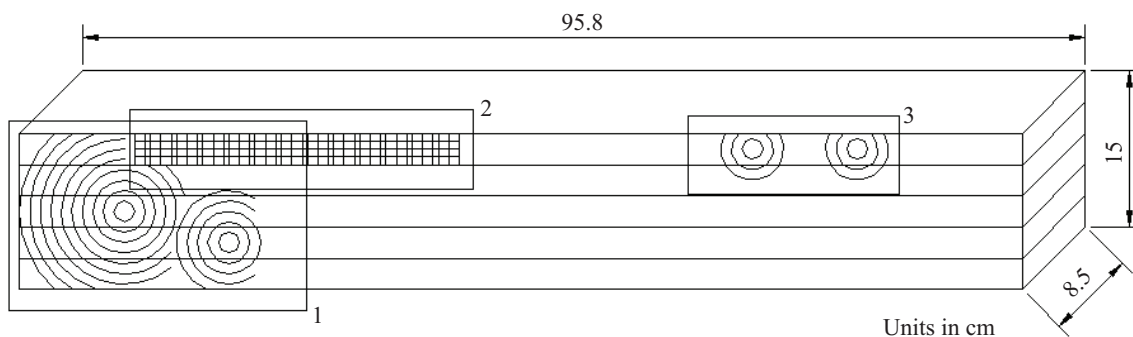
Figure 7 – Schematic representation of the second grid.

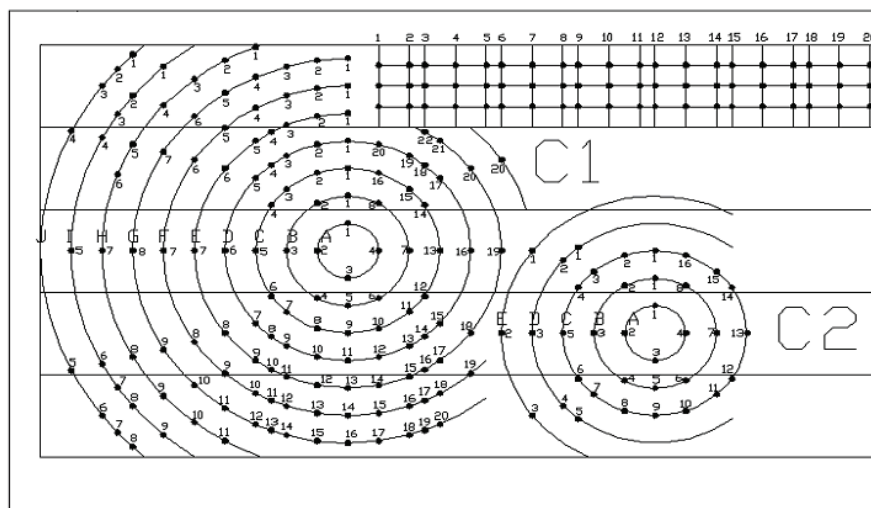
Figure 8 – Area 1 in detail.

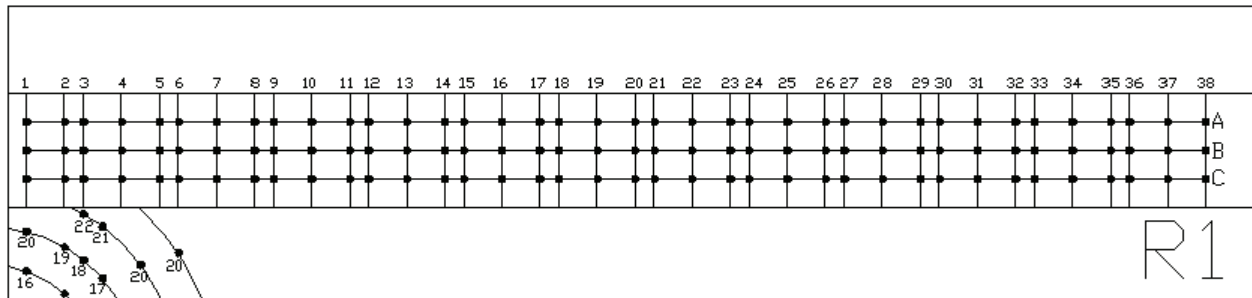
**Figure 9** – Area 2 in detail.

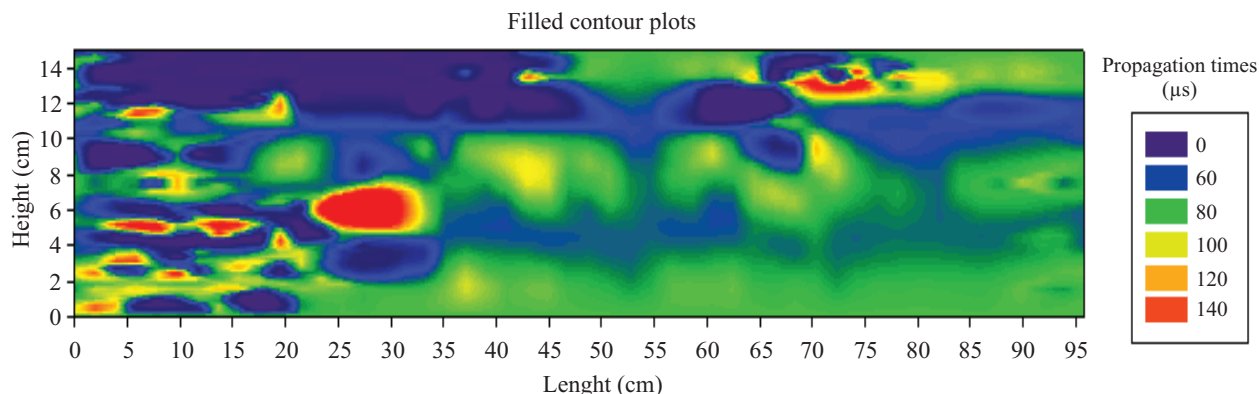
**Figure 12** – Deteriorated areas in the glued laminated beam.

With the propagation time readings obtained from the second grid, curves were generated, using SigmaPlot® version 10, to represent areas with same propagation times, as seen in Figure 11. This software allowed converting these curves into isochromatic patterns for better viewing of the areas considered degraded (Figure 12).

The legend in Figure 12 indicates propagation times, in  $\mu\text{s}$ , required for a pulse to travel from one side of the beam to the other.

A 0 m s value in propagation time can be related to pulse reflection, possibly indicating an obstacle along the path preventing the pulse from passing. And given that the ‘acoustic impedance’ between the interfaces of wood and holes/fissures is substantial ( $a \gg \lambda$ ), the ultrasonic energy is reflected on this interface (hole/wood) and thus fails to reach the receiver transducer positioned on the opposite side of the emitter transducer. These holes or fissures can be highly indicative of defects, including attack by wood-destroying insects. Where  $v$  values ranged from 60  $\mu\text{s}$  to 80  $\mu\text{s}$ , the wood piece was considered sound, that is, free from insect attack, holes or fissures, a fact confirmed by visual inspection.

Values above 100  $\mu\text{s}$ , according to reference propagation times, suggest occurrence of attenuation

caused by fungi or by pulse diffraction due to presence of fissures and cracks, often resulting from the very nature of the wood in question. Whenever a pulse deviates from empty space, the propagation time increases.
