Fonseca, Fernanda Lourenço Campos; Namen, Anderson Amendoeira Characteristics and patterns of inappropriate disposal of construction and demolition waste in the municipality of Cabo Frio, Brazil urbe. Revista Brasileira de Gestão Urbana, vol. 13, e20200091, 2021 Pontifícia Universidade Católica do Paraná

Características e padrões de disposição inadequada de resíduos da construção e demolição no município de Cabo Frio. Brasil

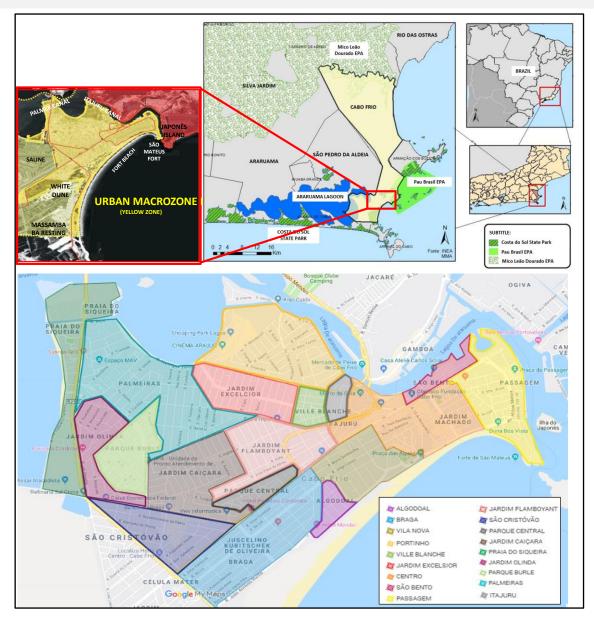
Figure 1 - Details of the study area. Source: The authors (2020).

Cabo Frio presents, according to the RJPSW, a per capita CDW generation of 0.90kg / inhabitant / year, with an estimated quantity of 126.44t / day (SEA, 2013). The municipality is home to important Environmental Conservation Units, containing biodiversity from endangered coastal ecosystems, such as Environmental Preservation Areas (EPA). It also has municipal and state parks and Permanent Protection Areas (PPA), protected by state law, based on the premises of the Law on the Protection of Native Vegetation, such as the dunes and lagoons, as shown in Figure 1 (Costa et al., 2017). The object of the present study is limited to the urban macrozone 1, located in the headquarters district of Cabo Frio (PMCBF, 2006). This macrozone is delimited by areas of ecological, landscape and scientific interest, such as Araruama lagoon, Siqueira beach, Palmeiras beach, Palmer canal, Itajuru canal, São Bento beach, Forte beach and the Dunes. This central region has the highest population density in the municipality (6,666 inhabitants / km²), and houses the historic center, in addition to some of the main beaches of Cabo Frio. These characteristics influence the flow of tourists in the region and the consequent rise of buildings and renovations encouraged by the real estate market (PMCBF, 2019). For the development of this work, the following neighborhoods located in urban macrozone 1 were chosen: Algodoal, Braga, Centro, Itajuru, Jardim Caiçara, Jardim Excelsior, Jardim Flamboyant, Jardim Olinda, Palmeiras, Parque Burle, Parque Central, Passagem, Portinho, Praia do Siqueira, São Bento, São Cristóvão, Vila Nova e Ville Blanche (see Figure 1).

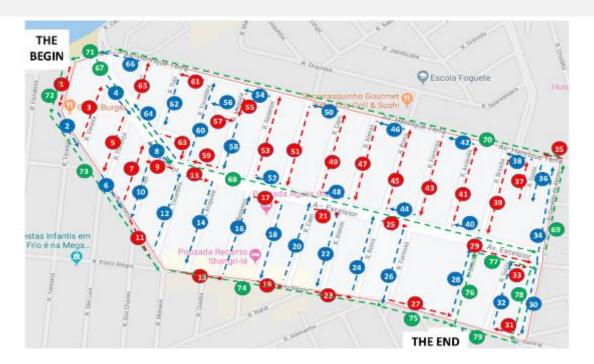
Figure 2 - Route travelled in Jardim Excelsior neighborhood. Note: The route started on the street identified with code 1 and ended on the avenue with code 79. Different colours were used only to facilitate the identification of the number corresponding to each arrow. Source: The authors (2020).

A map of each neighborhood was used to assist in controlling the paths travelled and the streets visited. The map of one of the neighborhoods is shown as an example, showing the route taken with the aid of an automobile (Figure 2).

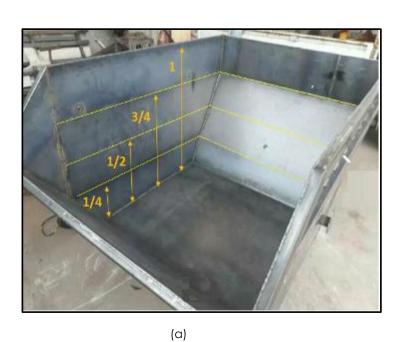
Figure 3 – (a) Internal division of a container with a volume of 5m³, showing how much approximately ¼ container, ½ container, ½ container, and 1 container are equivalent. (b) Form used to record information related to the inappropriate disposal sites.

Due to the impossibility of removing and measuring the volume of the discarded materials, visual analysis of the photographic records and on-site observations were performed, in order to estimate the discarded volumes of each place. A 5m³ container was used as a reference. The following measures were considered as volume criteria for each disposal place: ¼ container or less; ½ container; ¾ container; 1 container and more than one container of CDW. Figure 3a illustrates the container fractionation, where each mark represents the mentioned measures.

The form presented in Figure 3b was used as an aid to record the information.

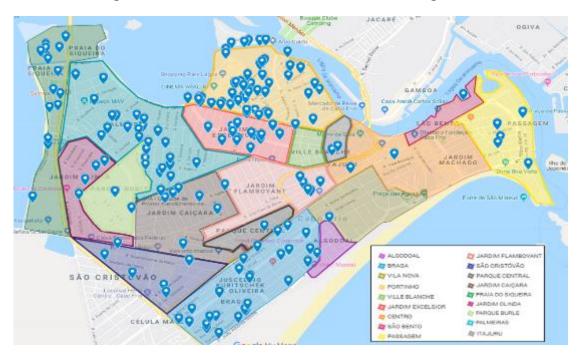
Figure 4 - Mapping of CDW inadequate disposal points in the neighborhoods. Source: The authors (2020).

A total of 179 inadequate CDW disposal points were detected in the 18 neighborhoods. The registered points were marked on a map with the aid of the Google Maps application to enable the visualization of their distribution (Figure 4). The elaboration of the map can also assist in the planning and definition of possible drop off sites in order to generate more effective results for the waste management.

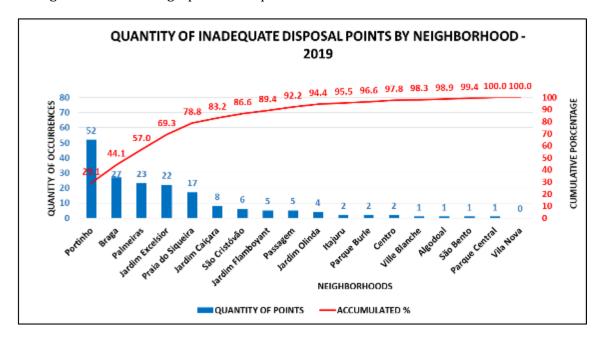
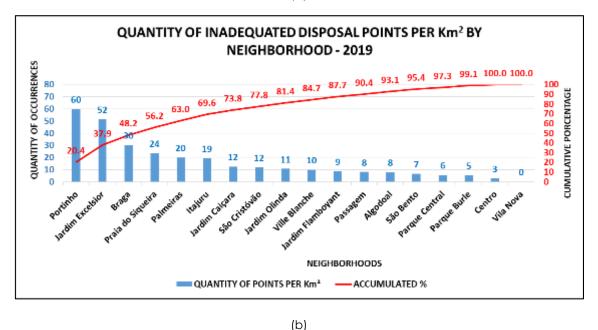
Figure 5 – (a) Pareto Chart with the number of occurrences per neighborhood and the cumulative percentage of occurrences.

(b) Pareto Chart with the number of occurrences per area in each neighborhood and the cumulative percentage of occurrences. Source: The authors (2020).

The Pareto Chart (Figure 5a) shows that the five neighborhoods with the highest incidence of inappropriate disposal of CDW accumulate 79% of the total dumped. These neighborhoods (Portinho, Braga, Palmeiras, Jardim Excelsior and Praia do Siqueira) have the following characteristics in common: they are predominantly residential neighborhoods, have vacant lots and are far from the center of Cabo Frio and the historic center. It is noteworthy that the city center is most frequented by tourists, where inspection tends to be more rigorous.

It should be noted that the territorial extension of each neighborhood must be observed, as larger neighborhoods may have a higher incidence of inappropriate disposal than smaller ones. Thus, a graph showing the number of points of inadequate disposal per km² shows the neighborhoods where the incidence per surface area is highest (Figure 5b). The five neighborhoods that have the highest amount of disposal points per square kilometer are the same, but the order of relevance is changed. Thus, the priority

of dealing with the problem of inappropriate disposal would become the sequence indicated in this figure. In this case, to eliminate approximately 80% of the points of inadequate disposal per km², the nine most impacted neighborhoods in the graph must be prioritized.

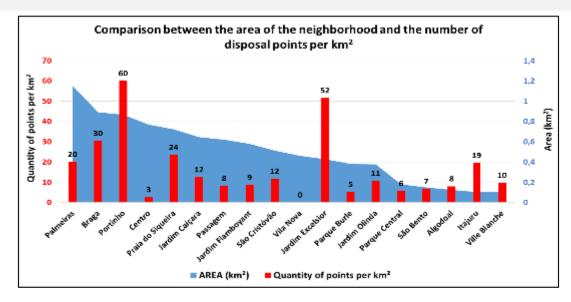
Figure 6 - Comparison between the area of each neighborhood and the quantity of disposal points per km2. Source: The authors (2020).

It is important to point out that the neighborhoods of the largest extension do not necessarily have the largest amount of points of inadequate disposal. The graph in Figure 6 shows the comparison between the surface area of each neighborhood and the amount of discard per km². The biggest neighborhood, Palmeiras, is not the holder of the greatest amount of inappropriate disposal points, being surpassed by Portinho, Jardim Excelsior, Braga and Praia do Siqueira. It can also be seen that neighborhoods with considerable extension, such as Centro, for example, had a low occurrence of inappropriate disposal points per km².

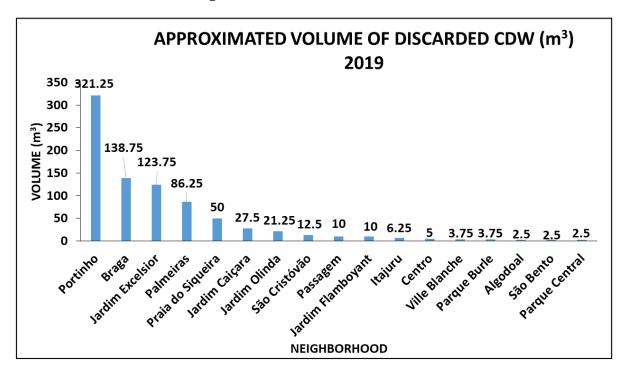
Figure 7 - Volume (m³) of CDW discarded by neighborhood. Source: The authors (2020).

Figure 7 shows the approximate volumes of CDW discarded, measured in m³, considering the use of a 5m³ container as a reference. Vila Nova neighborhood was not shown because there were no occurrences there.

The neighborhoods with the highest incidence of CDW inappropriate disposal points are also the ones whose CDW volumes are more expressive. Portinho, Braga, Jardim Excelsior and Palmeiras neighborhoods currently have new real estate developments under construction, in addition to renovations.

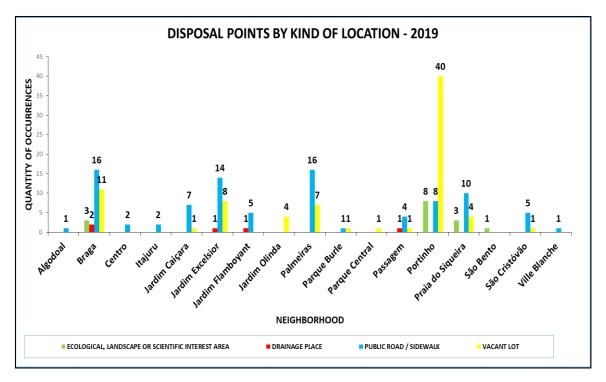
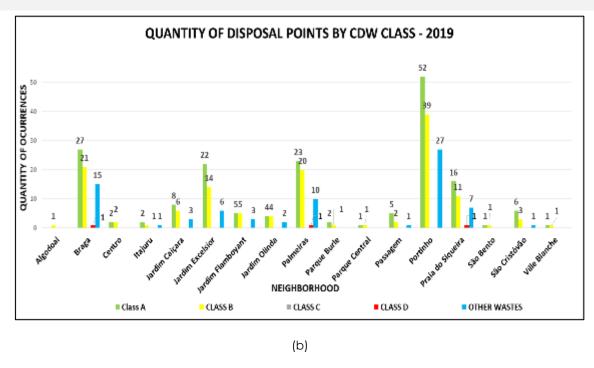
Figure 8 – (a) Quantity of disposal points by types of impacted location. (b) Number of occurrences by waste class. Source: The authors (2020).

Regarding the disposal sites, as shown in Figure 8a, there was inadequate disposal at 15 sites in areas of ecological, landscape or scientific interest (8.4% of the total), 5 discharges over drainage places, such as manholes and sewer grates (2.8%), 92 located on public roads or sidewalks (51.4%) and 79 on vacant lots (44.1%). It should be noted that these variables are independent, and the same disposal point may include more than one type of location (e.g. both a manhole and a public road).

The waste was also classified according to its composition. The number of occurrences of each class of waste by neighborhood is shown in Figure 8b. A higher incidence of class A waste was observed in most neighborhoods, followed by a significant proportion of class B waste. Discards of class D waste were detected in Braga, Palmeiras and Praia do Siqueira. No class C waste was observed in any neighborhood. Other kinds of waste (e.g. household waste, pruning and unserviceable items, such as furniture and sanitary wares) were dumped in most neighborhoods. They may cause disease proliferation due mainly to the presence of organic residues, which favour the presence of synanthropic, venomous and disease-transmitting animals.

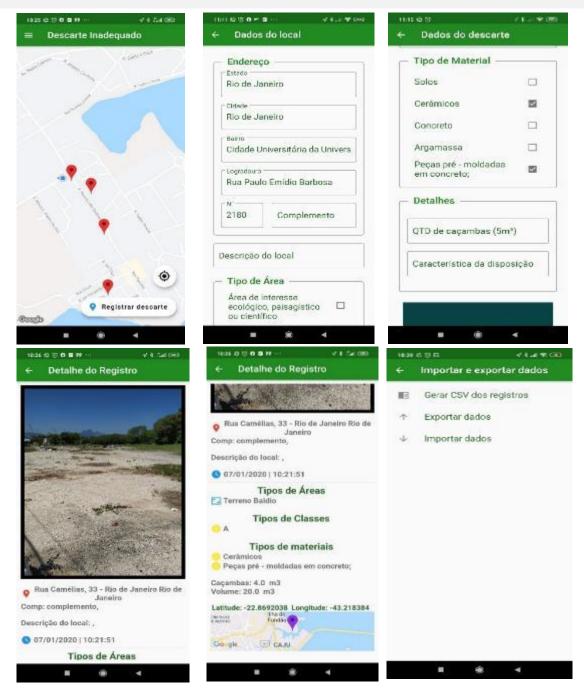
Figure 9 - Mobile App Forms. Source: The authors (2020).

During data collection, the difficulty of registering the information in real time was detected. So it was decided to develop a mobile application that could help marking the location of the CDW disposal site and recording its image, its estimated volume, its composition, and the main impacts generated on the environment.

Among the various features presented by the application it can be mentioned: integration with Google Maps and identification of the disposal location through the smartphone georeferencing mechanism; registration of the CDW disposal data (location, class of waste, type of material, characteristic of the place, volume, and image integrated to the smartphone camera); search for inappropriate disposals; import and export of data, including files in csv format that can be integrated with spreadsheets. Figure 9 shows the images of some forms from the application, which was developed in Portuguese language.
