# Eccentrically-compressed reinforced concrete columns strengthened with partial jacketing

Revista de la Asociación Latinoamericana de Control de Calidad, Patología y Recuperación de la Construcción,  
vol. 8, no. 2, 2018

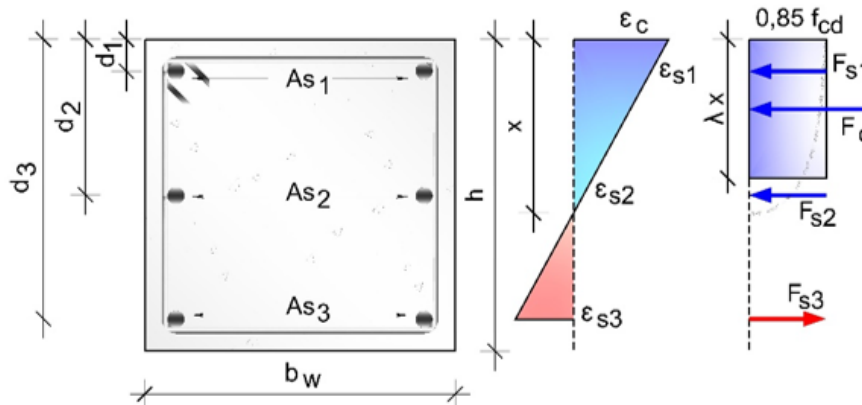
FIGURE 1

Stress, strain and resultant forces in the transversal section of the column.

The Interaction Diagram Method was employed to calculate the uniaxial compression strength, following recommendations by Wight & Macgregor (2009) and the prescriptions and simplifications of ACI 318 (ACI, 2008), coupled to parameters of NBR 6118 (ABNT, 2014). As an example of the calculation methodology, Figure 1 shows a uniaxial compression transversal section in which two layers of longitudinal reinforced concrete are compressed, whilst the lower layer in the transversal section  $A_{s3}$  is tensioned, where  $F_{s1}$ ,  $F_{s2}$  and  $F_{s3}$  are the force in each steel layer, and  $F_c$  is the compressive force in concrete. The

deformation limits adopted takes into account a concrete crushing at 3.5‰ and a steel yielding at 2.62‰ ( $\epsilon_{s3}$ , experimentally obtained) for all the reinforcement bars.

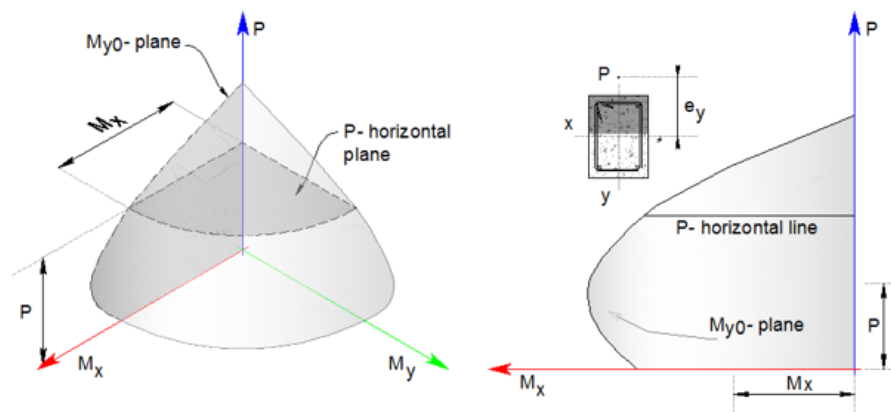
FIGURE 2  
Interaction diagram for biaxially and uniaxially loaded sections  
Macgregor, 1996

When deformation limits are established, the interaction diagram may be performed, as Figure 2 shows, where:  $M$  is the bending moment;  $P$  is the axial load. Figure 2 shows possible interactions and action plane of bending moments ( $M_x$  and  $M_y$ ) and axial load ( $P$ ), coupled to a simplification so that the bending moment may be considered only at the main direction ( $M_x$ ), like studied in this current work.

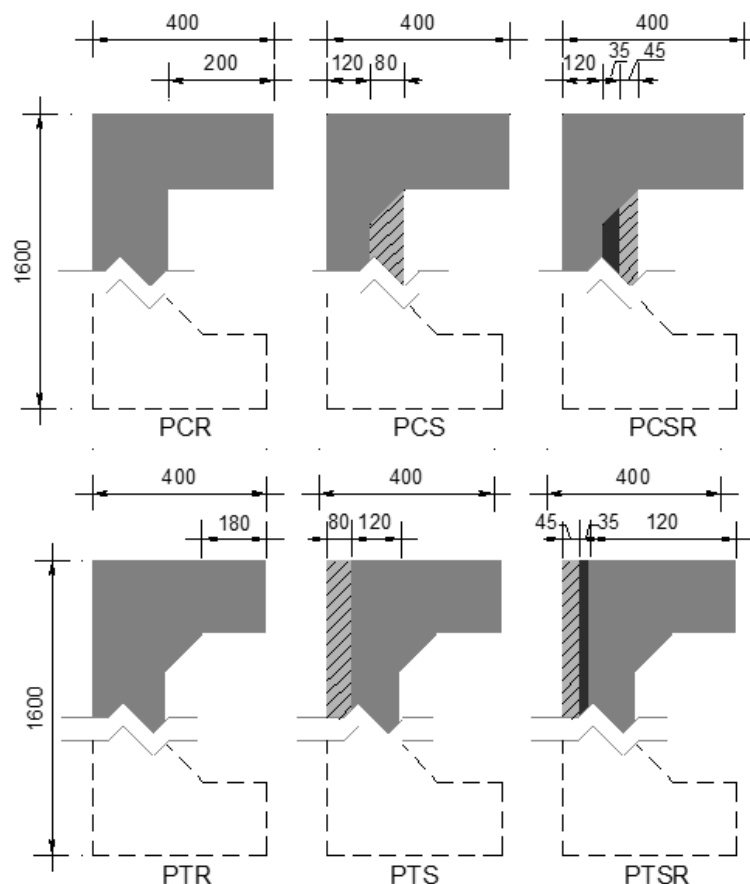
FIGURE 3  
Sizes of columns.

The eccentricity of axial load was 100 mm when compared to the longitudinal axis of the column's span. The columns were divided into two groups: a group of columns strengthened in the compression zone (PCR, PCS and PCSR) and another group of columns strengthened in the tensile zone (PTR, PTS and PTSR). A control column was cast in each group, one simulating the column strengthening without the removal of the mortar coating of the original section and the other with the complete removal. Control columns featured a transversal section of  $(200 \times 200)$  mm<sup>2</sup> and total length of 1.600 mm, with slenderness index of approximately 28. Strengthened columns had an initial section of  $(120 \times 200)$  mm<sup>2</sup> and total length of 1.600 mm, with 80 mm of strengthening layer. After the retrofit, the columns showed a final transversal section identical to that of the reference columns. Figure 3 demonstrates the columns' size, and the concrete corbel made to prevent premature concrete cracking in the strengthened specimens.

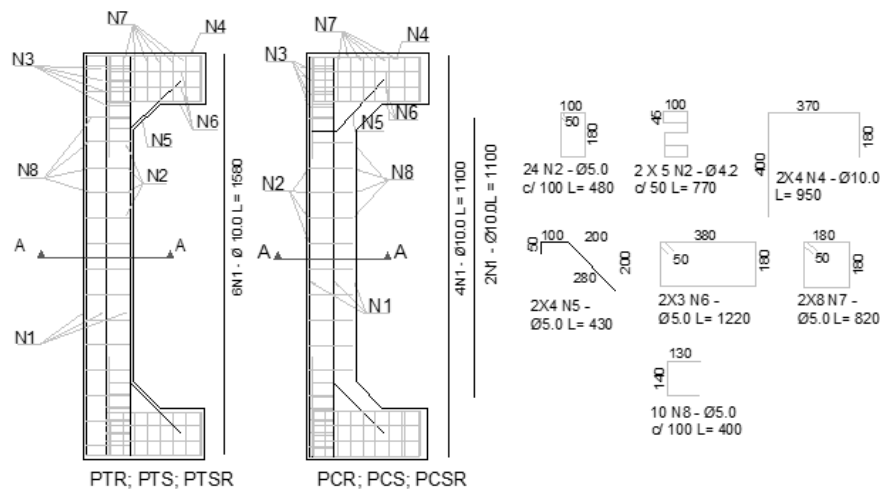
FIGURE 4  
Reinforcement of columns.

Representing conventional situation, the longitudinal reinforcement of reference columns featured 6  $\varnothing 10.0$  mm ( $A_s = 4.71 \text{ mm}^2$ ), with stirrups measuring  $\varnothing 5.0$  mm spaced at every 100 mm at the center, and  $\varnothing 5.0$  mm for every 50 mm at the edges. Further, additional open stirrups were employed with epoxy adhesive, measuring  $\varnothing 5.0$  mm for every 100 mm, later fixed in the hardened concrete to help in adherence between new and old concrete. Initial reinforcement of all columns measured 4  $\varnothing 10.0$  mm ( $A_s = 314 \text{ mm}^2$ ), with two longitudinal bars added for reinforcement, meeting the number of bars used in the reference columns without any reinforcement, or rather, 6  $\varnothing 10.0$  mm ( $A_s = 4.71 \text{ mm}^2$ ). Transversal reinforcement were of the same specification as that in the reference columns (Figure 4).

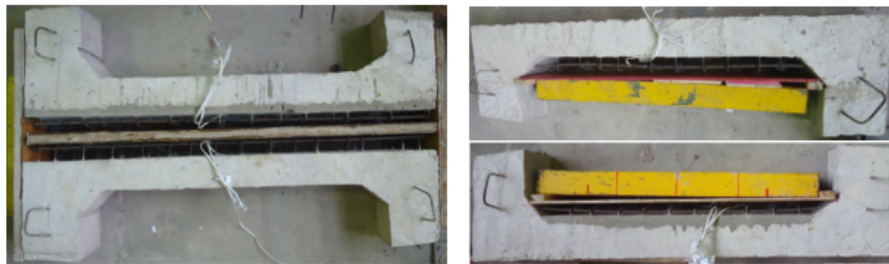
FIGURE 5

Extensometers installed in the concrete (PTS; PTSR; PCS; PCSR respectively).

For reinforcement at the tensile and compression region of the columns, the transversal reinforcement (open stirrups) was fixed into the hardened concrete with an epoxy-based structural adhesive in 60 mm-deep holes. It comprised  $\varnothing 5.0$  mm stirrups every 100 mm, simulating procedures in civil work. Posterior to the fixing of open stirrups (Figure 5), extensometers were placed on the concrete. A cement-sand mortar coating was applied to the PTSR and PCSR columns prior to the installation of the open stirrups. Another extensometer was placed on the coating surface. Longitudinal reinforcements (2  $\varnothing 10.0$  mm) were positioned to complete the positioning of the reinforcement by placing the wooden moldings and for the casting of concrete. The instrumentation of the concrete surface was finalized by placing an extensometer on the strengthening layer.

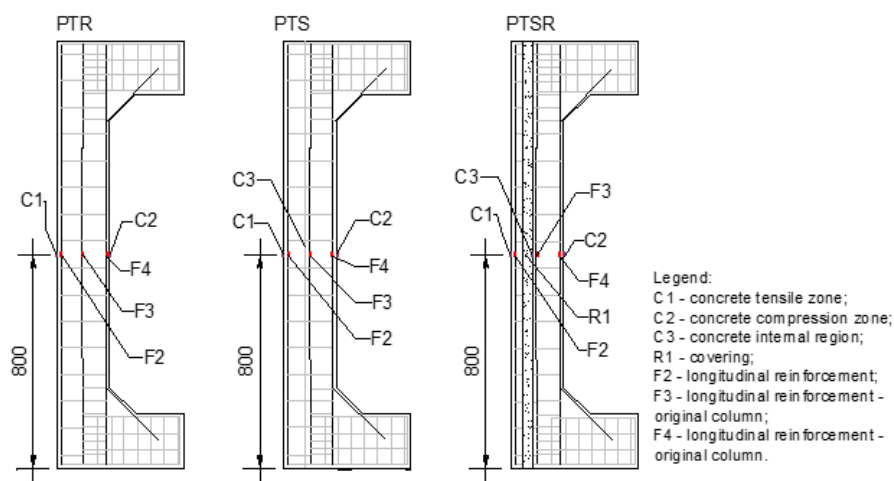
FIGURE 6

Extensometers on the rebar and concrete of the tensile zone strengthened columns.

Electrical resistance strain gauges were used on concrete and reinforcement bars to monitor deformations during the tests. Figure 6 shows the positioning of sensors in the columns PTR, PTS and PTSR and Figure 7 displays the placement of sensors in columns PCR, PCS and PCSR. Extensometers were positioned half way the columns' length.

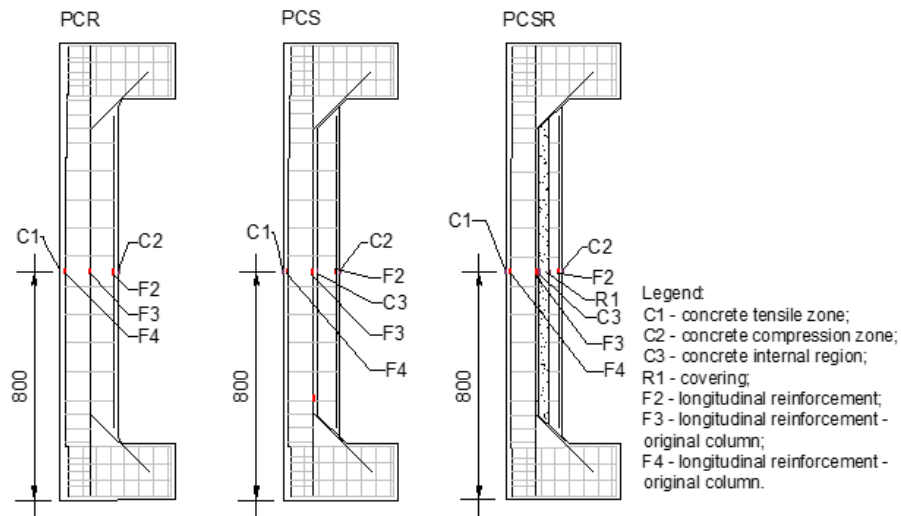
FIGURE 7

Extensometers on the rebar and concrete of the compression zone strengthened columns.

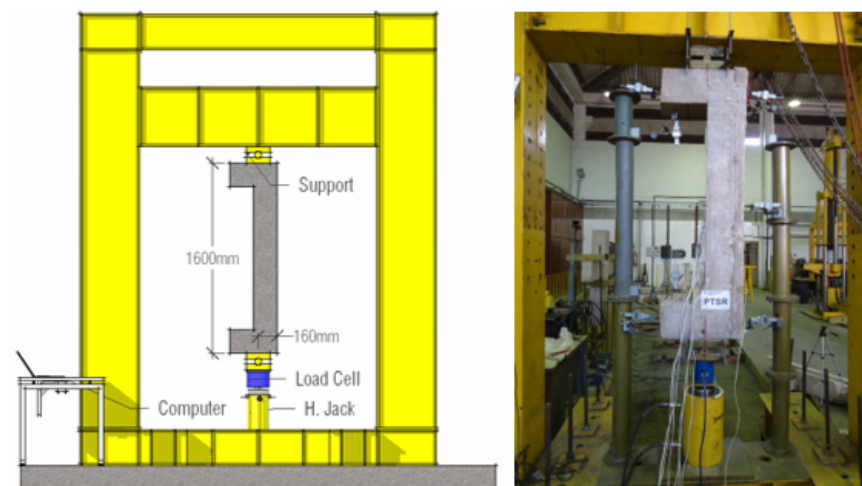
FIGURE 8

Testing setup system

Figure 8 details the test setup used in the experimental analysis of the columns. The system comprised a highly rigid metallic frame fixed to the reaction slab, a 2000 kN hydraulic jack driven by a hydraulic pump for loading, and a 2000 kN load cell with a 0.5 kN precision, locked to a digital indicator for load recording. Columns were coupled in pinned supports, simulating hinges placed eccentrically to the columns' axis and thus making viable the expected uniaxial compression. Extensometers were read by a computer-connected data logger, for sensors installed in the rebars and for those fixed on the concrete surface.

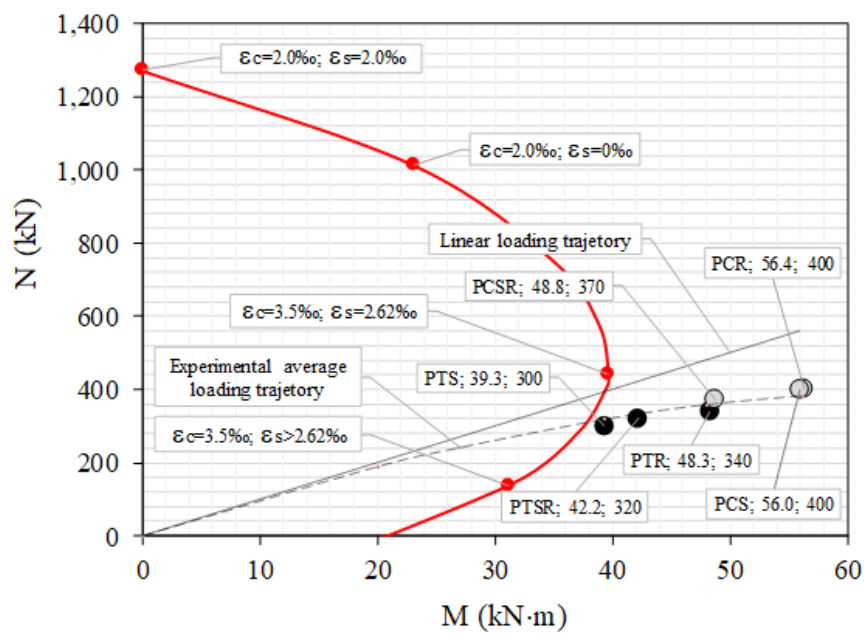
FIGURE 9  
Interaction diagram results.

Figure 9 shows an interaction diagram (based on MacGregor & Ibrahim, 1996) of the transversal section common to all columns and their respective final experimental resistance. For any eccentricity there is a unique pair ( $M/N$ ), and plotting these series of pairs corresponding to a different eccentricity the interaction diagram is obtained. The horizontal axis shows the bending moments values and the vertical axis the axial load values, so the radial lines show constant eccentricity. The more vertical radial lines the smaller eccentricity conducting to compression failure range, so the more horizontal radial lines the bigger eccentricity conducting to tension failure range. The linear load trajectory shows a proportional well balanced failure for both steel and concrete of the columns cross section according to NBR 6118 (2014). When load trajectories were compared, the second order effect, associated to physical non-linearity, decreased estimates of ultimate resistance to normal load up to 28%, whereas a mere 5% reduction occurred.

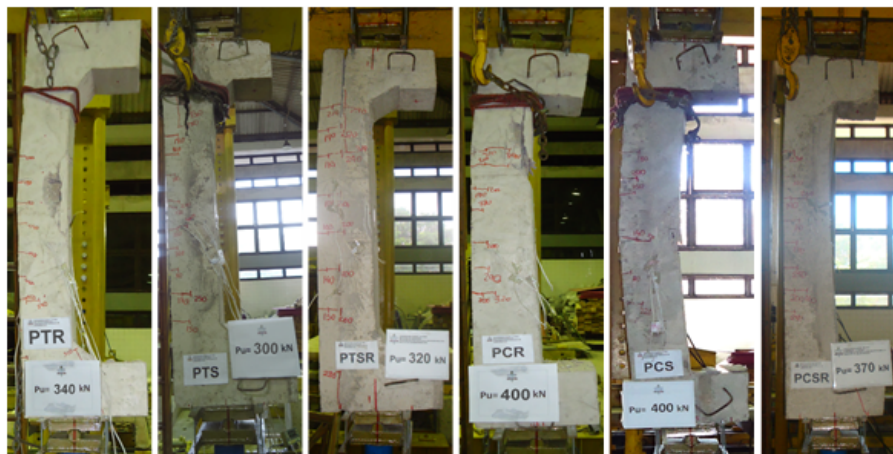
FIGURE 10  
Columns after failure.

The above demonstrates that, even at low slenderness indexes, this effect should be taken into account due to decrease in the safety of the columns. Whereas Figure 10 shows post-cracking columns, Figure 11 details damaged zones. The columns strengthened in the tensile zone showed detachment of concrete layer near the column's edge, due to the pullout of the stirrups with the failure of the column. The failure of the compressed zone at the edge of PCR column may also be noted.

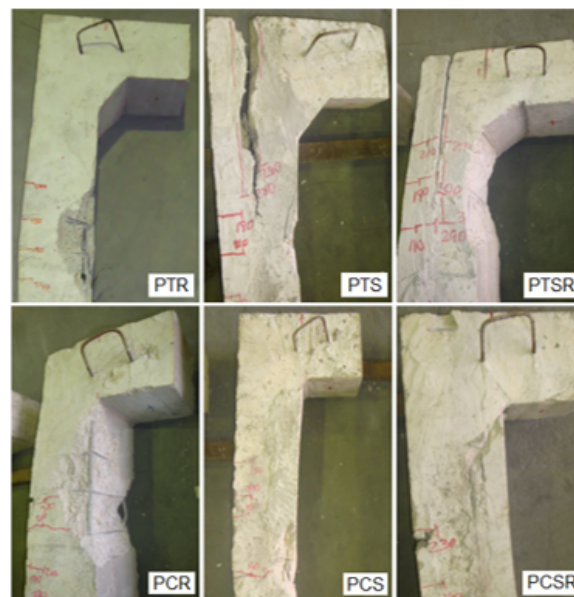
FIGURE 11  
Details of columns after failure.
