## Evaluation of the ultrasound test for estimating the depth of cracks in concrete

Revista de la Asociación Latinoamericana de Control de Calidad, Patología y Recuperación de la Construcción,  
vol. 9, no. 1, 2019

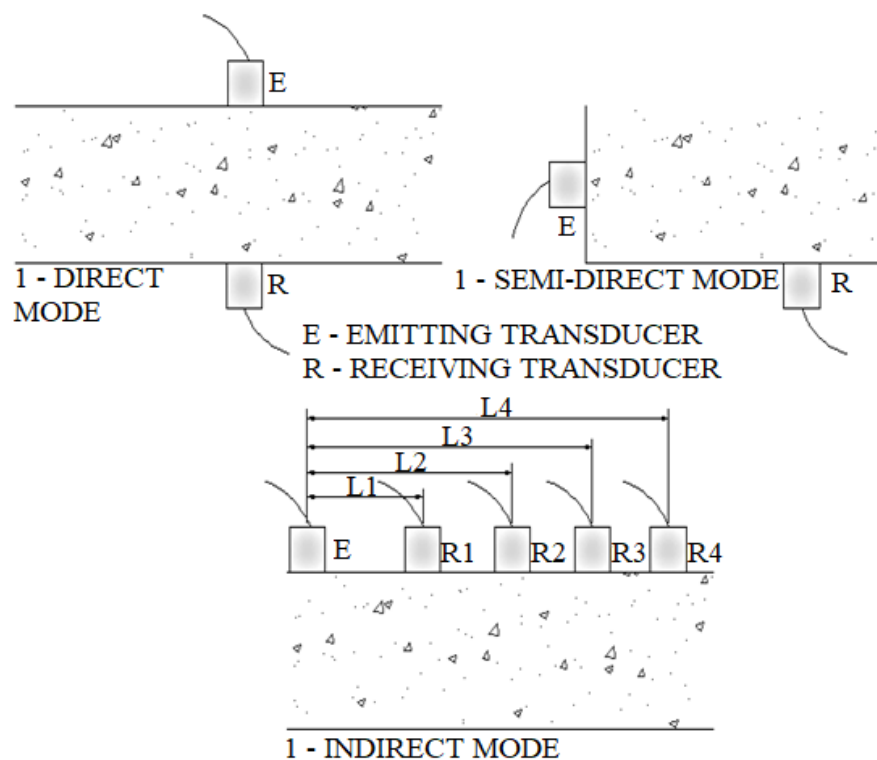
Ultrasound tests in Brazil are regulated by NBR 8802 - Hardened concrete - Determination of the propagation of ultrasonic waves (ABNT, 2013). According to this standard, there are three ways for waves to be transmitted along the surface of the concrete: direct, semidirect, and indirect, as shown in Figure 1.

FIGURE 1  
Transducer positioning  
ABNT, 2013

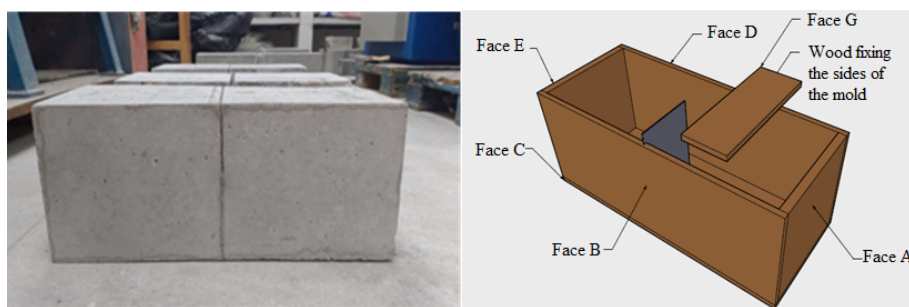
The concrete blocks had dimensions of 20 x 20 x 50 cm. The crack was induced along the axis of the block by placing a 0.95 mm thick zinc plate during the molding, which was then removed before the concrete hardened. All the blocks were produced with the same depth, because research in the literature showed no influence on the results caused by the depth. Figure 2 shows the details of these test specimens.

FIGURE 2  
Concrete block details

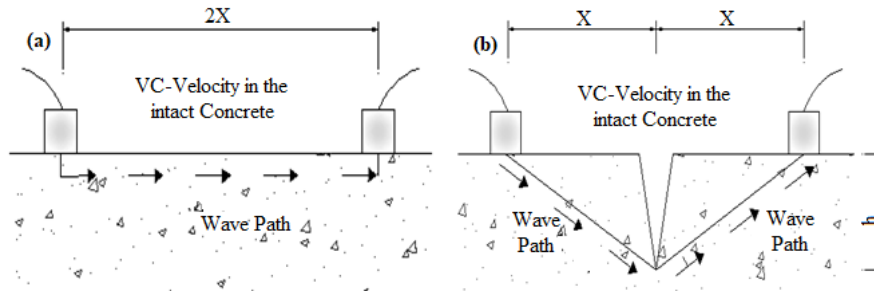
FIGURE 3

The model allows for the estimation of crack depth perpendicular to the concrete surface when the mode of transmission is indirect. Therefore, the transducers should be placed equidistant from the crack, as shown in Figure 3 (a) and (b).

(a) Wave path in unbroken concrete, (b) Wave path around the crack

In order to apply this model, the velocity of the ultrasonic wave through the integral concrete obtained using the indirect mode should be adopted as "Vc". That is, a speed "Vc" is found in a region of the concrete without cracks, having  $Y = 2X$  between the transducers.

Considering that the wave will deviate around the crack and that the velocity should remain the same because it is propagating through similar material, it is possible to estimate the depth of a crack that has its axis located at distance "X" from the transducers, as shown in Figure 3. The difference between these two paths will cause a slower wave propagation time, because the speed "Vc" should be the same.

The model assumes that the velocity will be equal for the two paths and that the wave will deviate because it is a mechanical wave, which requires a medium through which to propagate. Equation (1) represents the proposed mathematical model, a result of the equality of velocities along the two wave paths.

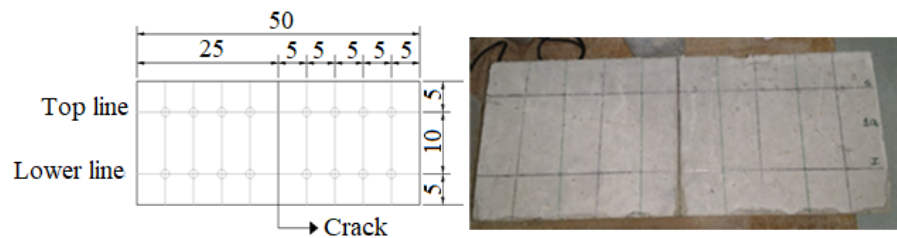
An observation grid was marked on the surface used for the test, composed of an upper and lower line, the detail of which is shown in Figure 4. At all points where measurements were to be taken, Vaseline was applied to connect the transducer to the surface.

FIGURE 4  
Test marking scheme

At each grid point, two readings were performed using the ultrasound and their average was used for the calculations of the model.

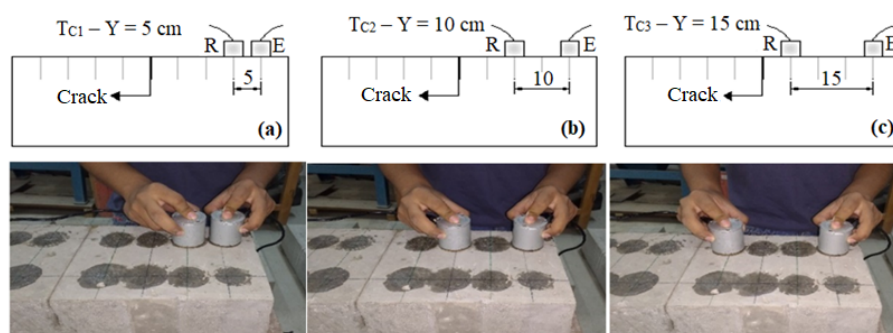
FIGURE 5

To obtain  $T_c$ , the emitting transducer was fixed at the first point of the mesh and the receiving transducer was moved in 5-cm steps, obtaining times for the distances  $Y = 5\text{cm}$ ,  $10\text{cm}$ , and  $15\text{cm}$ , according to Figure 5 (a), (b), and (c), where E is the transmitter, R is receiver, and Y is the distance between transducers (cm).

Time readings in the intact concrete -  $T_c$  with transducers at distances of: (a) 5 cm; (b) 10 cm; (c) 15 cm

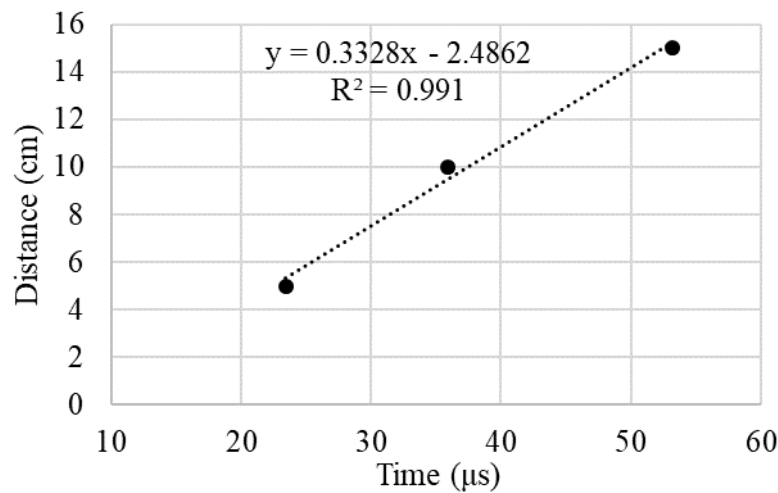
The results of the three readings of distance (cm) versus time ( $\mu\text{s}$ ) were plotted to obtain the best fit line (Figure 6) and to find the propagation times through intact concrete, adjusted by the line  $T_c'$  for all distances required to apply the model:  $Y = 10\text{cm}$ ,  $20\text{cm}$ ,  $30\text{cm}$ , and  $40\text{cm}$ , as shown in Table 1, which presents the results of the first repetition for the first test specimen of Series II. The measurements are identified first by the number of the block in the series (1, 2, 3, or 4), then by the depth ( $P5 = 5\text{cm}$ ,  $P10 = 10\text{cm}$ ,  $P15 = 15\text{cm}$ ), followed by the test execution distance  $D10 = 10\text{cm}$ ,  $D20 = 20\text{cm}$ ,  $D30 = 30\text{cm}$ ,  $D40 = 40\text{cm}$ ) and finally by a unique number for each repetition of the test (1 for the first and 2 for the second).

FIGURE 6  
Distance vs time plot (Series II - Block 1 - First repetition)

Identification	Tc (μs)	Y (cm)	Tc' (μs)
1P10D5-1	23.45	5.00	22.49
1P10D10-1	35.88	10.00	37.52
1P10D15-1	53.23	15.00	52.54
1P10D20-1	-	20.00	67.56
1P10D30-1	-	30.00	97.61
1P10D40-1	-	40.00	127.66
Linear Equation			$Y = 0.3328X - 2.4862$
Y-intercept			-2.4862
"Vc"(cm/μs) - Angular coef.			0.3328

The adjusted times (Tc') were found for the distances Y = 10cm, 20cm, 30cm, and 40cm, where  $Y = 2X$ , with X being the distance between the axis of the crack and the transducer.

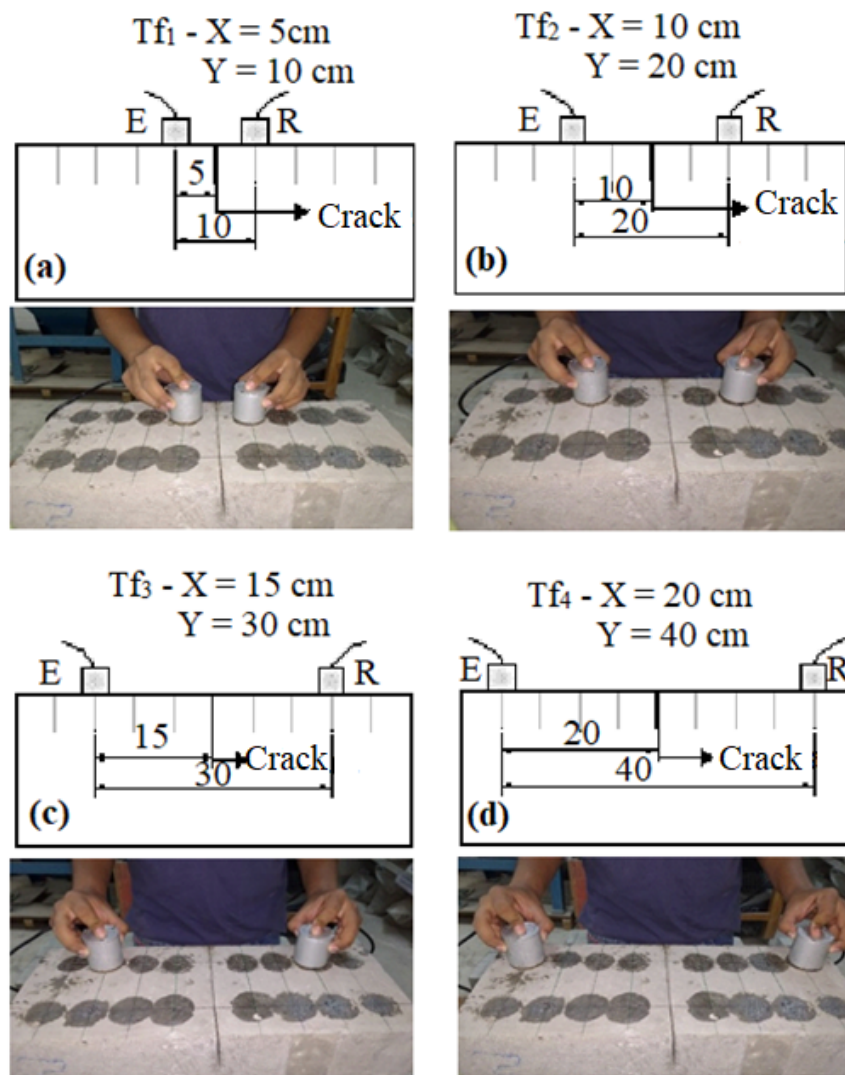
FIGURE 7

In order to measure the propagation time of the wave around the crack (Tf), the readings were taken with distances between the transducers of Y = 10 cm, 20 cm, 30 cm, and 40 cm, as shown in Figure 7 (a) (b) (c) (d).

Readings taken around the crack with transducers at distances of: (a) 10 cm; (b) 20 cm; (c) 30 cm; (d) 40 cm

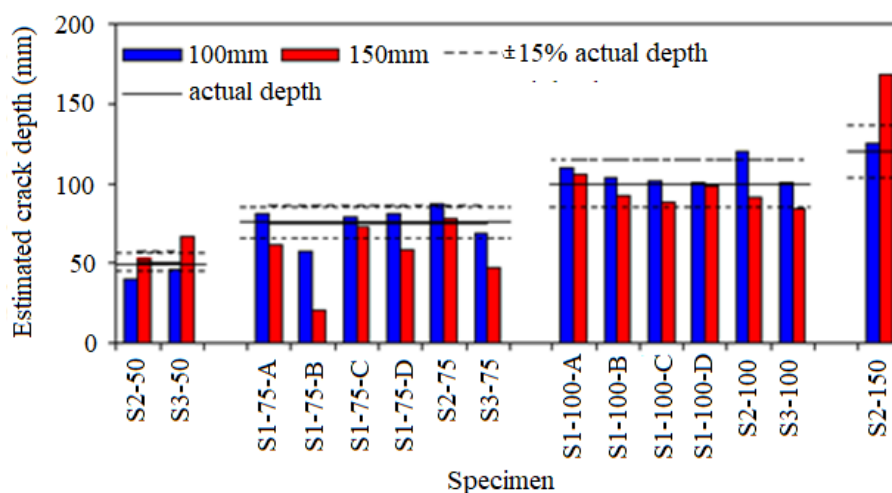
Pinto et al. (2010) also studied the estimated depth of cracks in concrete blocks, analyzing four different depths (50 mm, 75 mm, 100 mm and 150 mm), with test execution distances of 100 mm and 150 mm, applying the same mathematical model and arrived at the estimates presented in Figure 8, where the tests were identified by the series, then the depth, and then by the test specimen analyzed. For example, S1-75-B indicated Series 1, depth 75 mm, block B.

FIGURE 8  
Crack depths  
Pinto et al, 2010

The authors concluded that the results were mostly within the margin of error of 15% of the actual crack depth. A similar result occurred in this study, where the best results were found for crack depths of 10 cm.

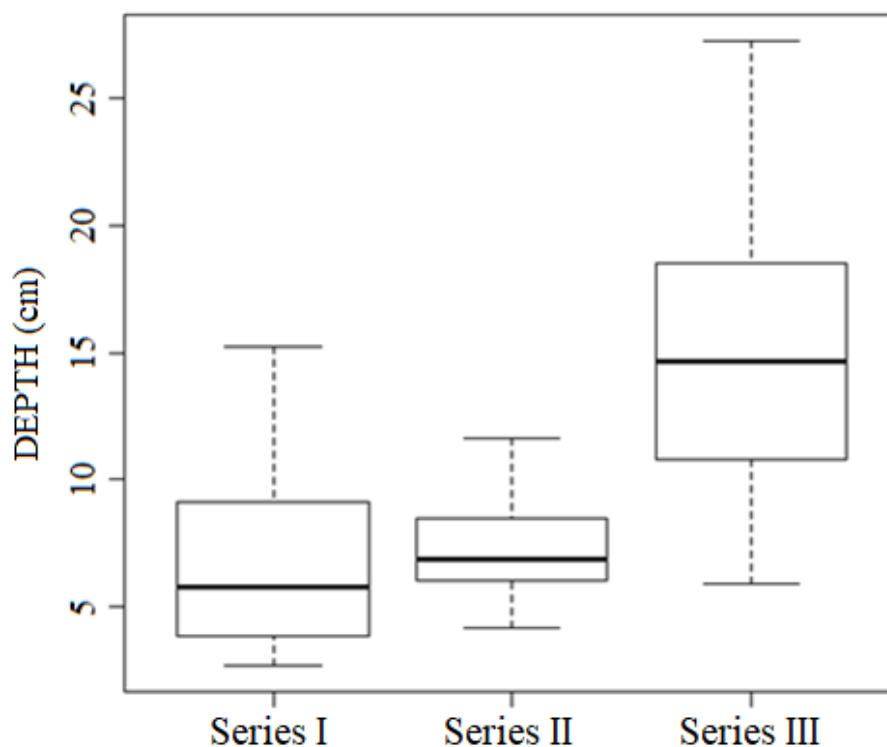
To facilitate the understanding of the behavior of the results found, the boxplot of the three series was used in Figure 9, a graphical statistical tool that represents the variation of the data of a numerical variable through quartiles.

A boxplot is formed by drawing a box parallel to the axis of the variable. The lower edge represents the 1st quartile, the thick line the median (2nd quartile), and the upper edge the 3rd quartile. The line that extends

vertically indicates the upper and lower limit of the data. This box represents 50% of the central values of the distribution. The flatter the box, the less scattered the data is.

It can be seen that the data from Series II (10 cm) were those with least variability, as data from Series III (15 cm) had greater dispersion. It can be said that the data from Series II (10 cm) behaved better in comparison to the other series in the analysis of descriptive statistics.

FIGURE 9  
Boxplot for variable: DEPTH

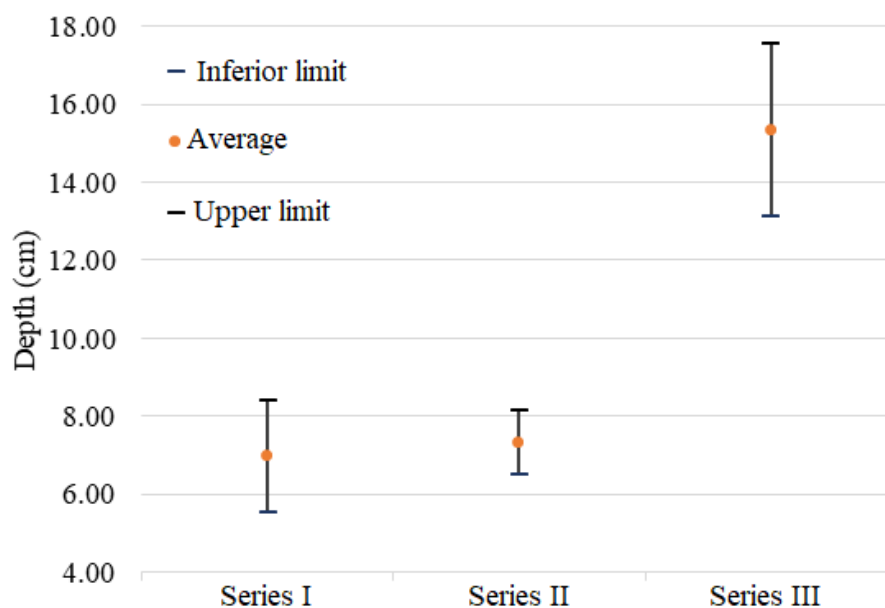
Table 4 shows the confidence intervals of the depth variable for the 3 series analyzed. Figure 10 shows the graphs of the confidence intervals for each series regarding depth.

FIGURE 10  
Confidence interval graph (depth variable)

For Series III, the depth variation calculated by the model falls within the range of 13.14 cm to 17.57 cm, with the actual depth being 15 cm.

In Series II, which had the smallest C.I., the depth calculated by the model varies from 6.48 cm to 8.14 cm. Although this is a small interval, the actual depth measurement of 10 cm does not fall within it, a fact that compromises the application of the model.

For Series I, which had an intermediate C.I., with crack depths calculated by the model ranging from 5.51 cm to 8.40 cm, the actual depth of 5 cm also lies outside the range.

It is also possible to see from the results that, for larger distances between the transducers (30 and 40 cm), there is a greater variation of the data, whereas the smaller test execution distances (10 and 20 cm) had less dispersion and a smaller margin of error.
