Suárez, Bladimir; Vera, José David; Botero, Francisco; Suarez, Byron H.; Giraldo, William Hidroituango intake gate closure - Emergency conditions* **

Revista Facultad de Ingeniería Universidad de Antioquia, no. 104, 2022, July-September, pp. 140-151

Hidroituango intake gate closure - Emergency conditions

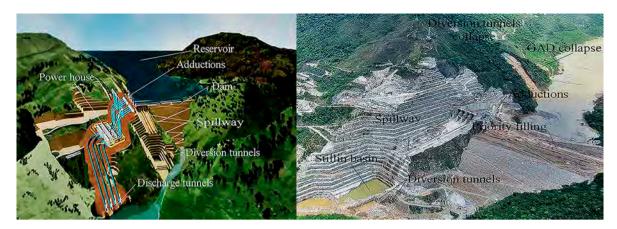
Figure 1 Hidroituango project sketch (a), and General view during contingency (b)

Figure 2 Profile of the wells of the gate

Figure 3 Main characteristics of the gate

with a capacity up to $450m^3/s$; and three diversion tunnels (the last one is called the *Galería Auxiliar de Desviación* or *GAD*). The intake structure is made up of two submerged civil structures with four independent penstocks; each one of them has a diameter 6.6 m. Fixed trash racks allow the flow of water to the eight turbines/generator assembly fixed in vertical axes in the powerhouse, which are connected with two surge tanks downstream and four discharge tunnels. The flowing water returned back to the *Río Cauca* through the discharge tunnels. Figure 1. shows a general schematic diagram of the project.

Further, the pressure wells 7 and 8 of the intake structure collapsed in the middle of May 2018 due to the damage caused by the free flow falling into these wells. This situation forced the closure of gates 7 and 8 with balanced pressure. As a consequence, the remaining flow passing through adductions 1 and 2 peaked at roughly $725m^3/s$, which caused damage in wells 1 and 2 resulting in induced rock instability around those wells [3], making a cavity or rock hollow. These adverse events led to the immediate closure of gates 1 and 2 against the free flow. This situation warranted a high complexity in operation involving processes such as aeration, high water velocity with several energy levels, and hydraulic transients that act as multipliers of the dynamic forces occurring within the hollow rock (Figure 2).

The gate was designed following the standard DIN 19704/1976. The closure operation was designed so that its ease of operation is facilitated by its weight, in addition to the stem system weight and a concrete counterweight (Figure 3). The normal hydrostatic design pressure was estimated for a maximum level of operation of the reservoir at 420.00 masl, and its exceptional pressure was related to the probable maximum flow (PMF), which would raise the level of the reservoir to level 435.00 masl. The sill level of the gate is 342.65 masl.

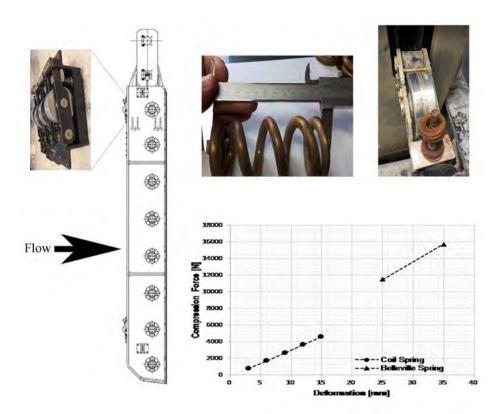
Figure 4 Counter guide wheels (a), Gate sketch (b), Steel coil springs (c), Belleville springs (d), and Strength-deformation curve for the springs (e)

Figure 5 Lifting handles (a), and Accelerometers chamber (b)

Original "Belleville" springs were replaced by stainless steel coil springs due to the deterioration that occurred in the original springs during the contingency time. Some of the characteristics of these elements are illustrated here (Figure 4).

same manner to install three accelerometers to measure vibrations in the three axes in the body of the gate (Figure 5).

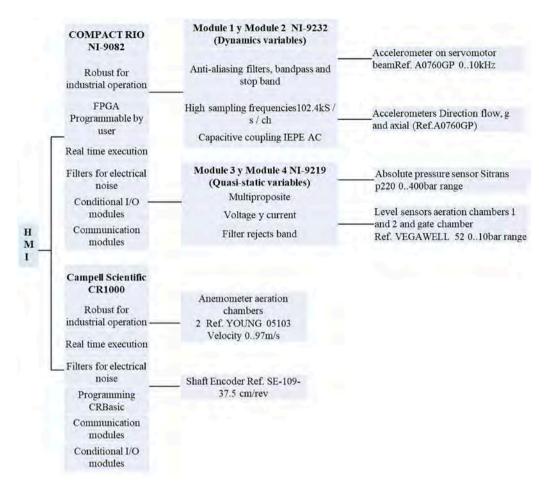
Figure 8 General structure of the hardware

A distributed architecture was adopted with two data acquisition systems duly configured and synchronized. The first one is the Campbell Scientific CR1000 recorder that received and conditioned the quasi-static signals of the anemometers and the "shaft encoder" used to measure the position of the gate. This device can filter electrical noise generated by other equipment connected to the network. The sampling of this equipment was carried out in real-time, utilizing an RS232 protocol to 19200 bauds every 500 ms.

The second is the National Instruments cRIO NI-9082 industrial system with modules for the acquisition and signal conditioning of quasi-static signals and other modules for dynamic signals. The first type of module received signals from three accelerometers located on the gate in the direction of flow, gravity, and transverse directions. The conditioning of these signals included AC couplings and anti-alias filters. Samples were collected simultaneously from accelerometers at a rate of 1024 samples s^{-1} that allowed investigation of the vibratory phenomena up to 512 Hz.

The second type of module is connected to the pressure of the servomotor and the water levels in the gate and aeration wells. All these signals were in the range +/-25mA. It should be noted that the sampling frequency was set to 9.09091 Hz with a 60 Hz reject-band filter (frequency of the low voltage network) (Figure 8).

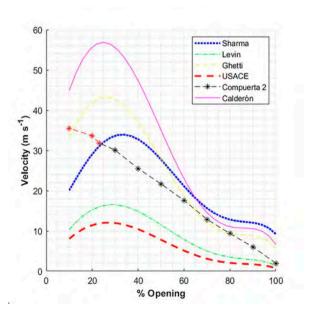
Figure 9 The estimated velocity of the air vs. measured velocity of the air

Figure 9 shows some estimated curves and the data of aeration measured during the closing.

- Based on the results presented in figure 9, it can be deduced that the aeration associated with the closure of gate N°2 showed a behavior very similar to that estimated with the Ghetti and DiSilvio equation up to 50% of the closure. Further, aeration was affected between 50% and 100% of the closure due to the connection between the pressure wells and the rock hollow.

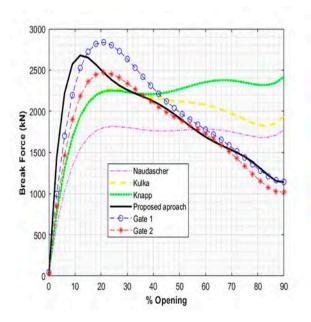
Figure 10 Lifting force at the servomotor

The estimated forces of the gate based on previous studies are shown in Figure 10.

Further, the sampled forces during the closure operation of the gates $N^{\circ}1$ and $N^{\circ}2$ and the newly proposed Equations (8) and (9) are also included.

- The pressure data obtained from the variation of headwater into the well of the gate (H*) and the hydraulic pressure at the annular chamber of the servomotor (see figure 10) during the closure operation was fundamental and instrumental to determine the downpull factor (K*).

- From the results presented in figure 10, it can be figured out that the lifting force at servomotor for a closure of a fixed-wheel gate against free-surface flow could be estimated in a more conservative way using the Naudascher method but calculating this force with the real headwater into the well of the gate. To obtain a more accurate estimation of this lifting force, equations (8) and (9) proposed by Suarez and Vera could be used.

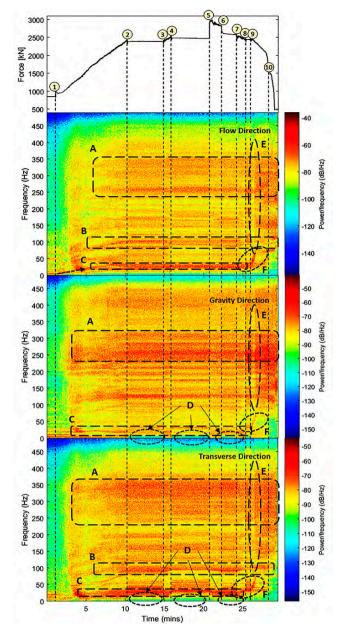
Figure 11 Spectrogram of the closure of the gate

Figure 11. shows a frequency analysis of the sampled forces in the gate N°2. Numerical marks included in the figure correspond to:

- 1. Start of the closure of the gate.
- At 9.1min, the gate was at 61% of the closure, and it was necessary to stop the operation because the connection between the pressure wells 1 and 2 was noticed, i.e., a huge rock hollow has been created between both wells.
- 3. At 13.5 min, the decision was made to continue with the closure despite the connection between the pressure wells.

- 4. At 14.9 min, the gate was at 71% of the closure; the operation was stopped again due to the interference between the hoisting system of steel cables and the servomotor of the gate.

- 5. At 19.4 min, the decision was made to open the gate by 30 cm to solve this interference.
- 6. At 21.2 min, the gate returns to 66% of the closure. The hoisting system of steel cables was positioned in front of the servomotor of the gate.

- 7. At 23.1 min, the closure operation was restarted again.
- 8. At 24.3 min, the gate was in 77% of the closure, and it was necessary to stop the operation again due to strong transients and trepidation in the aeration well of gate N°2, which produced the sudden change in the flow direction of the air, expelling air with earth and rocks and water coming from the connection between the pressure wells and the rock hollow.

- 9. At 25 min, it was decided to continue the closure operation.
- 10. At 27.2 min, the gate was in 97% of the closure, but a strange behavior of the gate occurred due to interference between the steel cables and the lintel of the gate.

The alphabetical marks shown in the figure show a selection of inferences associated with the hydraulic phenomena presented during the closure operation, based on the data obtained by the instrumentation system installed in gate N°2:

- A. A range of frequencies between 230 and 350 Hz was noted, which are related to some harmonic modes of vibration of the gate structure. These can be estimated by hydrodynamic phenomena. This behavior developed from the moment the gate contacted the surface of the flow and remained constant until the complete closure.
- B. An exciting frequency is observed below 100 Hz, which conforms with the adhered mass of water (see mode 4 in Table 2).
- C. The excitation of a frequency near 29 Hz was observed, which concurs with the natural frequency of the servomotor beam (see in Table 5). This frequency showed a change when the gate first gets in contact with the free surface of the flow (backflow) due to the shift in the adhered mass.

- D. It was observed that when the gate was stopping (see point 3 indicated in the figure), frequencies below 10 Hz have disappeared. These frequencies appear to be caused by other vibrating modes similar to the produced by the movement of the gate seals in contact whit its seal plate.
- E. A slight attenuation of the vibrations was observed in 97% of the closure, due to the subsequent effect of the transient occurred in the aeration well N°2 (see marks 8 and 9) and the impact that produced the entry of air from the well N°1 through the rock hollow.
- F. An increase of the frequency is indicated in Table 2, and it was observed due to the decrease of the mass adhered during the approach of 100% of the closure and due to the interference between the steel cables and the lintel of the gate.
