Maderas. Ciencia y tecnología, vol. 25, 34, 2023

# WATER ABSORPTION, THICKNESS SWELLING AND MECHANICAL PROPERTIES OF CEMENT BONDED WOOD COMPOSITE TREATED WITH WATER REPELLENT

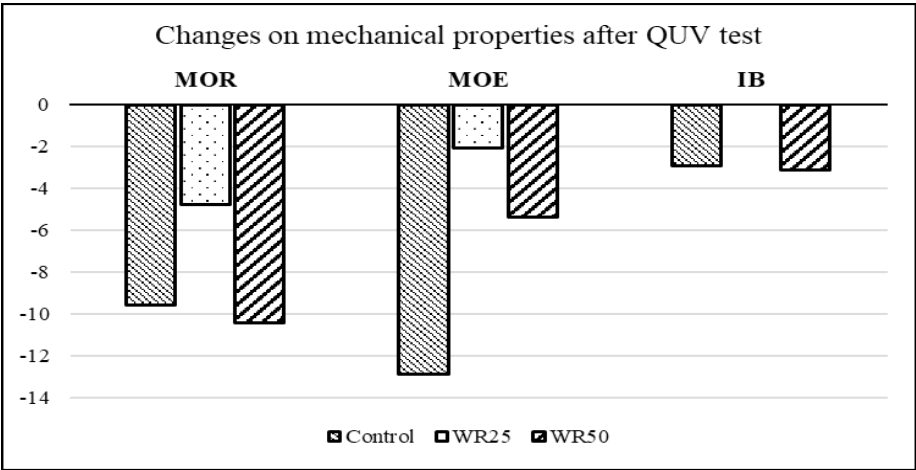
**Figure 1:** Changes on the mechanical properties after accelerated weathering test.

According to results, all wood-cement composites tested in this study provide the minimum MOR and MOE requirement of the CEN EN 634-2 (2007) standard. In addition, the minimum requirements of IB strength in the CEN EN 634-2 (2007) standards are 0,5 MPa for general usage and 0,3 MPa after the cyclic test. Therefore, all types of board met the minimum IB requirement of the EN standards. Changes on the mechanical properties after QUV test are shown in Figure 1.

As expected that, mechanical properties of wood-cement composites decreased after 350 h weathering test. This can be attributed that the weathering test can lead to surface damage due to forming the micro-cracking, resulted in reduction on mechanical properties (Page and Page 2007, Hung *et al.* 2017). The lowest mechanical changes were obtained from the composites treated with 25 % of WR. Higher concentration of WR increased the mechanical properties losses. This may be related with some negative effect of cement in composite structure and WR.
