Schwantes-Cezario, Nicole; Peres, Maria Vânia Nogueira do Nascimento; Fruet, Thomas Kehrwald; Nogueira, Geovana Souza Ferreira; Toralles, Berenice Martins; Cezario, Davi De Souza  
Crack filling in concrete by addition of *Bacillus subtilis* spores - Preliminary study  
DYNA, vol. 85, no. 205, 2018, April-June, pp. 132-139  
Universidad Nacional de Colombia

## Crack filling in concrete by addition of *Bacillus subtilis* spores – Preliminary study

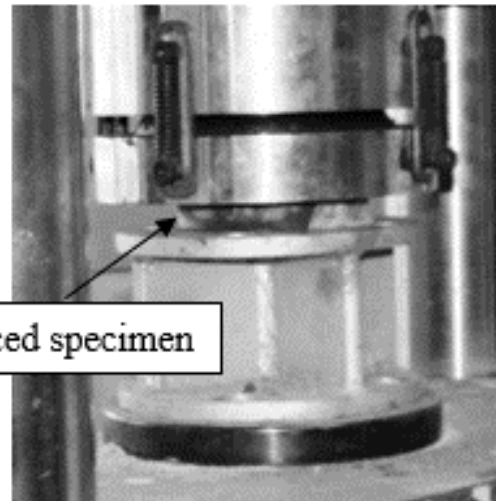
Figure 1. Cracking simulation.

In order to evaluate the cracks filling by spores addition compared to reference, a 2 centimeters slice was extracted from each concrete ( $n=3$ ). These slices were sent to the hydraulic press on the seventh day of healing to apply a strength to simulate a crack, as shown in Fig. 1.

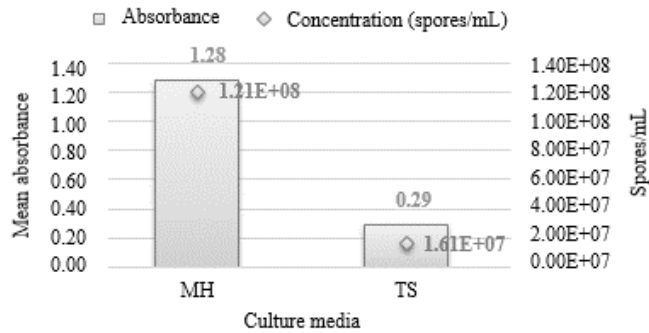
Figure 2. Mean absorbance and concentration of bacteria in each culture medium.

From the two culture medium used in the experiment, the spores quantification of each medium was performed in accordance with Eq. 1., Fig. 2 shows the results of absorbance and concentration of spores/mL of culture media MH and TS.

Through the analysis of Fig. 3, it was observed a higher absorbance values and concentration of spores in the medium MH, of 1.28 and  $1.21 \times 10^8$  spores/mL, respectively, while under the same conditions, the medium TS presented, respectively, 0.29 and  $1.61 \times 10^7$  spores/mL. From this result, only the culture medium MH was selected for this experiment.

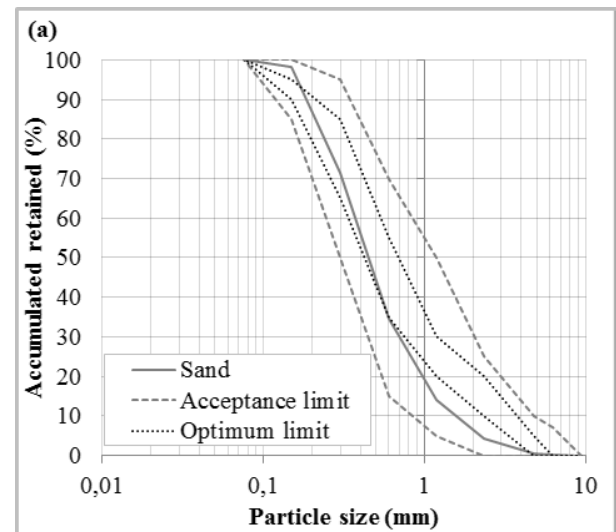
Sand was performed by Particle size analysis [24]. The results of these test were presented in Fig. 3.

The fine aggregate used was a medium sand. The particle size analysis is shown in Fig. 3. It was found that the grading curve is inside the limits established by NBR 7211/2009 (Brazilian standard) [29]. Analyzing the grading curve it should be noted that it has a continuous particle size, with desirable characteristic for use in cementitious materials due to the better packaging of the grains in the structure of the material. For the grading curve, it were calculated the maximum size, specific mass and unit mass. The values found were 2.36 mm,  $2.62 \text{ g/cm}^3$  and  $1.57 \text{ g/cm}^3$ , respectively. Besides that, the gravel has maximum size of 19 mm.

Figure 3. Particle size analysis of sand.

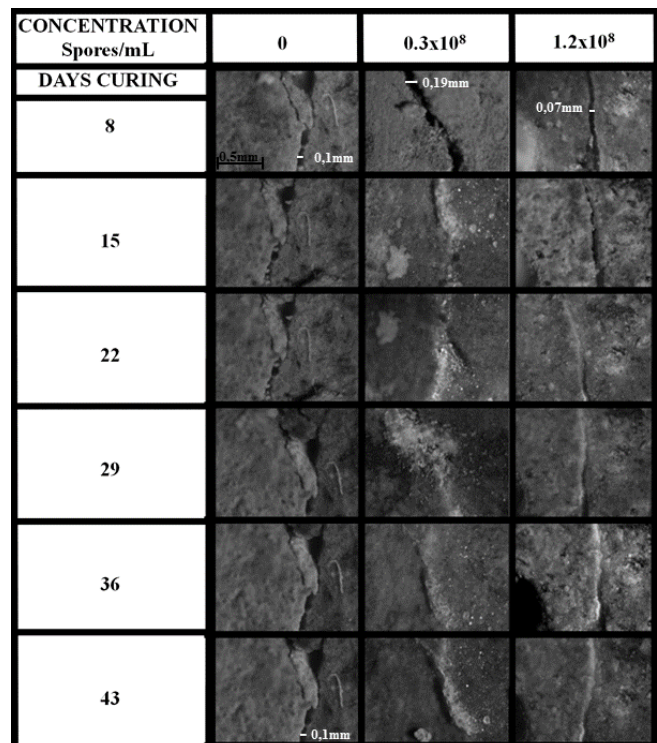
The visual analysis of crack filling was performed with one crack per specimen until 43 days of curing, being that three specimens of each concrete were analyzed ( $n=3$ ). The images obtained from an optical microscope with attached camera are shown in Figs. 3 and 4.

Figure 4. Visual monitoring of crack filling in the specimens of composition 1:1:2.

It can be seen that in all the compositions in which bacteria were added, there was a crystal precipitation from the 15th day on, possibly calcium carbonate ( $\text{CaCO}_3$ ) according to literature [20,22,30-35]. Besides that, the same strain was used in another study [23] that performed an analysis in vitro of the bioprecipitation of calcium carbonate by pH change during biofilm formation. The authors found that the *B. subtilis* AP91 were able to precipitate crystals of  $\text{CaCO}_3$  with the same morphology as other researches [11,36-40].

The filling of cracks up to 0.19 mm were visible in concretes with addition of spores of *B. subtilis*. However, in the samples without spores addition, precipitated material was not visible and the crack remained with the same feature throughout the curing period analyzed.

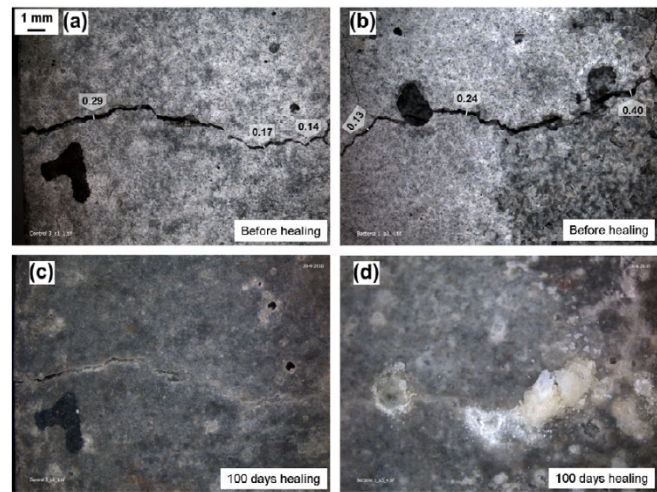
Fig. 6 shows the crystals formed by calcium carbonate precipitation promoted by the bacterium *B. alkalinitrilicus* added with a nutrient source and curing totally submerged under water for the healing regime [3]. It was observed that there was closure of the cracks from 0.13 to 0.40 mm thickness after 100 days of curing. Similar results were found in this research. Besides the above referenced authors, similar results using the bacterium *B. sphaericus* have been presented [18].

Figure 6. Stereomicroscopic images of crack-healing process in control mortar specimen before (a) and after 100 days healing (c), in bio-chemical agent-based specimen before (b) and after 100 days healing (d). Source: [3].

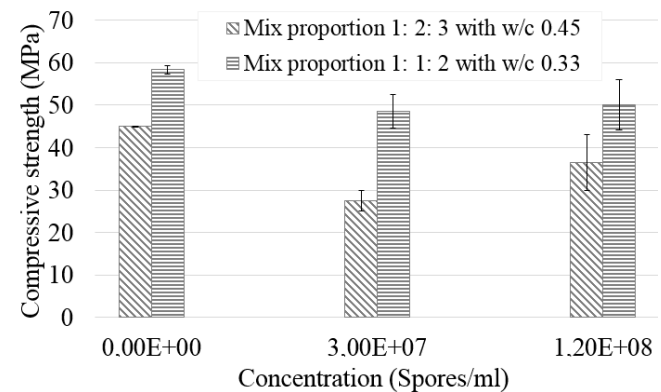
Figure 7. Compressive strength of concretes.

The compressive strength test was performed on the 28th day of curing and the results are shown in Fig. 7. There was a difference in resistance between the compositions due to the proportions of materials used and the water/cement ratio (w/c), with higher resistance for the mix proportion 1:1:2 compared to w/c of 0.33 and without addition of bacteria, and the lowest resistance for the mix proportion 1:2:3 with w/c of 0.45.

Through the analysis of the results, it was noted that there was a decrease in the mean resistance of samples with added spores when compared to the reference. This decrease in the mix proportion 1:1:2 was of 20.06 and 16.58% for the treatments  $0.3 \times 10^8$  and  $1.2 \times 10^8$  spores/mL, respectively. For the mix proportion 1:2:3, the difference was greater, corresponding to 63.63 and 23.28% for the treatments  $0.3 \times 10^8$  and  $1.2 \times 10^8$  spores/mL.

There was an increase in the resistance of the samples with  $1.2 \times 10^8$  spores/mL compared to the ones with  $3.0 \times 10^7$  spores/mL in both mix proportions, demonstrating that the
