Ley-Paredes, Victor José; Ríos-Soberanis, Carlos Rolando; Pérez-Pacheco, Emilio; Vinajera-Reyna, Carlos Emilio; Wakayama, Shuichi; Sakai, Takenobu  
Experimental studies on the mechanical behavior of Mayan archeological rocks  
DYNA, vol. 86, no. 208, 2019, January-March, pp. 227-233  
Universidad Nacional de Colombia

# Experimental studies on the mechanical behavior of Mayan archeological rocks

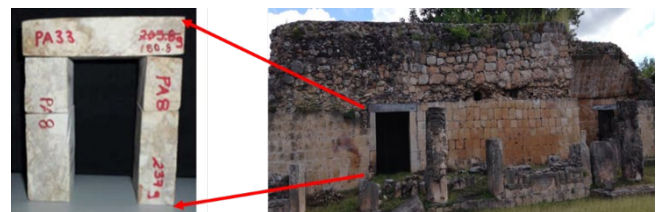
Figure 10. Schematics of archeological lintel as a horizontal structural part that is placed above across the opening.
