Ramírez-Barrantes, Juan Carlos; Quesada-Rojas, Francisco Javier  
Biomechanical and Chemical Behavior of Various Bioactive Materials in Class II Restorations  
Odontos International Journal of Dental Sciences, vol. 25, no. 1, 2023, January-April, pp. 44-57  
Facultad de Odontología. Universidad de Costa Rica

## BASIC RESEARCH

### Biomechanical and Chemical Behavior of Various Bioactive Materials in Class II Restorations

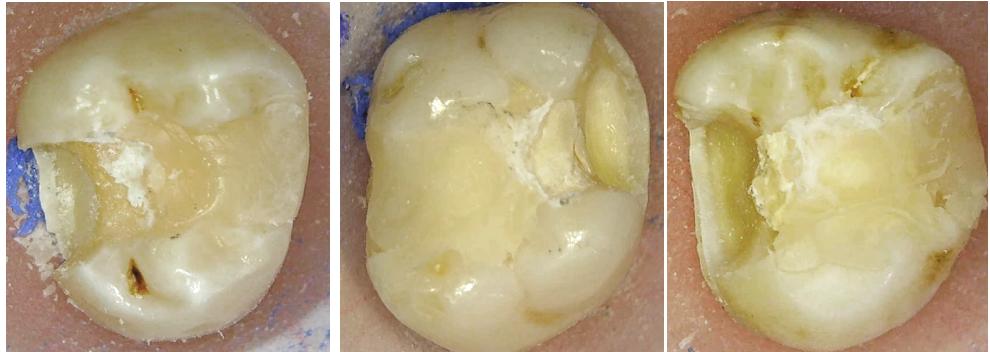
**Figure 3.** Representative failure types in each group.

The modes of fracture of all the groups are described in Figure 2 and Figure 3. Group 1 displayed most samples with root failure beyond repair (60%) and failure at restorative material and cervical structure (40%). In Group 3, a mixed-

mode of failure was observed, being predominant in categories 2 (40%), 3 (40%) and 4 (20%). Group 4 showed 30% of the samples with failure at category 3, 60% at category 2, 10% at category 1, and just one sample with root failure beyond repair. Group 2 displayed failure at the restorative material in 80% of the samples.
