Baracaldo, Rodolfo Rodríguez; Camargo Santos, Mauricio; Acosta Echeverría, Miguel Arturo
Effect of flash butt welding parameters on mechanical properties of wheel rims
Scientia Et Technica, vol. 23, no. 1, 2018, January-March, pp. 51-57
Universidad Tecnológica de Pereira
Colombia

Effect of flash butt welding parameters on mechanical properties of wheel rims

Rodolfo Rodríguez Baracaldo, Mauricio Camargo Santos, Miguel Arturo Acosta Echeverría
Ingeniería mecánica, Universidad Nacional de Colombia, Sede Bogotá., Bogotá, Colombia.
 Correo-e: rodriguezba@unal.edu.co

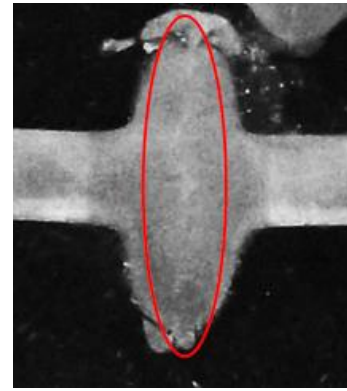
Figure 7 shows optical microscopic images of the transversal section of the welded joint. It is observed a white vertical line which refers to decarburized layer due to the carbon of base metal diffusing into the welded area during flashing process which is expelled in the upsetting process. Decarburization is characteristic on this type of resistance welding. Kim et al., also reported these kinds of discontinuities in their work about effect of FBW parameters on the mechanical properties of steel mooring chains for offshore structures [9].

Figure 7. Optical Micrographs of macro section of Flash Butt Welding. White line indicates the decarburized zone.

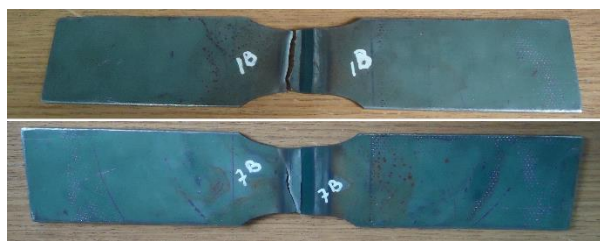
Figure 8 shows the specimens with treatment 1 and 7 already tested. These are the ones which presented better and outstanding ductility and tensile strength values. The welding parameters with the defined operating conditions, such as low-level voltage (LV), low upset height level (LUH), and low flashing time level (LFT), can be seen in table 3. Those specimens showed suitable properties because of the welding process parameters which allow for the ring manufacturing.

Figure 8. Tensile test specimens which presented a fracture outside the welded joint; a) with treatment 1 and b) with treatment 7.
