Furrier, Max; Silva Barbosa, Tamires  
GEOMORPHOLOGY OF JOÃO PESSOA MUNICIPALITY AND ITS ANTHROPOGENIC  
AND ENVIRONMENTAL ASPECTS  
Journal of Urban and Environmental Engineering, vol. 10, núm. 2, 2016, pp. 242-253  
Universidade Federal da Paraíba  
Paraíba, Brasil

## GEOMORPHOLOGY OF JOÃO PESSOA MUNICIPALITY AND ITS ANTHROPOGENIC AND ENVIRONMENTAL ASPECTS

Max Furrier\* and Tamires Silva Barbosa

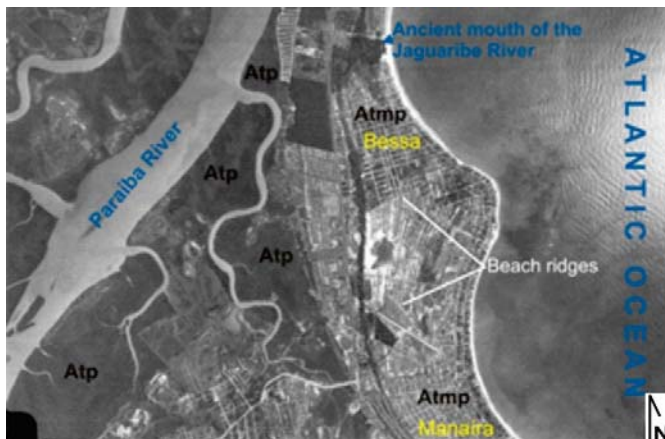
**Fig. 3** Aerial photograph of Bessa and Manáira districts and their surroundings, showing the beach ridges that were not urbanized in 1985.

**Marine plain and terraces (Atmp):** beach and inland beach ridge areas (Figure 3) formed by decreasing sea level since the last transgression, which occurred in Brazil at 5100 before present (BP) (Suguio & Martin, 1978). These areas extend for over 10.6 km<sup>2</sup> or 6% of the municipality and are found in Ponta do Seixas, Cabo Branco, Tambaú, Manáira and Bessa districts. The marine plains consist of the area from the current beach to the high spring tide mark. The fluvial terraces are the old marine plains that no longer flood during high tides because of the decreases in sea level over the past 5,100 years. These areas are flat and prone to flooding during the rainy season at the sites that lack engineering works to control fluvial drainage.

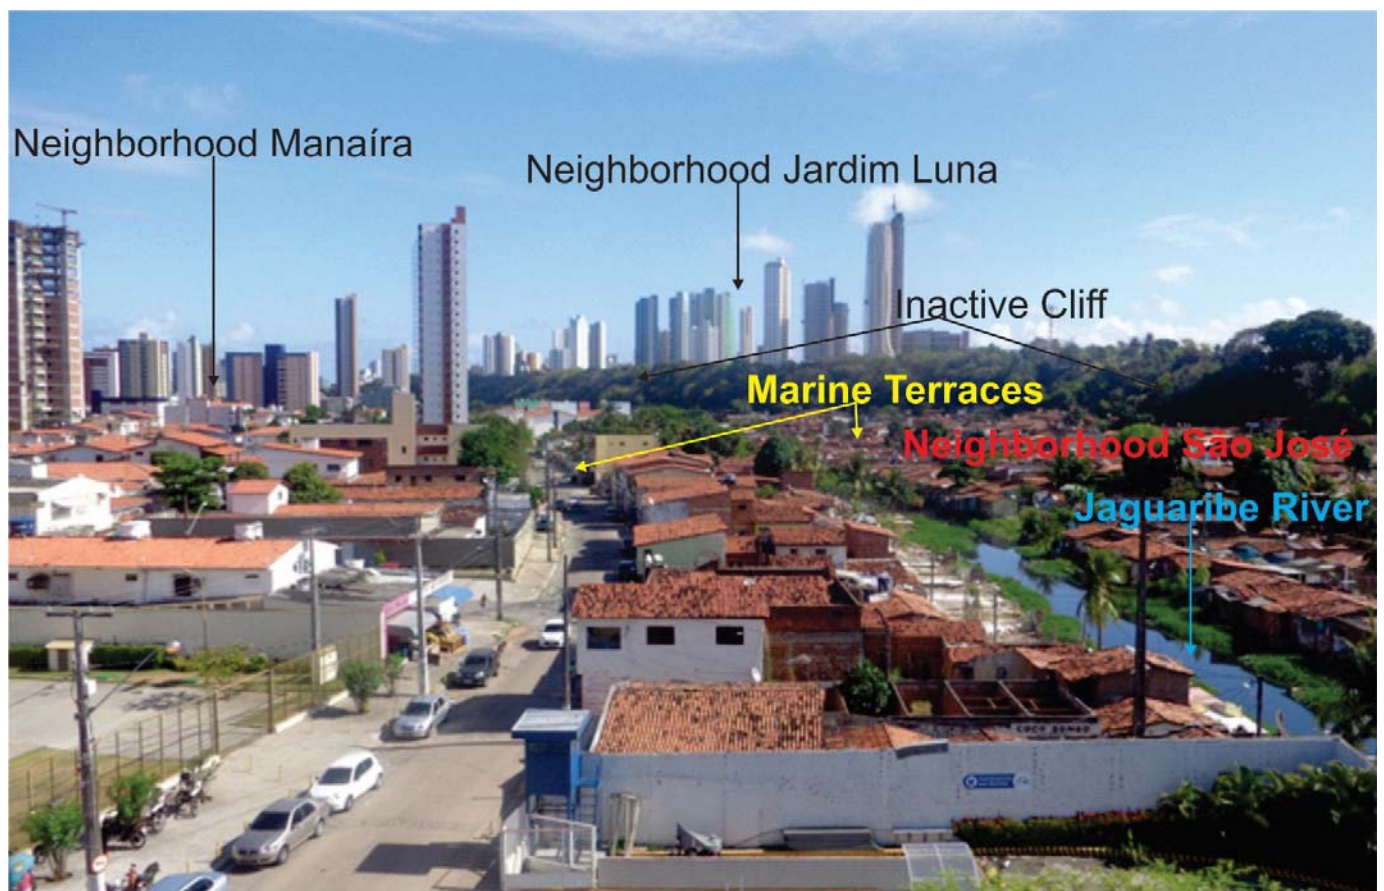
**Fig. 4** The line of inactive cliffs covered by vegetation is visible in the background. The São José neighborhood developed over the marine terraces is shown in the foreground. The line of inactive cliffs relates to the last transgressive event, which reached its peak in Brazil at 5,100 BP (Suguio & Martin 1978).

The inactive cliffs are visible and easily identified at the inland of São José district, north of the municipality

(Fig. 4). This community is clearly exposed to geological risks because of the likelihood of mass movements because the cliff has been impacted by new dwellings, and frequent floods occur because of the heavy geomorphological degradation of the Jaguaribe River and colmatation caused by excessive garbage dumping. Unfortunately, the neighborhood of São José is directly affected by the river Jaguaribe and is at risk of mass movements of inactive cliff that separates the districts of Jardim Luna and Bairro dos Ipês (Fig. 4).

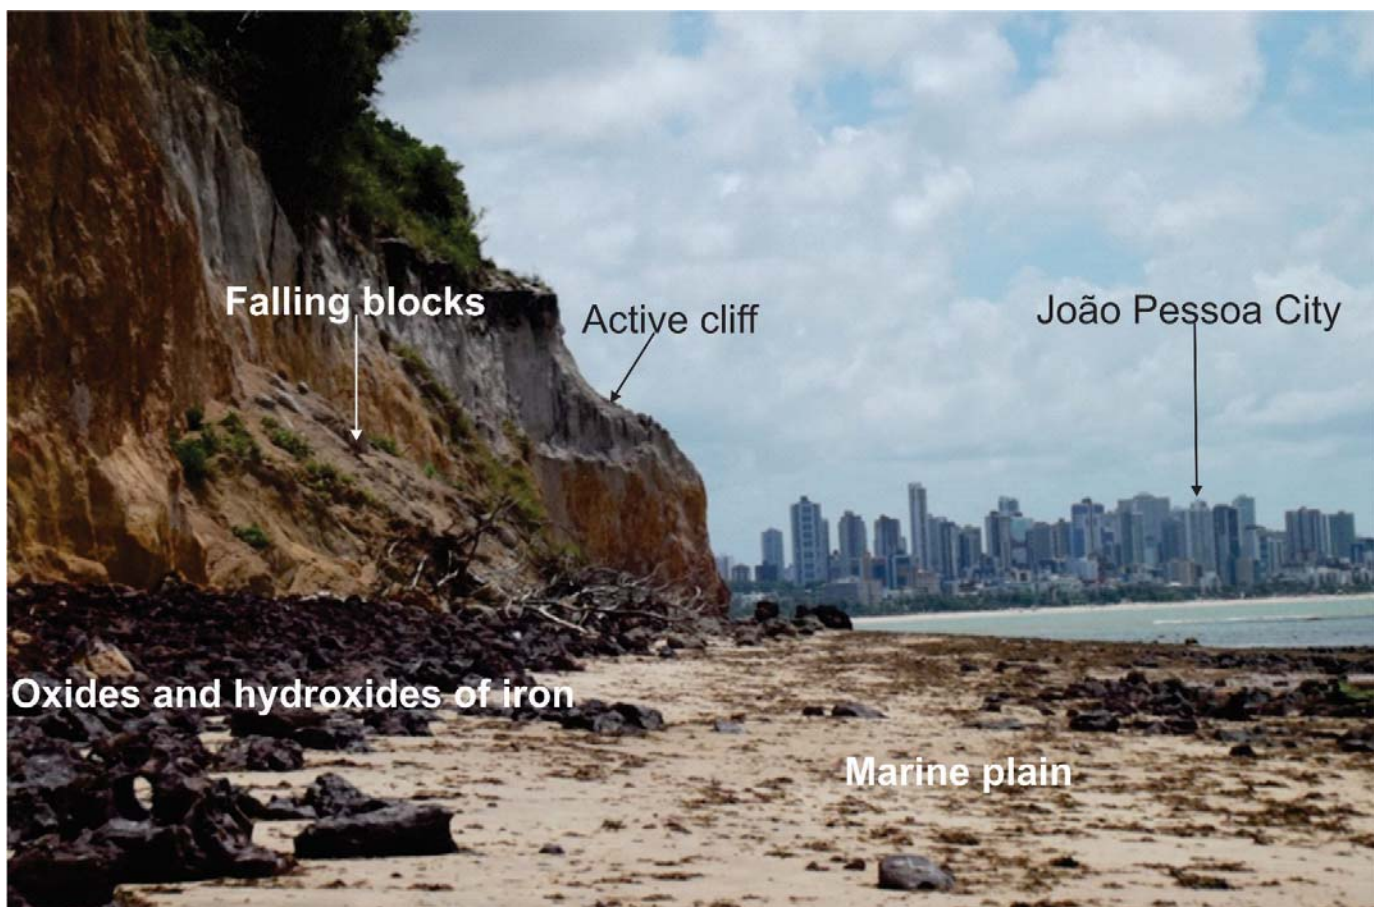
Fig. 5 Rock falls at the active cliff of Cabo Branco. Photo taken by the author in 2014.

In the active cliffs located at the south of the municipality, the main risk is related to landslides because the cliff base is undermined by wave action, which is enhanced when the spring high tide and storms coincide. Urbanization on the cliff tops increases the weight affecting the landforms and increases the risk during construction and with increased traffic, particularly by heavy vehicles. It is worth noting that the local geology consists solely of poorly consolidated sediments of the Barreiras Formations (extremely soft rocks). Evidence of localized frequent landslides has been observed on the active cliffs that separate the

southern area of Cabo Branco district from the northern area of Ponta do Seixas district (Fig. 5).

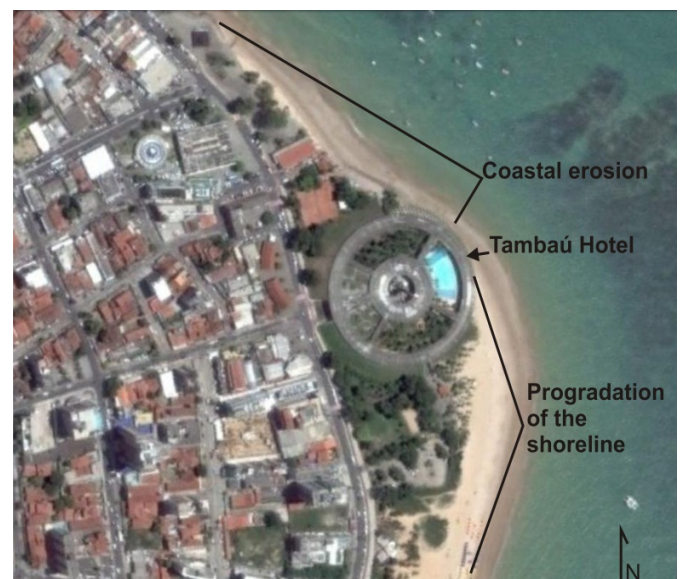
**Fig. 6** Hotel Tambaú showing the prograding Tambaú Beach to the south and the eroding Manaíra Beach to the north.

Sediment deposition in the northern sector of Tambaú Beach created a sediment deficit (Figure 6) in the southern sector of Manaíra Beach, where intense coastal erosion resulted in the collapse of an old pier and allows waves during spring tides to reach the seawall that protects the promenade.

The Hotel Tambaú acts as a sediment trap because it influences littoral drift by abruptly separating a shoreline under progradation from a sector experiencing shoreline retreat by a few hundred meters, thereby eliminating the possibility that shoreline erosion in Manaíra was caused by natural processes. The presence of the hotel will always promote the accumulation of sediment updrift and erosion downdrift causing serious problems of coastal erosion along the southern sector of Manaíra Beach.
