Hundelshaussen Rubio, Ricardo; Florez, Jorge Hernan; Zingano, André Cezar  
Slope stability analysis at highway BR-153 using numerical models

Rem: Revista Escola de Minas, vol. 69, núm. 2, abril-junio, 2016, pp. 185-191

# Slope stability analysis at highway BR-153 using numerical models

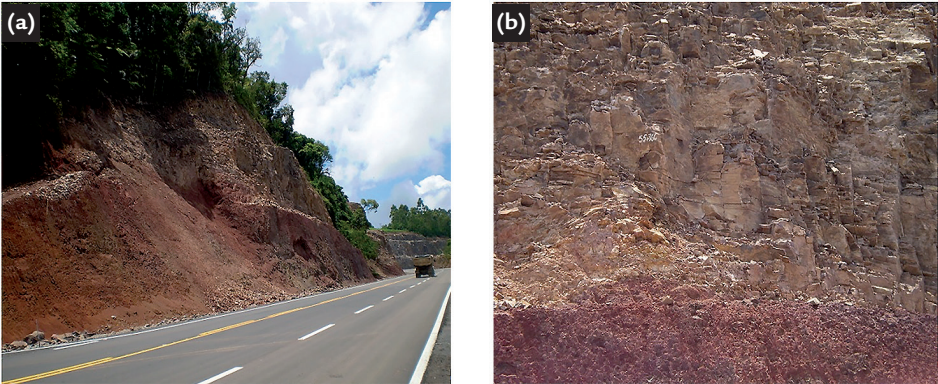
sequence (with the volcanic breccia on the top) and the acid sequence (with the rhyolite as its base). The studied slope is at k55+340 of the construction project, between altitudes of 505 and 480 m, corresponding to a half-hillside and a homogeneous cut section. No regional faulting is found at this point

(see Figure 2). The rhyolite layer has a low degree of weathering, but a high level of fracturing (5–50 fractures/m). This situation is currently causing constant rock falls (Varnes 1978; Cruden and Varnes 1996). No global rupture has been observed, at least in this slope.

Figure 2  
(a) Overview of the studied slope.  
(b) Fracture condition on the rhyolite layer.

The distribution of displacement vectors presented in Figure 7 confirms the main source of rock particle falls, which are deposited on the lower part of the slope as well as on the highway (see Figure 2b). There exist a few points

namely, continuity of stresses above and below it. The highest levels of tension arise at the foot of the slope, reaching yielding levels in the breccia and causing local rupture of the material (see Figure 2a).

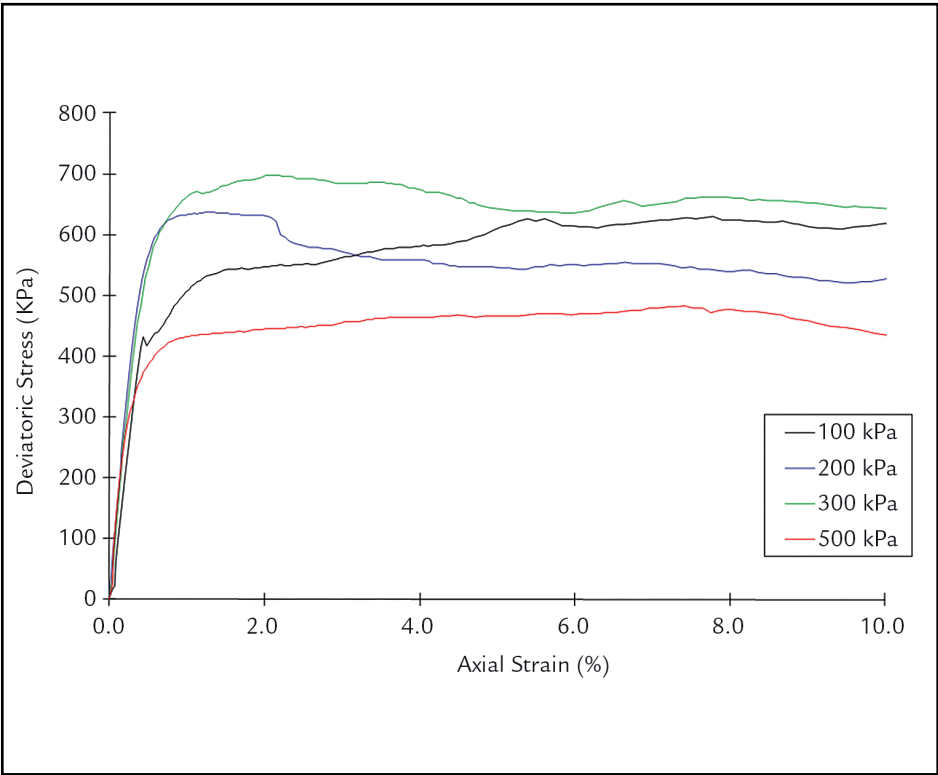
the angles of friction and the cohesion were estimated from the results of CIU triaxial tests, made in undisturbed test bodies (see Figure 3).

Figure 3  
Deviatoric stress versus axial  
strain for k55+340 (LMS-UFRGS 2004).

elasticity was calculated from linear elastic sections obtained from each of the triaxial compression tests. The

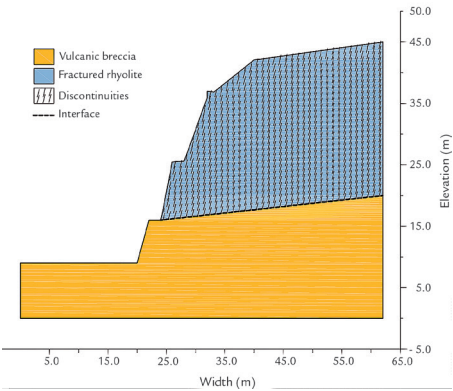
Figure 4 presents the model to be evaluated, including the system of discontinuities of the rhyolite. For the analyses ignoring the presence of discontinuities, the geometry of the

Figure 4  
Model of the evaluated section.

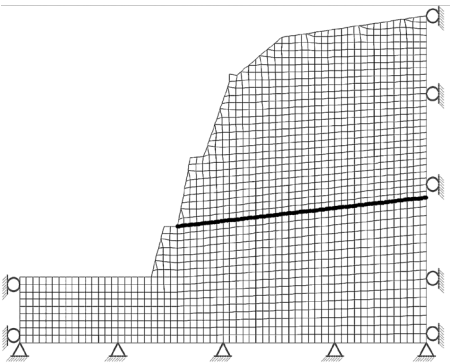
without discontinuities are obtained as part of the results of the simulation process. Figure 5 presents the element mesh for this analysis, as well as the boundary conditions imposed on the

model. The thick black line indicates the interface defined by the material

Figure 5  
Mesh of elements with fixed areas.

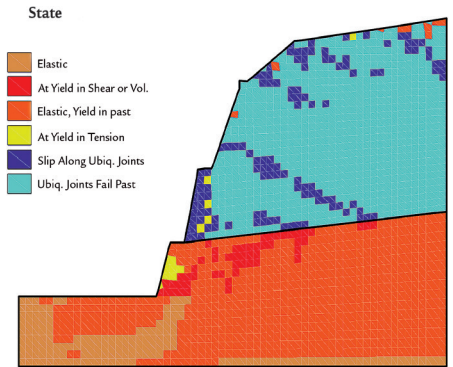
rupture surfaces for continuum materials according to the Mohr–Coulomb criterion, allows visualization of the effects of ruptures associated with sliding along different discontinuities. Figure 6 presents different states for the elements of which the model is composed, enabling visualization of the elements under instability, either for the

curved surfaces of rupture (see the volcanic breccia) or for the sliding of the elements along the discontinuities. In the center of the rhyolite mass, it is also possible to observe the presence of consistent slide surfaces with the formation of alleviating tensions caused by the lateral expansion (in the lower part of the rhyolite layer).

Figure 6  
States of the model (with *Ubiquitous-joint*).

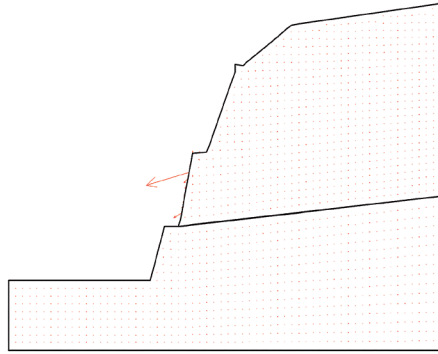
of origin of rock falls in the upper part of the layer, mainly caused by the slope declivity angle. The distribution of shear stress presented in Figure 8 is consistent with the condition imposed on the interface between the two layers,

Figure 7  
Displacement vectors  
(with Ubiquitous-joint).

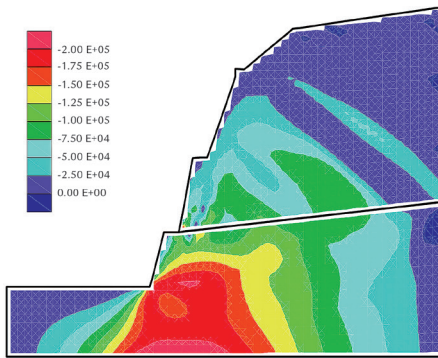
Figure 8  
Shear stress  $S_{xy}$  (with Ubiquitous-joint).

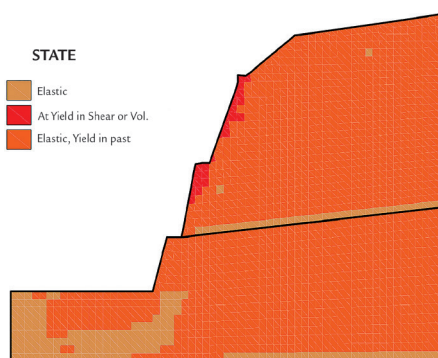
Figure 9 shows the results of this

simulation. The properties of the breccia were not decreased, since the existence of a rupture surface in the breccia influences its propagation along the rhyolite layer. For the given angle of declivity of the slope, the angle of friction for the rhyolite given by the simulation is not consistent with any values in literature: however, it does predict shallow failures (see Figure 10). These flat ruptures retain the form predicted by a Mohr–Coulomb model, exhibiting a rupture surface curve.

Figure 9  
States of the model  
(continuous, flat rupture).

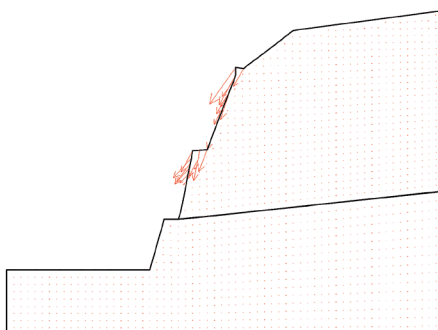
Figure 10  
Displacement vectors  
(continuous, flat rupture).

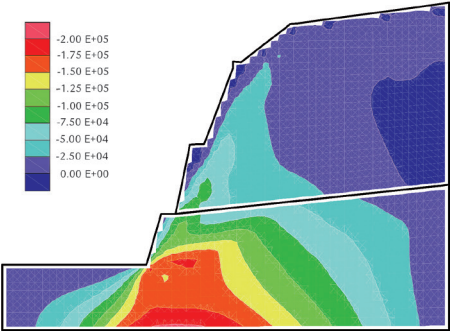
The distribution of shear stress presented in Figure 11 suggests a reduction

in the levels of shear stress in the areas next to the slope face, but the condition of

maximum tension at the foot of the slope is maintained.

Figure 11  
Shear stress  $S_{xy}$  (continuous, flat rupture).

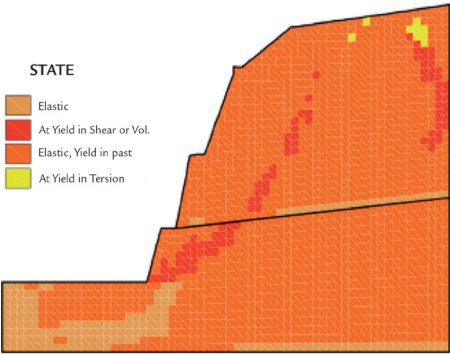
Figure 12 presents different states of the model. No surface rupture was observed in the slope. The value for the angle of friction of the rhyolite was adopted because of the

Figure 12  
States of the model  
(continuous, deep rupture).

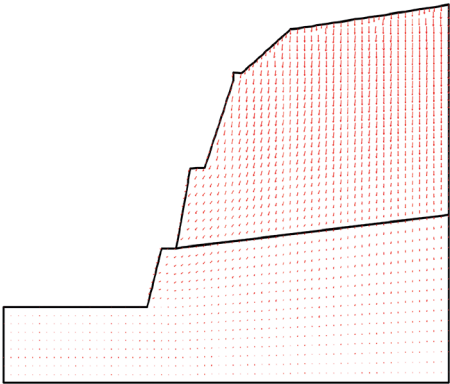
sensitivity of this material to a rupture surface from the breccia. With this value of the angle of friction, the susceptibility of the rhyolite remained low, although it should be pointed out that it is a theoretical value, not necessarily representative of realistic situations. It can be seen from Figure 13 that it was not possible to obtain significant horizontal displacements along the slope face, confirming the absence of boulders in unstable condition, and therefore, denying the possibility of rockfalls.

Figure 13  
Displacement vectors  
(continuous, deep rupture).

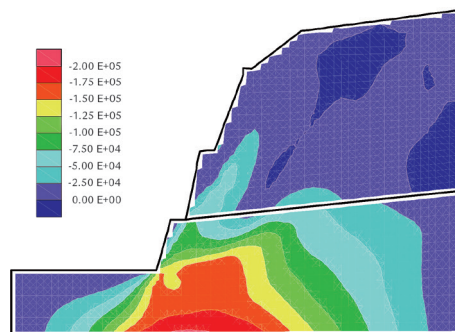
The distribution of shear stress presented in Figure 14 is similar to those obtained in the previous cases, but with a reduction in the stress concentration at the foot of the slope. Although the concentration of shear

stress at the foot is reduced, there is a concentration of the mechanical response in the volcanic breccia layer, representing a minor mechanical contribution for the rhyolite, with an absence of ruptures in the slope face.

The plastification zones inside the rhyolite mass are associated with a Mohr–Coulomb failure surface along the slope, initiated by the rupture in the breccia.

Shear stress  $S_{xy}$  (continuous, deep rupture).
