Water table monitoring in a mined riparian zone

Ambiente & Água - An Interdisciplinary Journal of Applied Science, vol. 5, núm. 1, abril, 2010, pp. 29-42

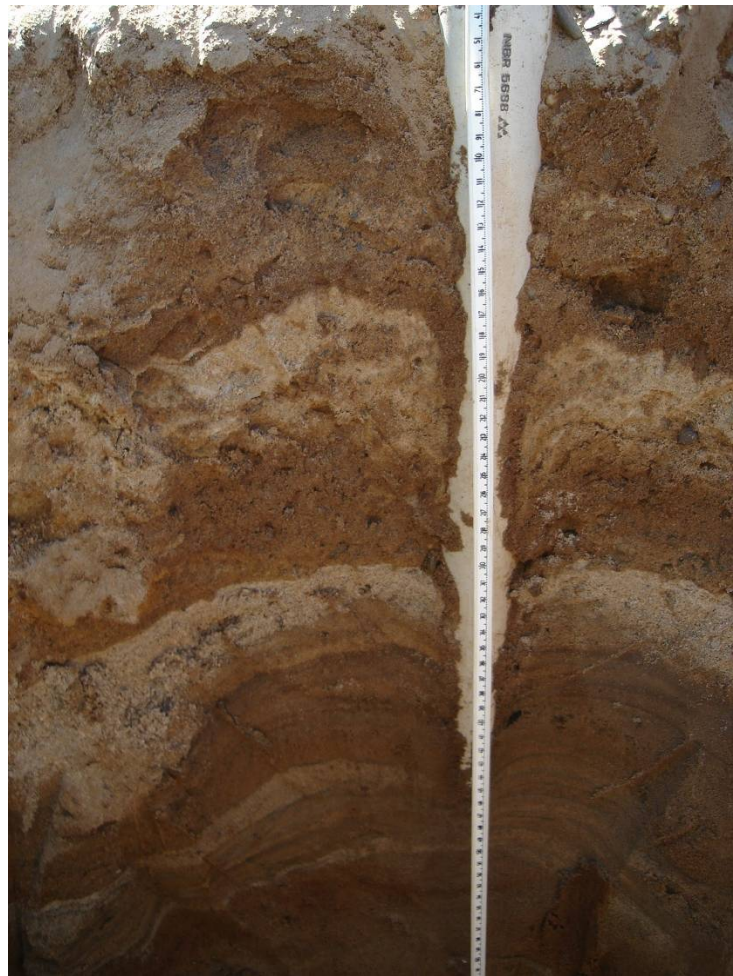
The sediment reposition after mining was done in a way that different layers were formed. Figure 8 shows a soil profile at area 1 and the effect of the well drilling upon it. The upper 50 cm presented several distinct layers organized in an heterogeneous pattern, while after that it became more homogeneous. Piezometers perforation had altered the layer's structure, as it pushed particles downward at the well, forming a funnel shape design. This new configuration of the layers, however, may contribute to an overestimation of water table data by promoting a higher infiltration rate just around the well and also orienting the water to a less permeable stratum. Furthermore, overestimation might be increased by water flow through the external surface of the PVC cover.

Figure 8. Soil profile from 0 to 60 cm at the location of piezometer 1.1 at the *Gualaxo do Norte* River Watershed, Minas Gerais, Brazil, 2007.
